*An autopsy study of a fouled reverse osmosis membrane element used in a brackish water treatment plant*

Gray, Stephen, Tran, Thuy, Bolto, Brian, Hoang, Manh and Ostarcevic, Eddy (2007) An autopsy study of a fouled reverse osmosis membrane element used in a brackish water treatment plant. *Water Research*, 41 (17). pp. 3915-3923. ISSN 00431354

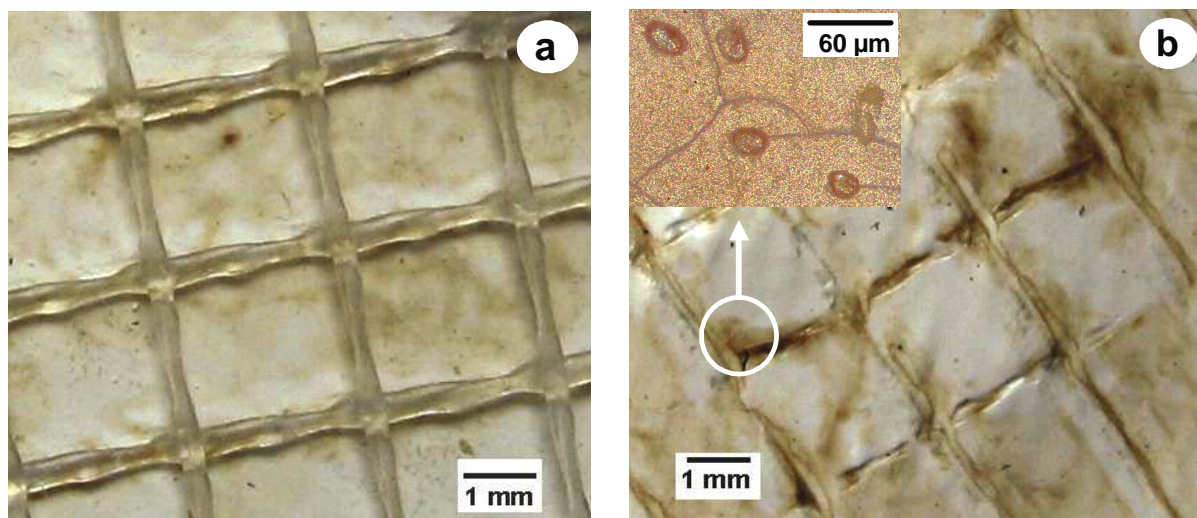
**Figures 1a and b:** Optical images of the membrane surface before (a) and after (b) the feed spacer was removed.

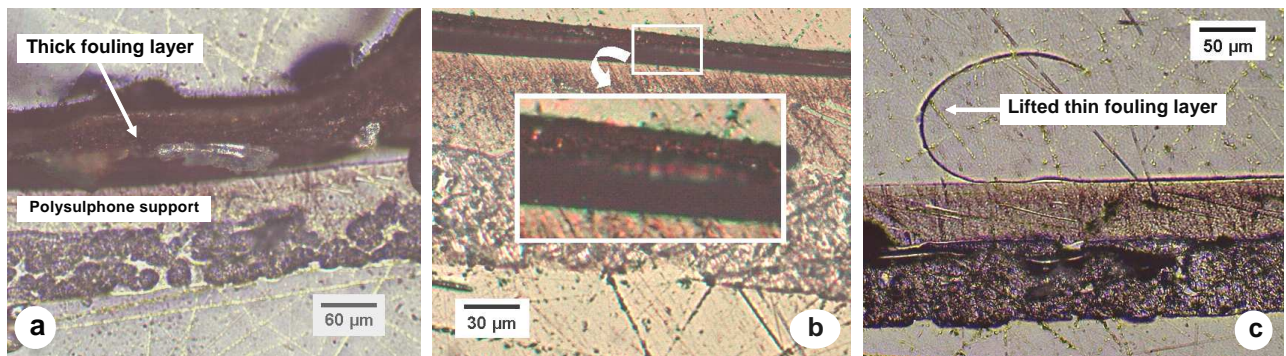
**Figures 2(a), (b) and (c):** Optical images showing: (a) a thick fouling layer in regions near the spacer strands; (b) and (c) fouling layer with varying thickness in regions located further away from the strands.

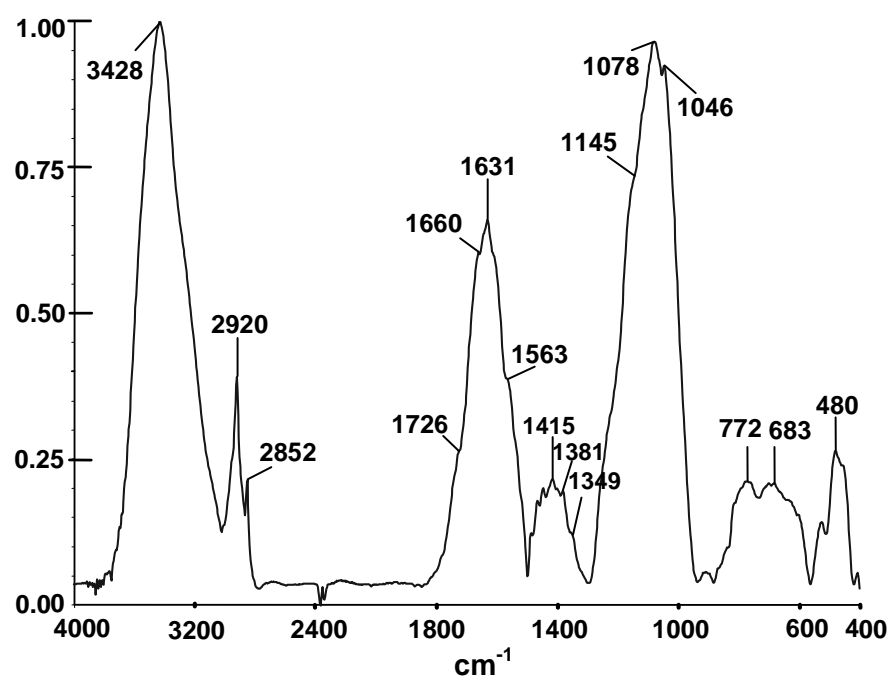
**Figure 3:** FTIR spectrum of the fouled membrane extract.

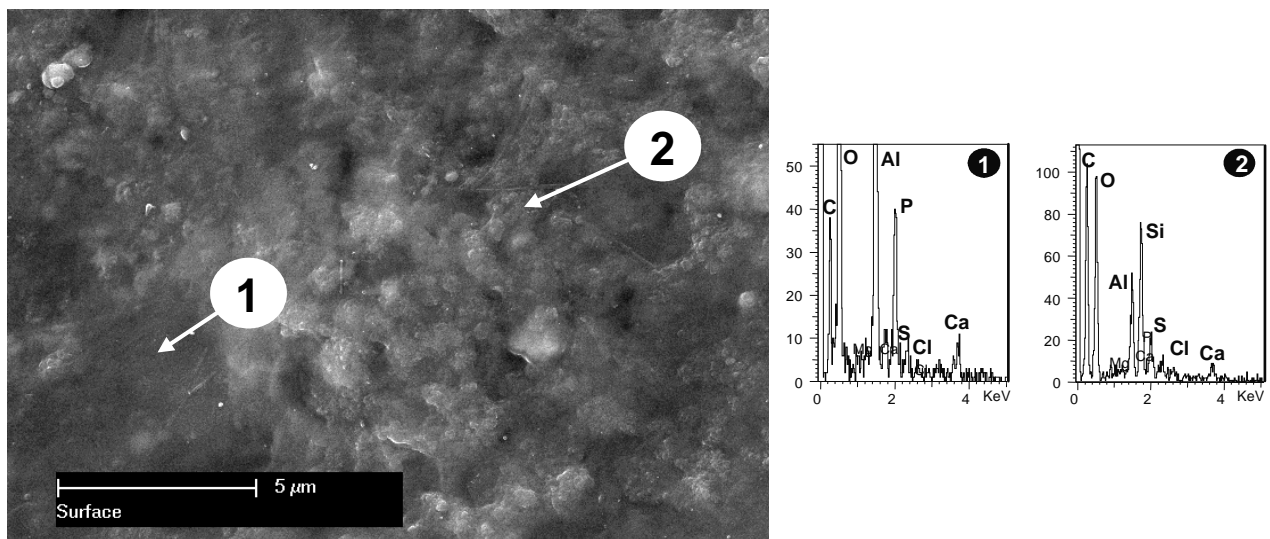
**Figure 4:** SEM micrograph and associated EDS showing particulate matter embedded in an amorphous matrix.

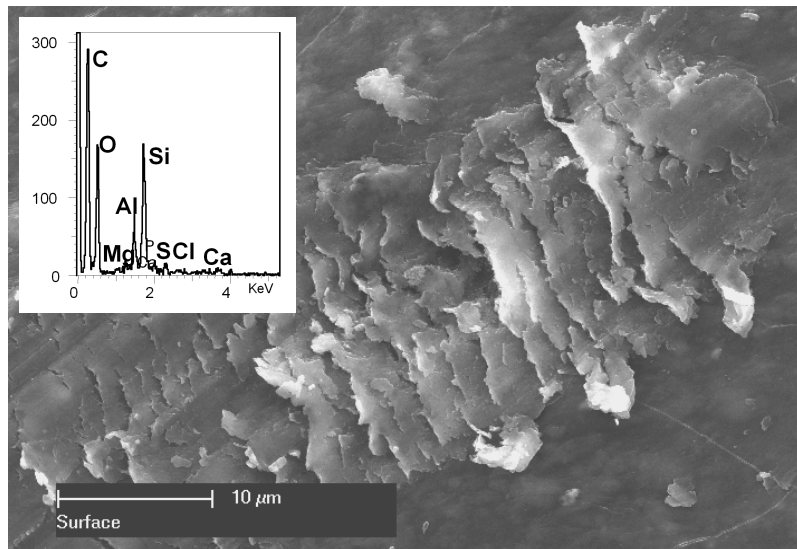
**Figure 5:** SEM micrograph and associated EDS showing aluminium silicate scaling.

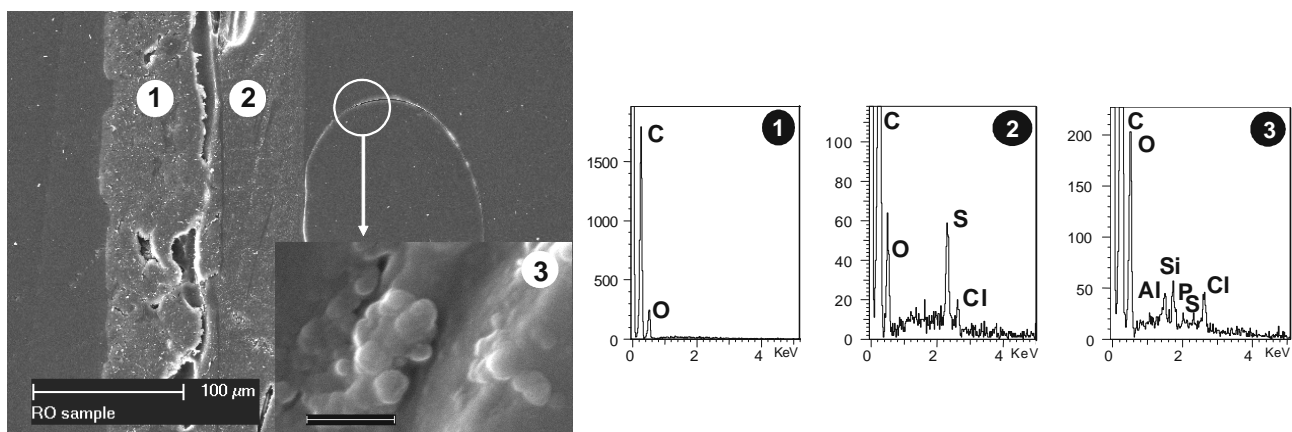
**Figure 6:** SEM micrographs showing a thin fouling layer at different magnifications and associated EDS analyses. Bar (inset) = 500 nm.

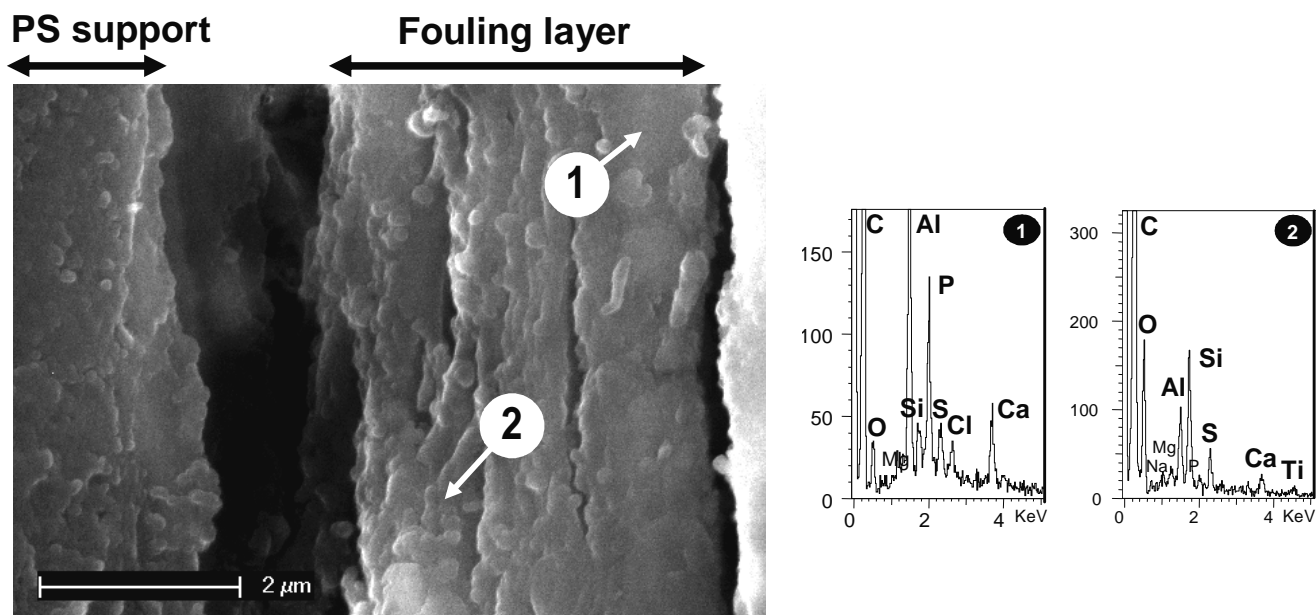
**Figure 7:** SEM micrograph and associated EDS analyses showing a thicker fouling layer.

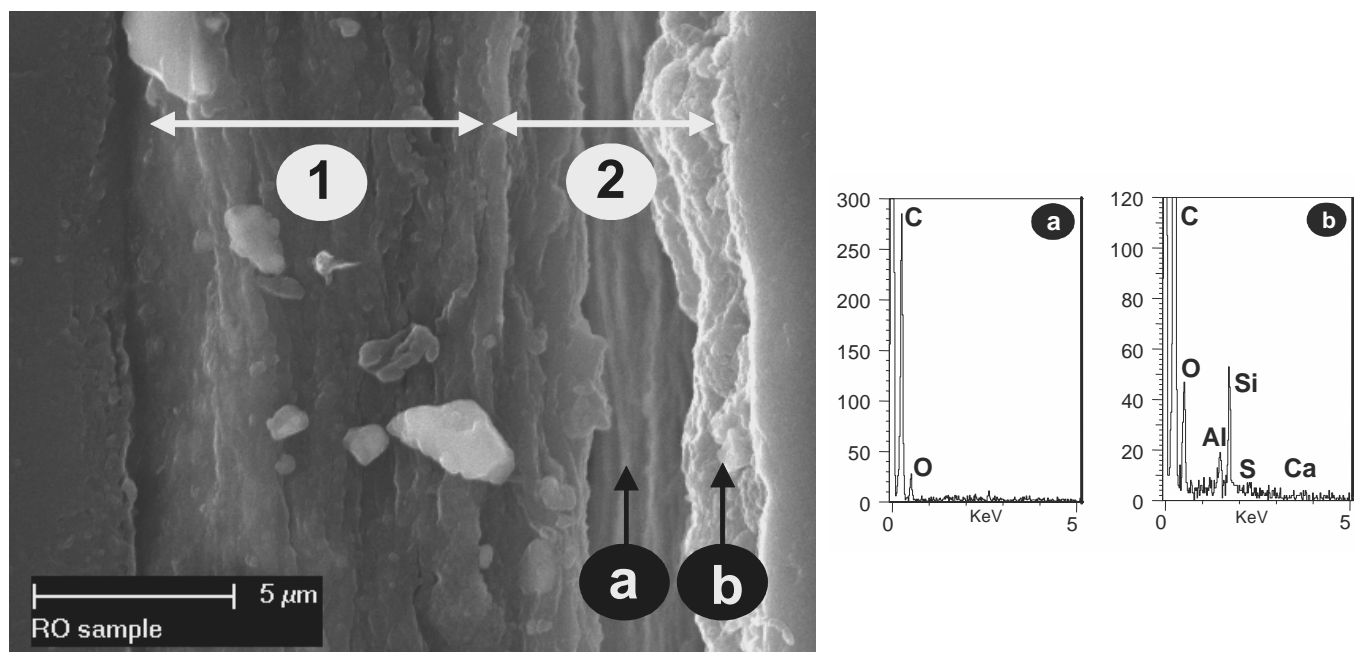
**Figure 8:** SEM micrograph showing two distinct Regions (1 and 2) of a thick fouling layer and EDS analyses of the inner amorphous (a) and outer crystalline (b) layers of Region 2.
