International High- Performance Built Environment Conference – A Sustainable Built
Environment Conference 2016 Series (SBE16), iHBE 2016

Temperate climates, warmer houses and built fabric challenges

Mark Dewsbury^{a,*}, Tim Law^a

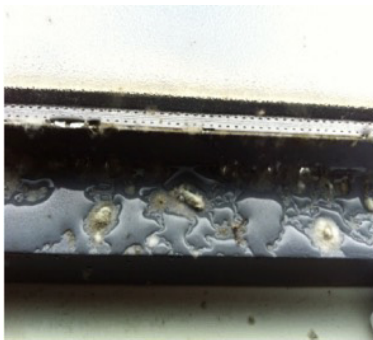
Fig. 1. Excessive condensation and mould on aluminium window.

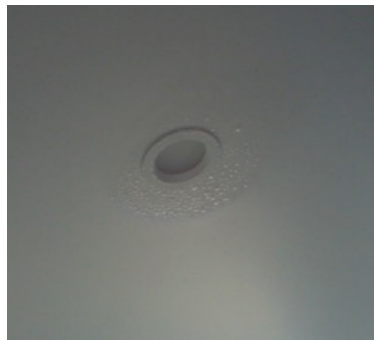
Fig. 2. Condensation forming around downlights.

- The conditioning pattern created a very significant and constant vapour pressure driver from the level 2 rooms to the external walls and roof space.
- The flow of vapour into the roof space is further supported by the number of holes in the ceiling fabric caused by the use of down lights, cavity sliding doors and the bathroom ventilator.
- It can be clearly seen that the environmental conditions near to the sarking were nearly always at saturation temperature, causing the constant presence of significant condensation on the sarking material.

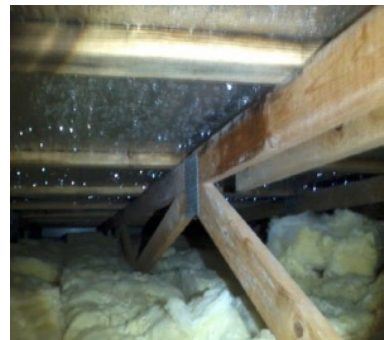
Fig. 3. Condensation forming in roof space.

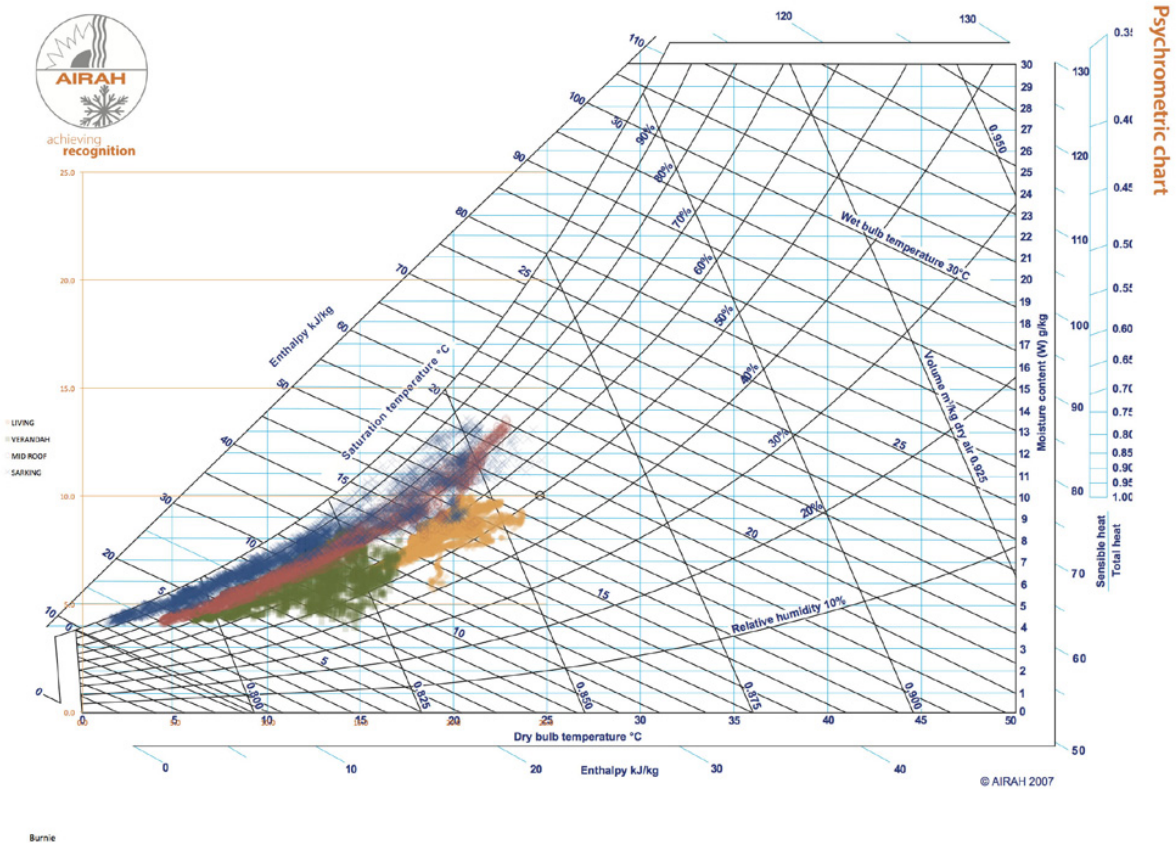
Fig. 4. Burnie psychrometric chart.

The detailed measurement established empirical data documenting areas within the built fabric that had very high levels of moisture and saturation, as shown in the psychrometric charts of Fig. 4 and Fig. 5. In Fig. 4 the Orange/Yellow = Level 2 living room, the Green = Site conditions, the Red = Level 2 mid roof space and the Blue = Near Level 2 roof space sarking. This chart is typical of the several months of data which was collected and highlights some distinct patterns, namely:

- The temperature within the Level 2 living room is always considerably warmer than the site air temperature. This is due to the home owners thermal comfort expectations and has been achieved through the use of a reverse-cycle air-conditioner on a 24 hour, 7 day a week basis.

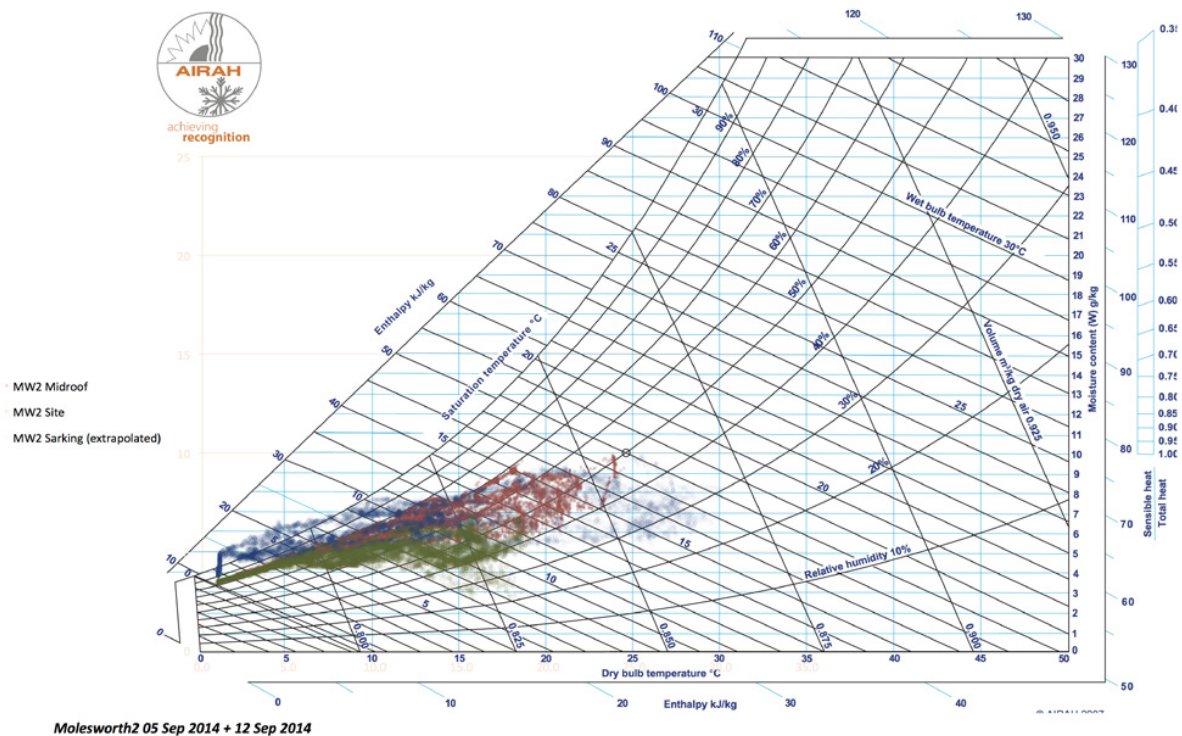
Fig. 5. Molesworth psychrometric chart.

Fig. 5, below, shows one of the psychrometric charts for a new home in Molesworth. In this graph the Red = mid-roof space, the Blue = sarking, the Orange = living, and the Green = site conditions. This psychrometric chart, documents that the mid roof temperature and humidity were both higher than site conditions. This was caused by the additional energy and moisture created within the house through human occupation and heating. The sarking conditions are based on the measured sarking temperature taken with the concurrent measurement of mid-roof absolute humidity. Where the data extended beyond the saturation curve (i.e. on the left of the 100% RH curve) condensation can be expected, and it occurs frequently in this graphical analysis and in corresponding time-lapse photographs from this roof space. The constant high moisture environment resulted in regular data logger resistor failure. The high condensing environments in the measured houses roof spaces proved to be a challenging condition for the relative humidity sensors and data logging equipment.

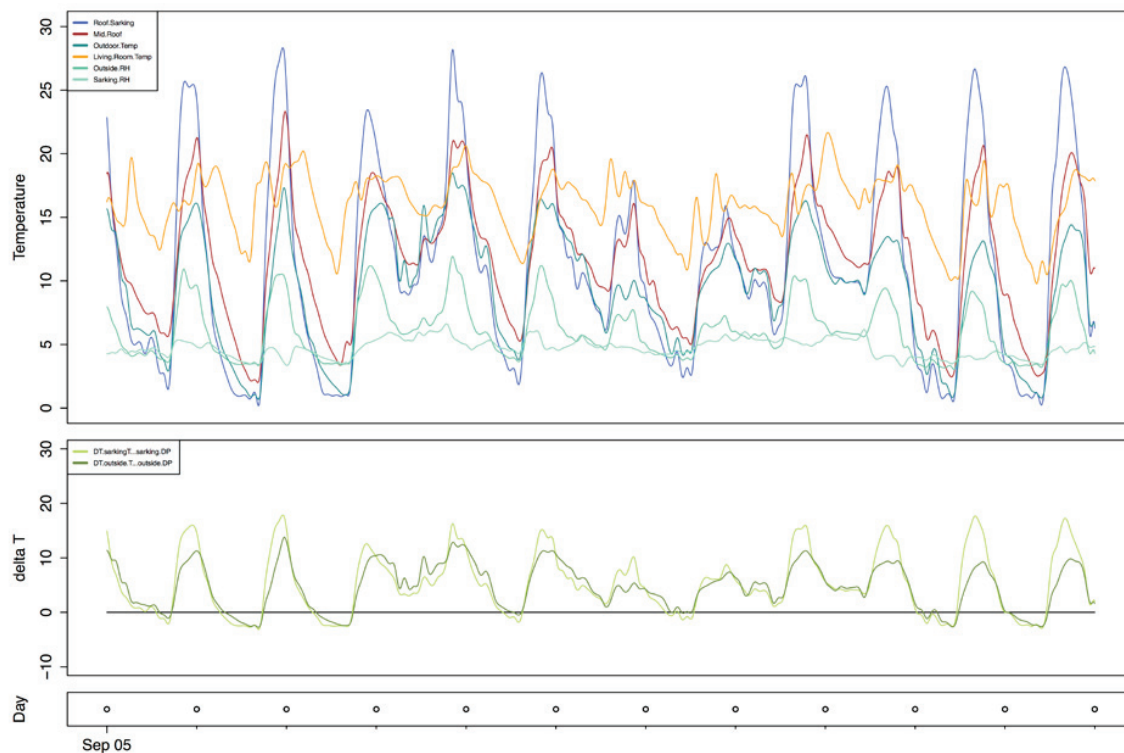
Fig. 6. Molesworth composite temperature graph.

Fig. 6 below, shows a sample of the measured temperatures for the Molesworth House recorded from 5-16 Sep 2014. This graph shows some regular flat-lining of the minimum temperatures indicating periods when the moisture

around the temperature sensors was freezing. The lower graph is an analysis of likely dew-point temperatures. Whenever sarking temperature is below dew-point (i.e. when dT [sarking T – sarking DP] is a negative value) condensation can be expected on the inside surface of the sarking. During this eleven day example, condensation was likely to form on the inside surface of the roof space sarking, and this was supported by the surveillance camera imagery. However, due to the regular high moisture content of the roof space, condensation was occurring during daytime and evenings which is not evident from the dew-point analysis. The occurrence of condensation and moisture was not limited to roof spaces. Fig. 7 below shows expanded window reveals in a 8 week old residence. This occurrence, and other obvious forms of excessive condensation caused the home owners to contact the project Building Surveyor. Fig. 8 below shows what the research team found when the external wall cladding and building wall wrap were removed. The wall batt insulation, and timber studs, bottom plate, joist and bearer were all sodden, with timber moisture levels greater than 17%.

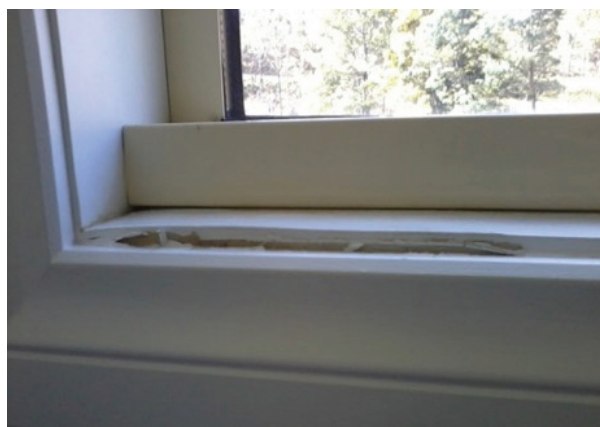
Fig. 7. Expansion and cracking of timber due to moisture pooling at glazing.

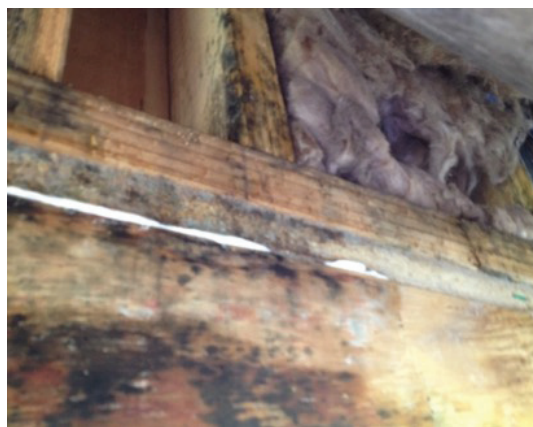
Fig. 8. Mould growth on bearer, joist, wall batts and gaps left in wall insulation.

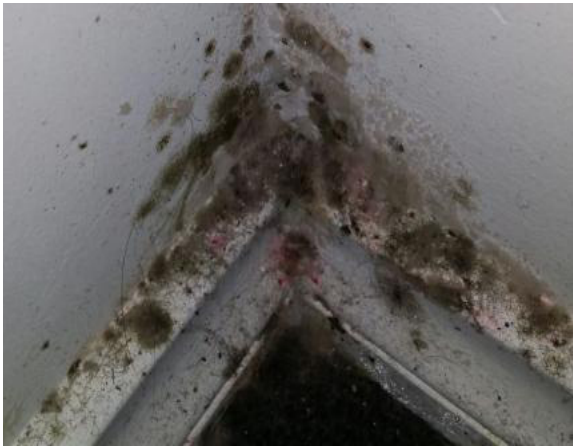
An aspect that is not fully comprehended in Australia is the impact that condensation and mould within buildings has on short and longterm occupant health. In addition to the previous images which showed mould growth, Fig. 9 and Fig. 10 below show some further examples of mould growth in new homes, less than three months old. The benefit of mould growth in Fig. 9 is that it is visible to the home owner and advice can be sought. However, the mould growth on the underside of the foil blanket sarking system, shown in Fig. 10 would often be invisible to most home owners, who rarely look into their roof spaces.

Fig. 9. Mould growth in carpet, wall base, skirting board and on plasterboard.

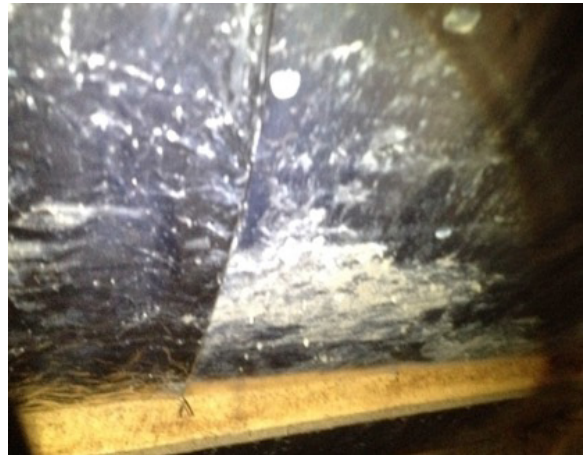
Fig. 10. Mould growth on foil backed blanket sarking system.
