Managed Aquifer Recharge and Recycling Options: Understanding clogging processes and water quality impacts

A report of a study funded by the
Australian Water Recycling Centre of Excellence

Managed Aquifer Recharge and Recycling Options (MARRO)

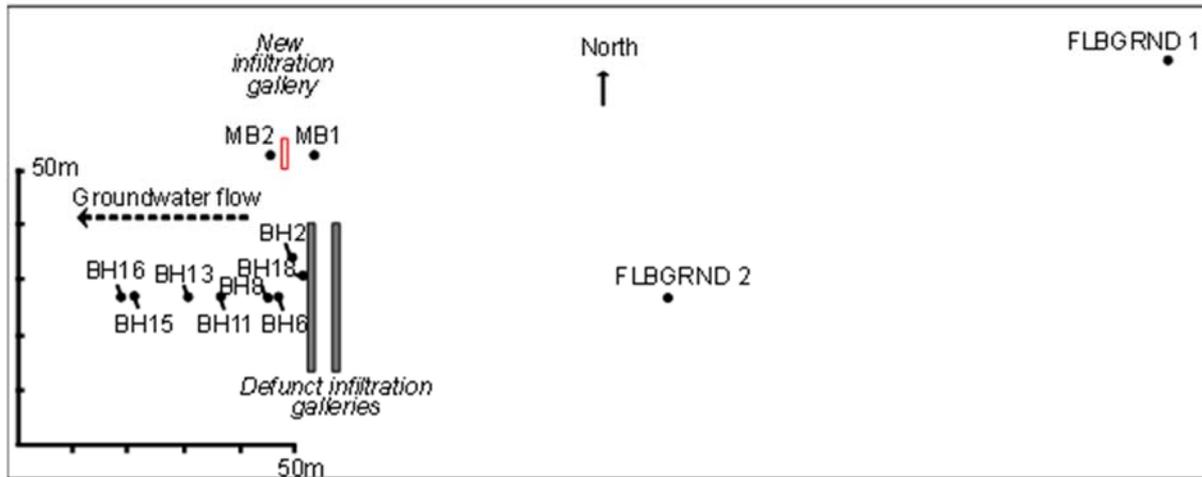
Figure 3 The Floreat MAR site showing the location of the new infiltration gallery, the former (defunct) galleries from a previous study, and monitoring wells that were sampled and used to infer the direction of groundwater flow. There were not enough bores between MB1 and FLGRND1 to delineate groundwater flow paths between these bores; however, groundwater flow to the west was determined at the MAR site using the bores labelled MB and BH.

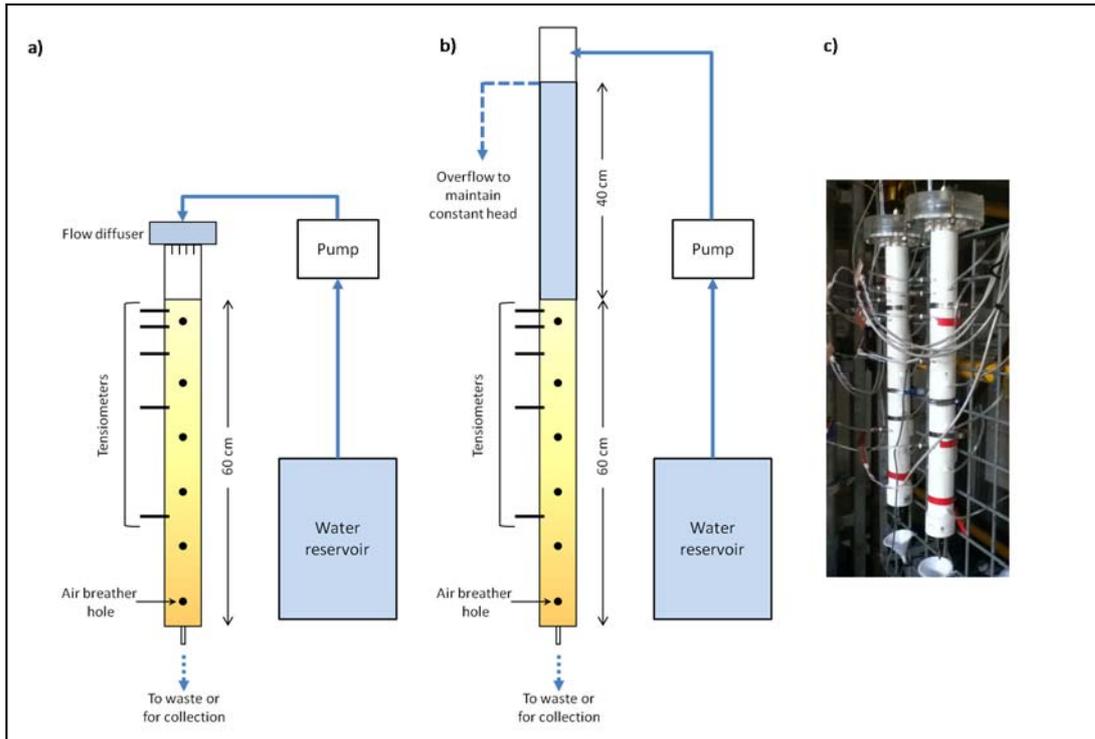
Figure 4 Schematic of column setup showing the 60 cm of Spearwood Sand, and the locations of tensiometers and breather holes for (a) pre-clogging showing water introduction through a flow diffuser and (b) post-clogging showing the constant head conditions (40 cm) imposed and (c) the PVC columns.

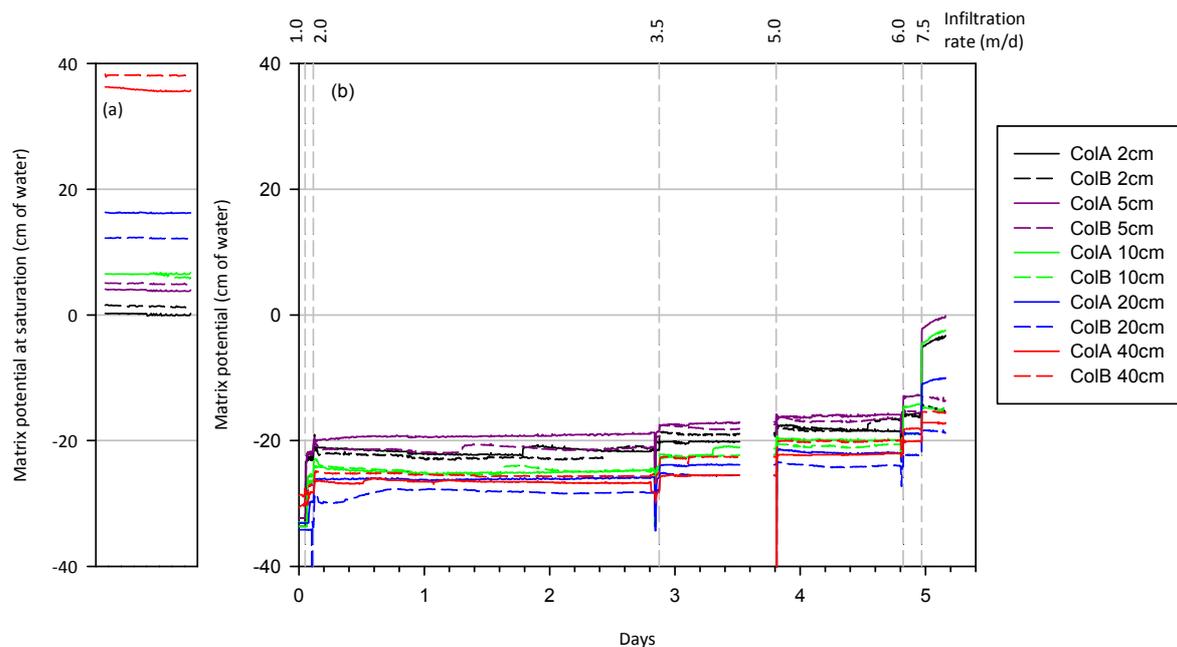
Figure 5 Infiltration rate test with synthetic wastewater in Spearwood Sand columns (left) matrix potential measured under saturation conditions prior to application of synthetic wastewater and (centre-right) changes in matrix potential during the unsaturated experiment (following column draining) with step changes in application rate (indicated at the top). The location of the tensiometers is given in cm below the top of the soil.

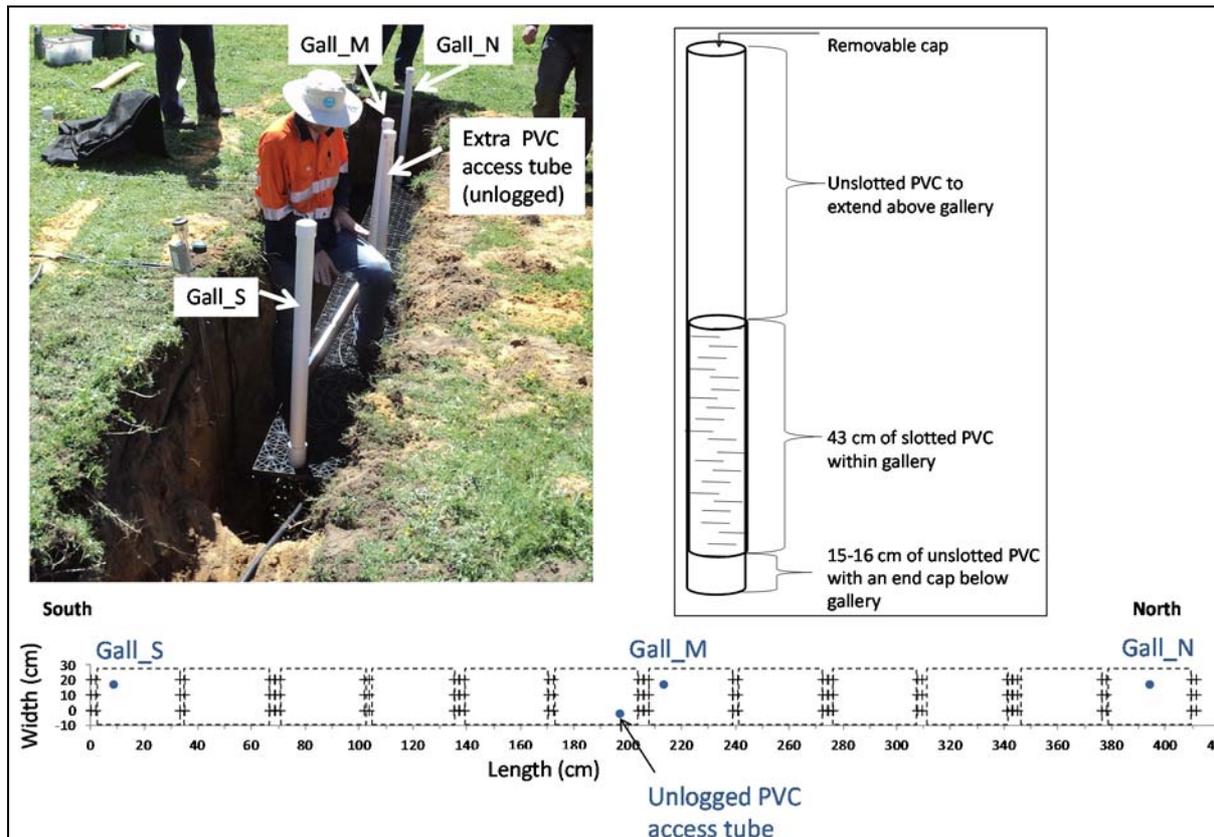
Figure 6 Locations of water level logging within the infiltration gallery. The diagram on the right (not to scale) shows the design of the PVC tubes used to monitor water levels in the gallery. Geofabric (not shown) was used to cover the top and sides of the gallery to lessen the opportunity for roots to grow into the gallery.

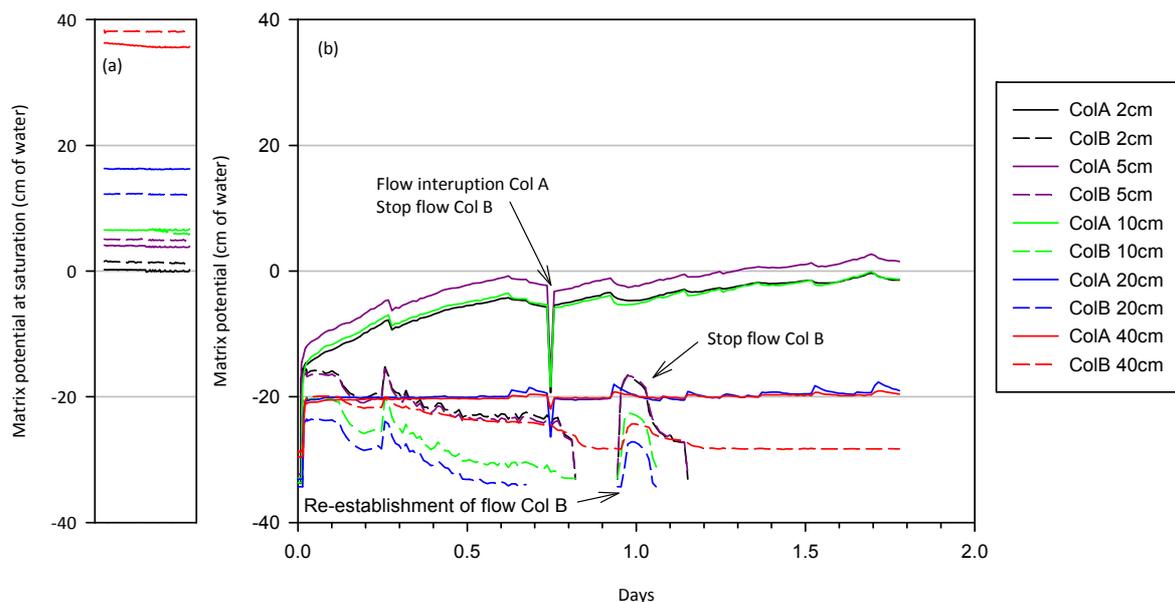
Figure 7 Infiltration of secondary treated wastewater from the Subiaco wastewater treatment plant in Spearwood Sand columns (left) matrix potential measured at saturation, and (centre-right) changes in matrix potential upon the application of wastewater at 5 m/d.

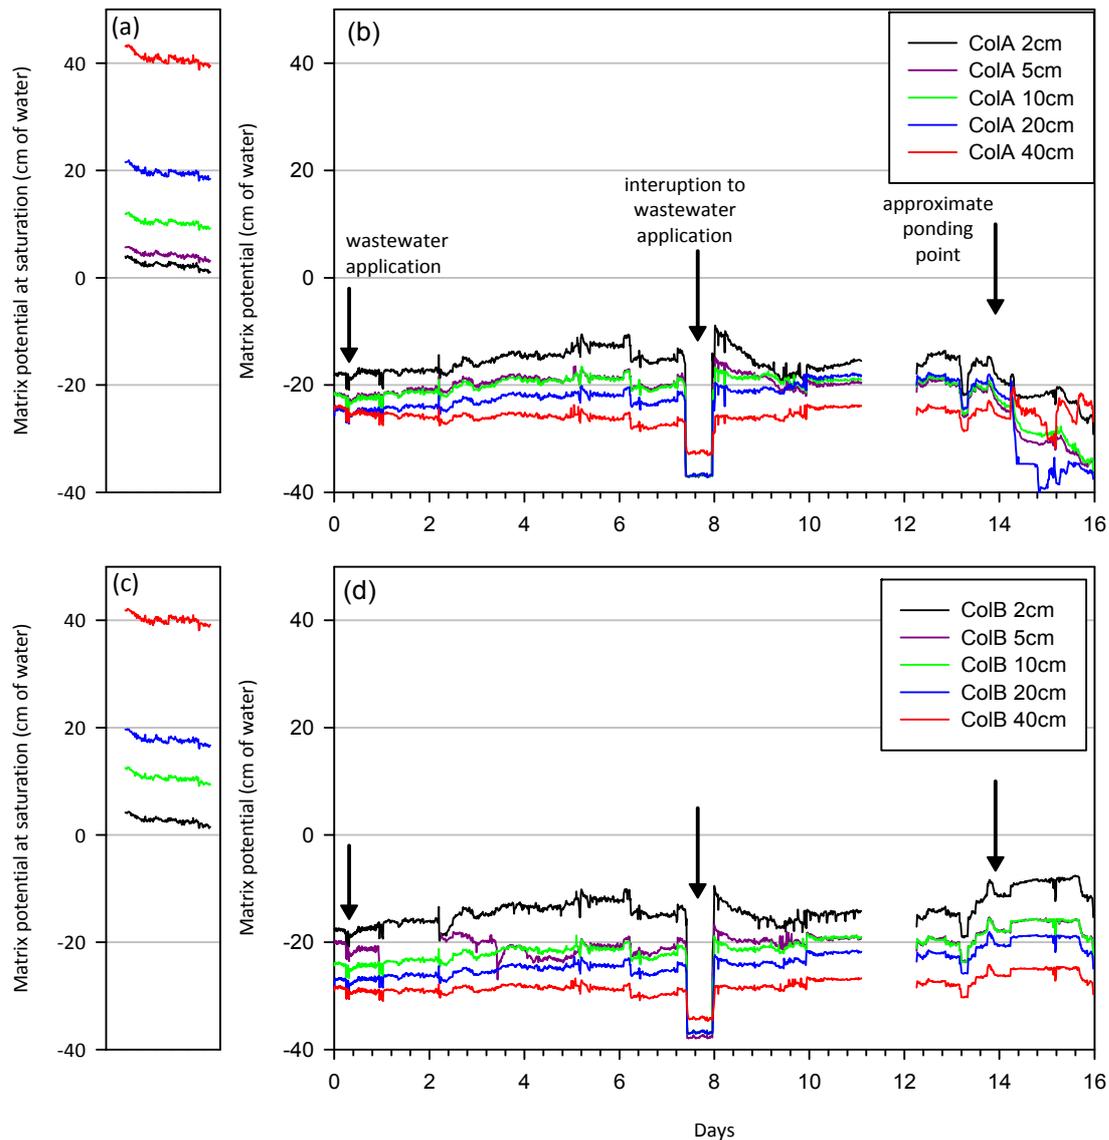
Figure 8 Infiltration of filtered secondary treated wastewater from the Subiaco sewage treatment plant in Spearwood Sand columns matrix potential measured at saturation (a – column A, c – column B), and changes in matrix potential upon the application of filtered treated wastewater at 5 m/d (b – column A, d – column B).

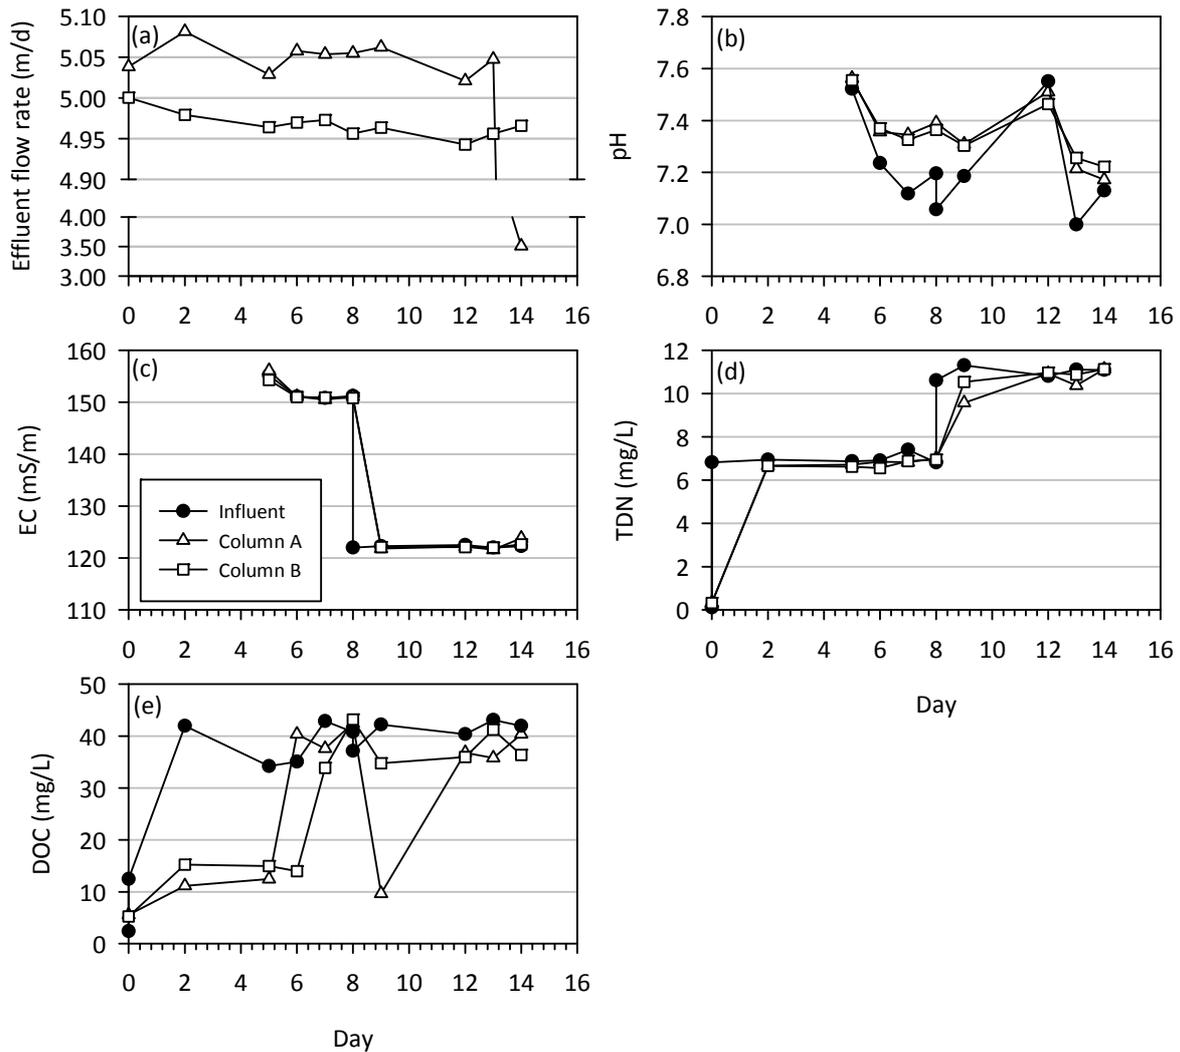
Figure 9 Filtered secondary treated wastewater column effluent flow rates (a) and comparison of column influent and effluent (b) pH, (c) electrical conductivity (EC), (d) total dissolved nitrogen (TDN), and (e) dissolved organic carbon (DOC) for columns A and B.

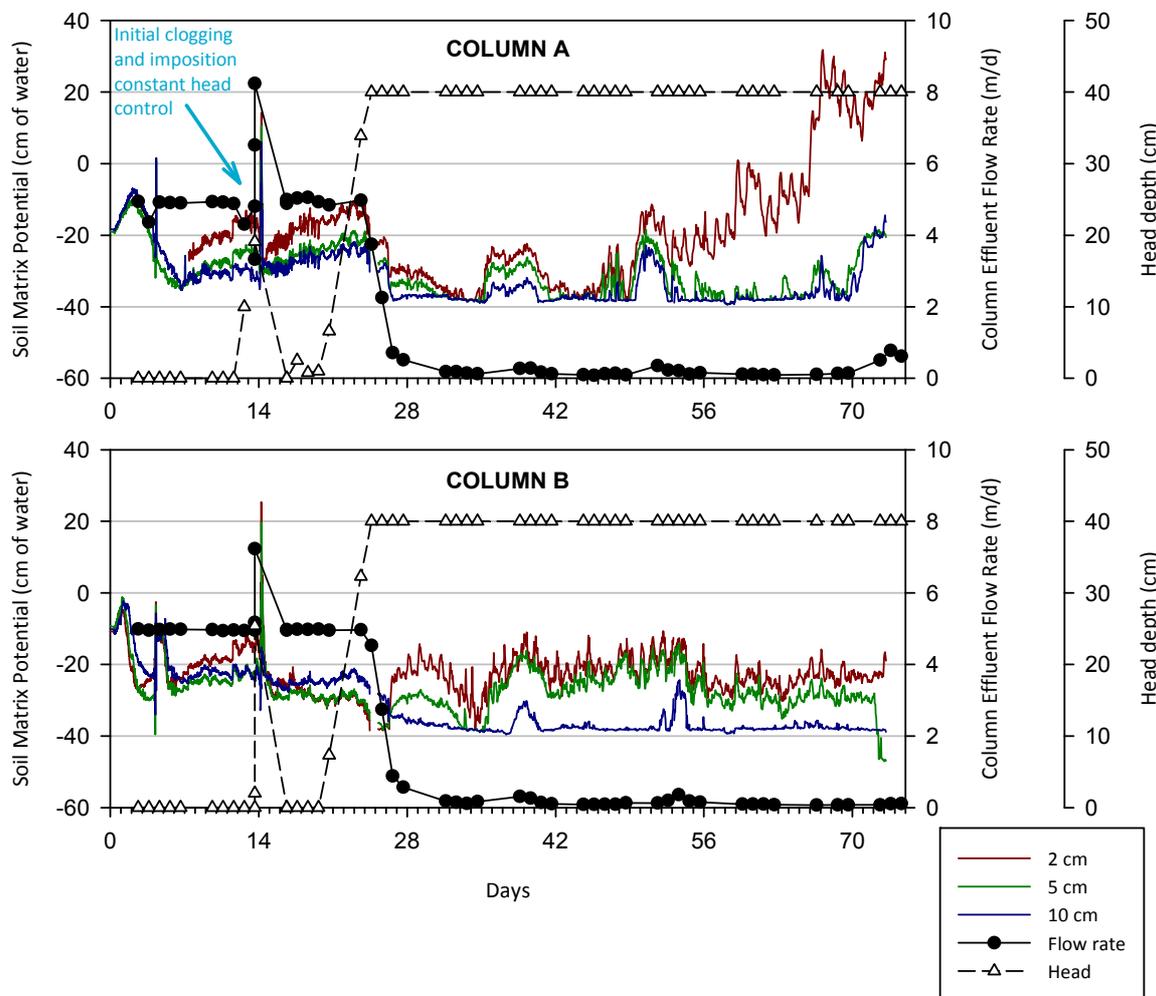
Figure 10 Effluent flow rate for columns A and B following infiltration of recycled water through Spearwood Sand columns, showing initial rates of 5 m/d and the effect of clogging on flow rates and soil matrix potential measured at 2, 5 and 10 cm below the soil surface. A constant head of water (40 cm above the soil surface) was applied following the observance of ponding of the recycled water.

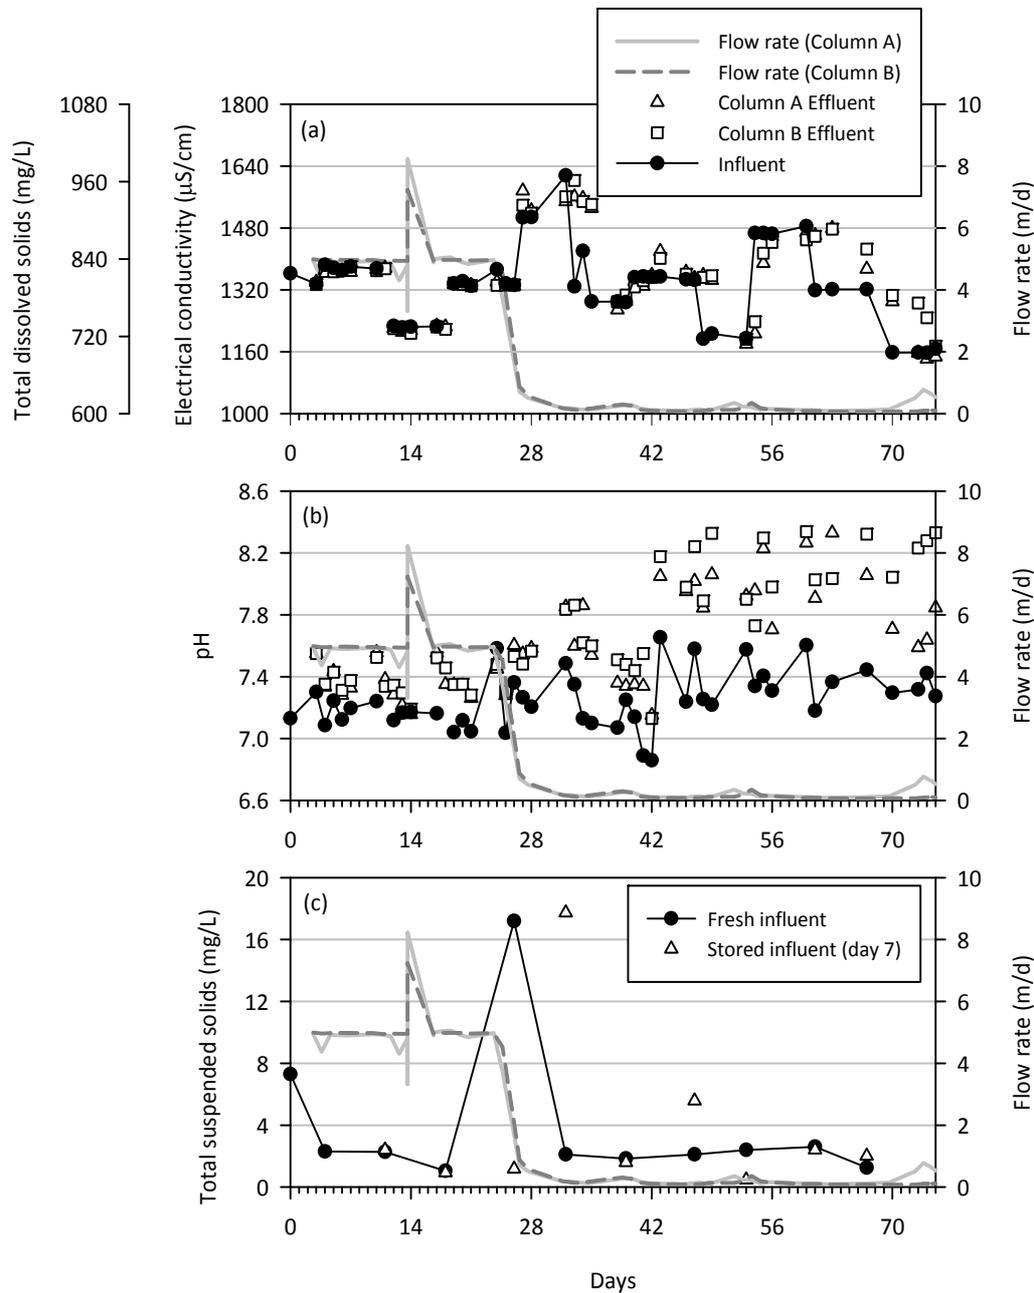
Figure 11 Recycled water and column effluent physio-chemical characteristics (a) electrical conductivity (EC) and calculated total dissolved solids, (b) pH and (c) total suspended solids. The legend for (a) also applies to (b). The column effluent flow rates are shown for comparison.

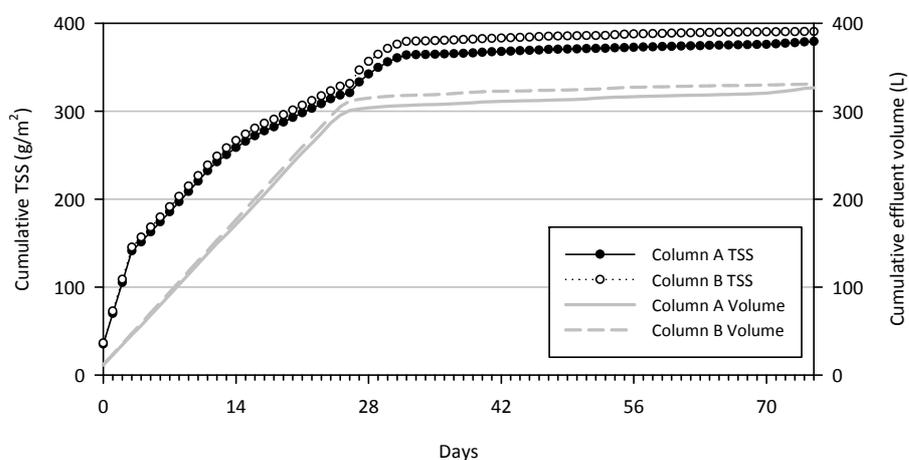
Figure 12 Accumulation of suspended solids (TSS) and cumulative effluent following recycled water infiltration. Non-measured TSS and flow data interpolated between measurements.

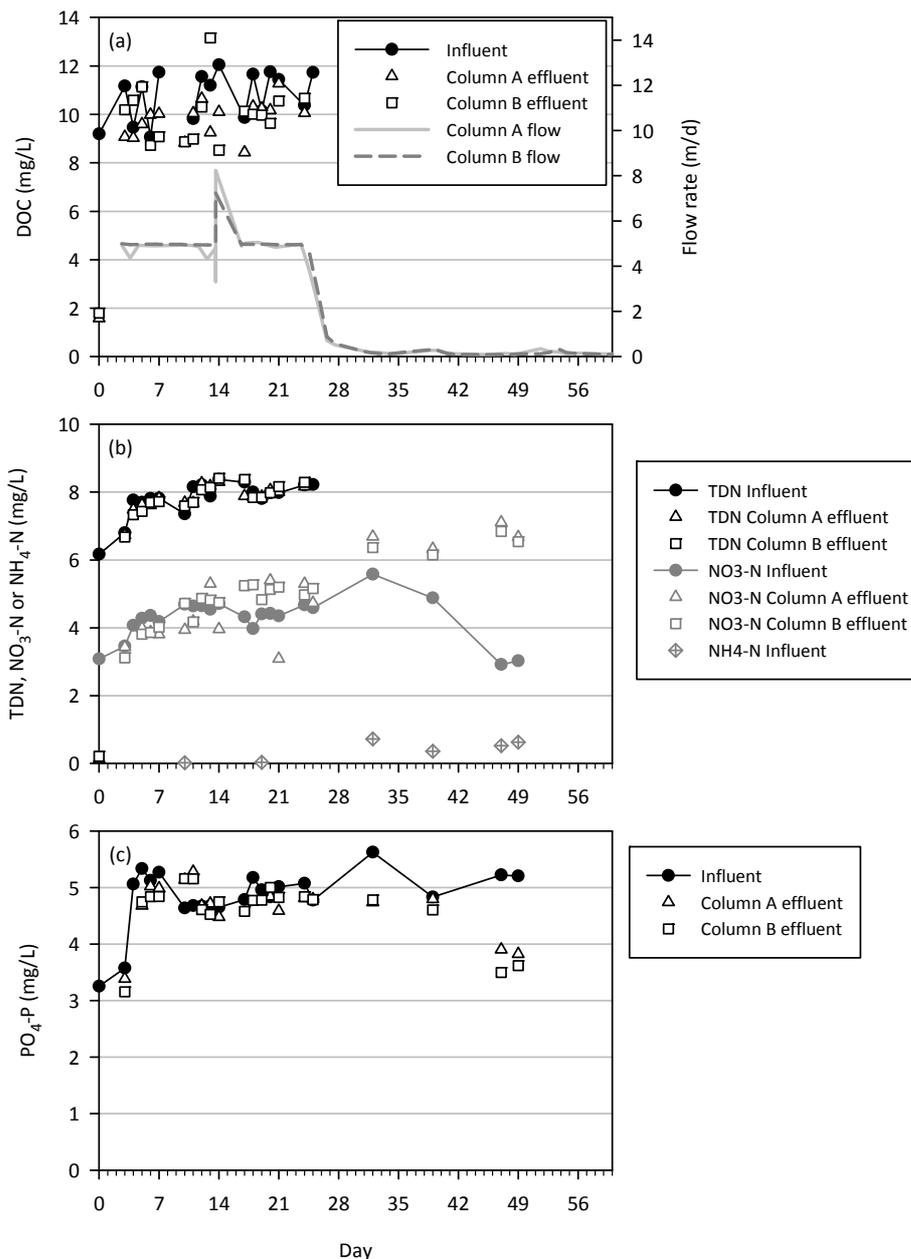
Figure 13 Nutrient concentrations in influent recycled water and column effluent.

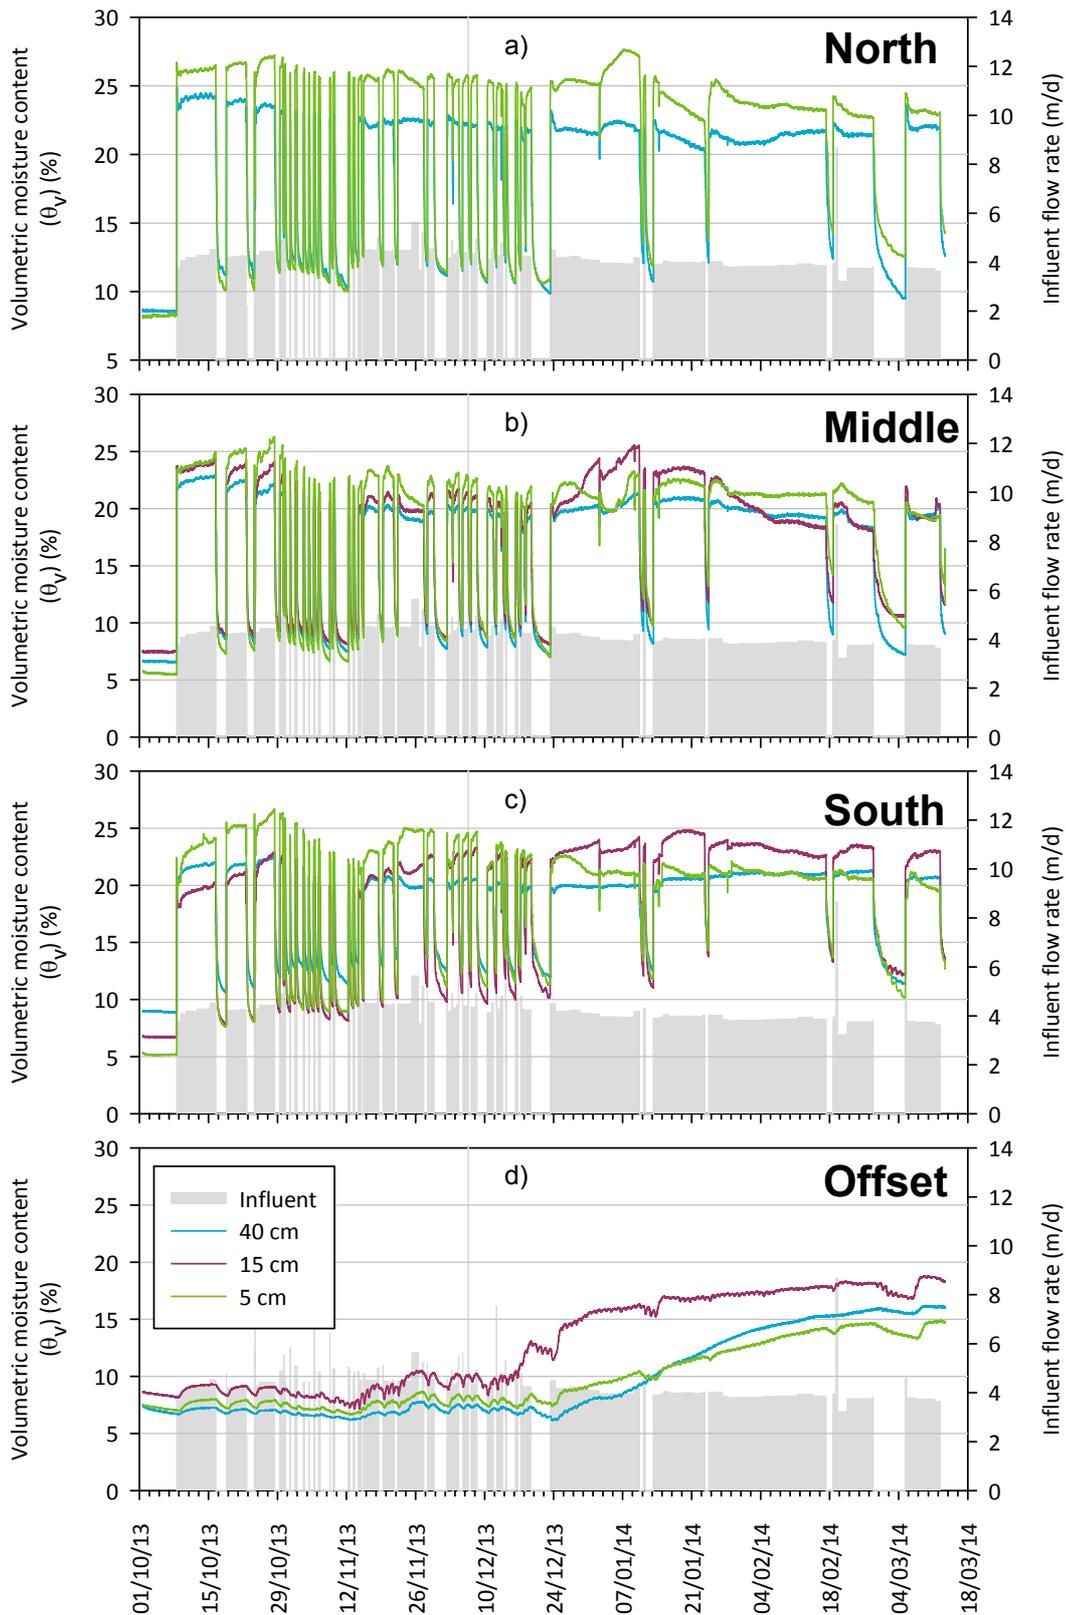
Figure 14 Comparison of soil moisture data from the a) North, b) Middle, c) South and d) Offset probes at the CSIRO infiltration gallery site. Note the frequent interruptions of wastewater flow until late December due to equipment problems at the Subiaco STP, and absence of 15 cm soil moisture data at the North probe location due to sensor malfunction.

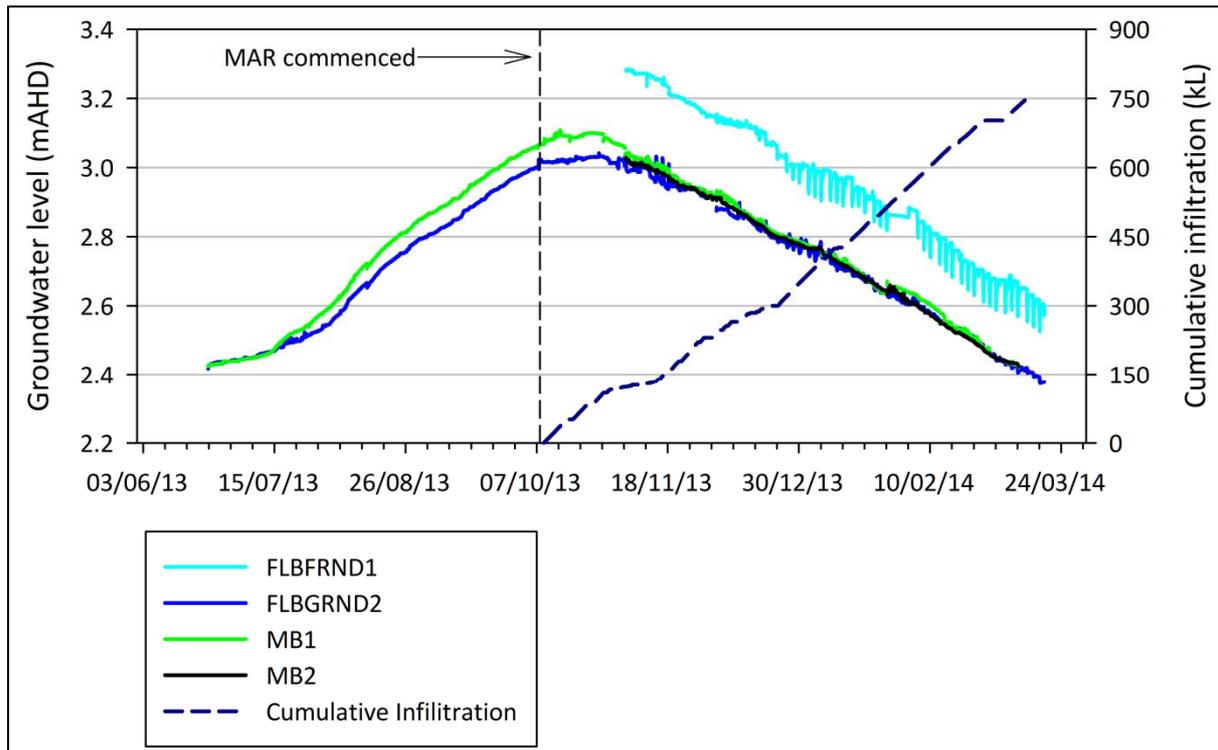
Figure 15 Groundwater measured in the monitoring bores. FLBGRND1 is located farthest from the MAR site (177 m northeast of the site).

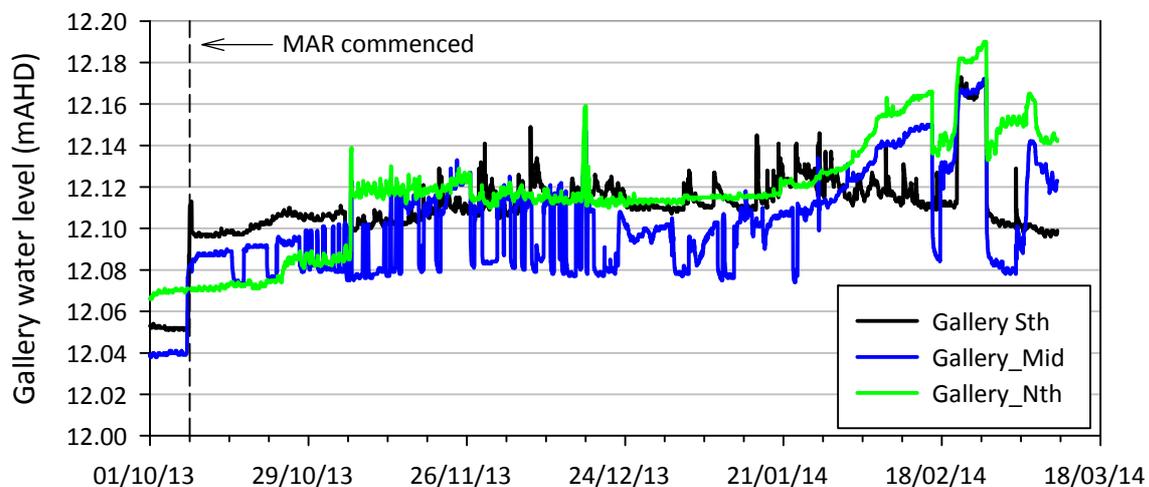
Figure 16 Level of wastewater in the gallery monitored in the three PVC wells. Elevation of gallery base was 12.10-12.19 m AHD.

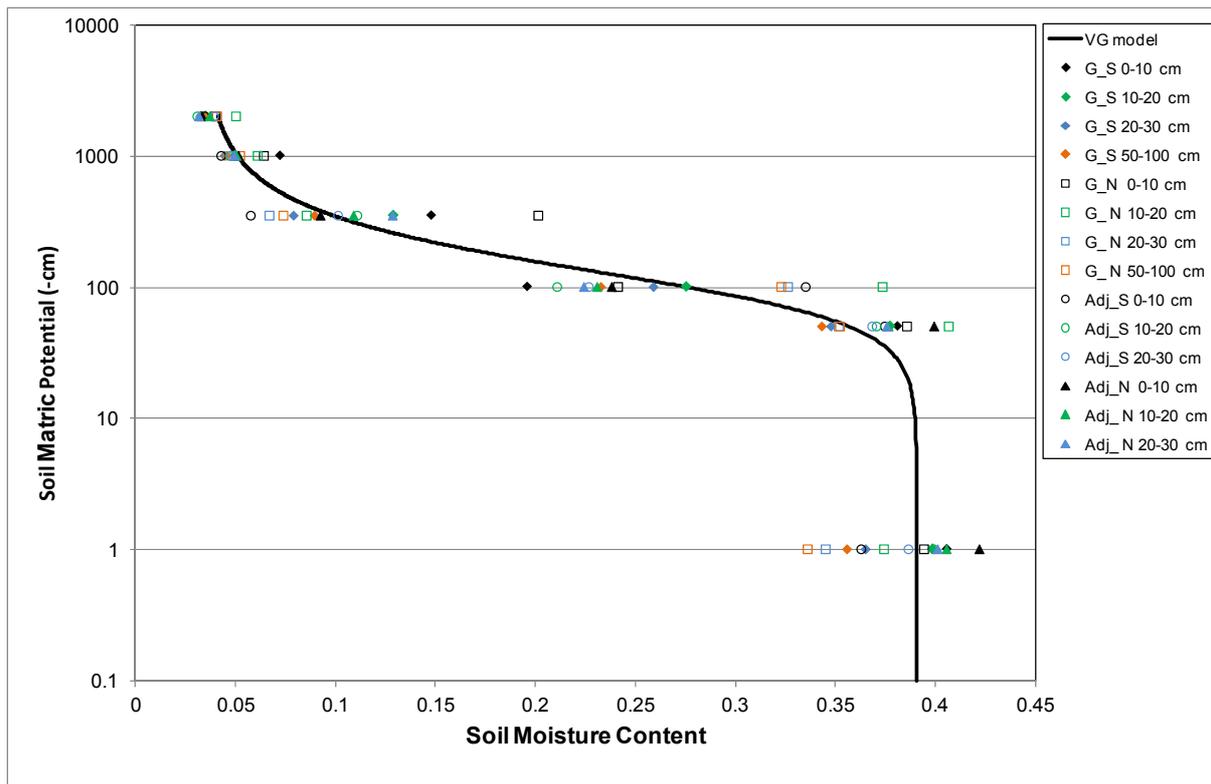
Figure 17 Soil moisture retention function for Spearwood Sand sampled from the zone through which wastewater infiltrated. The van Genuchten model was fitted using RETC software.

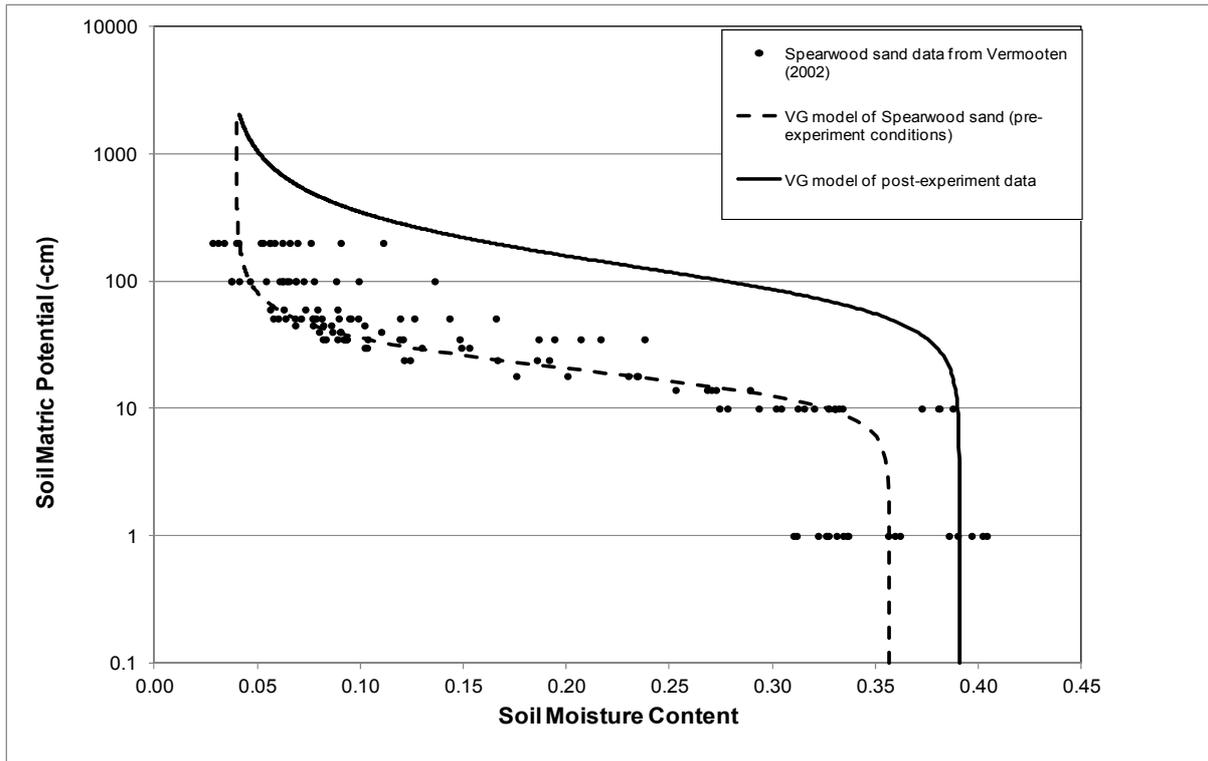
Figure 18 Soil moisture retention data and the van Genuchten model for Spearwood Sand based on data from Vermooten (2002), representing initial conditions at the infiltration site prior to any wastewater infiltration (dashed line). The model of post-experiment data from Figure 17 (solid line) is plotted for comparison.

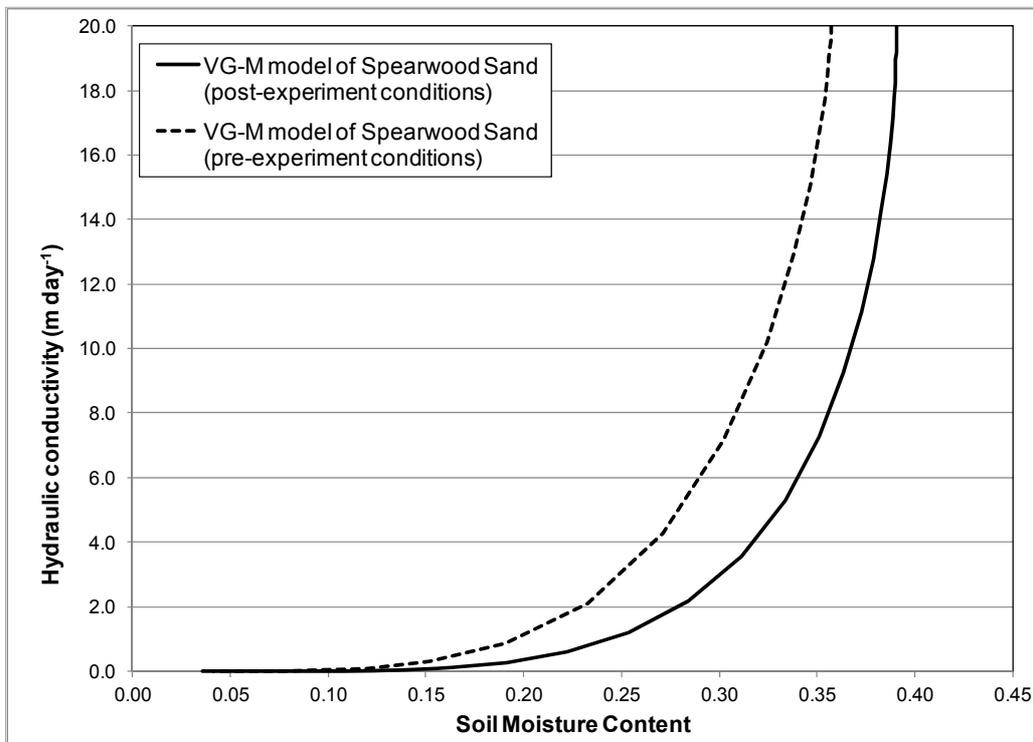
Figure 19 Unsaturated hydraulic conductivity predicted by the van Genuchten-Mualem model with HYDRUS.

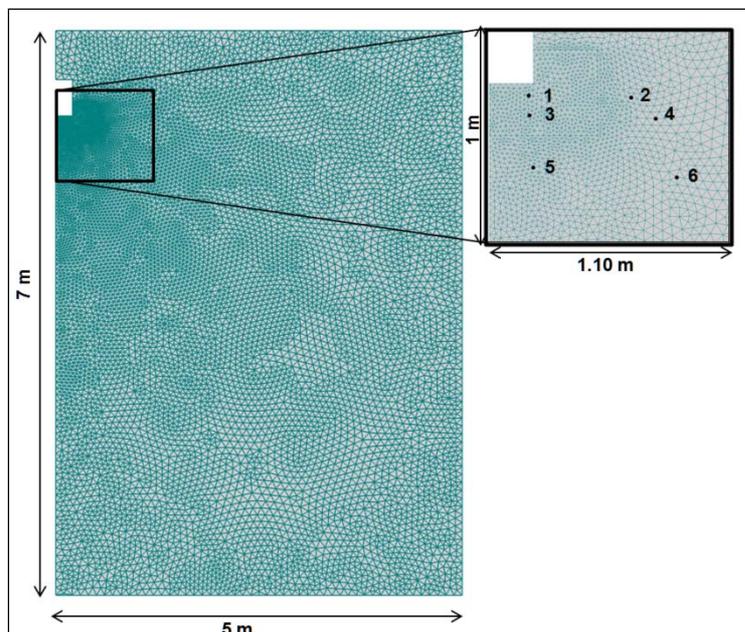
Figure 20 Finite element mesh for the HYDRUS flow model through a cross-section of the gallery from 0 to 7 m below ground level. The close-up view shows the six observation points for examining model output that correspond to the approximate locations of soil moisture probes.

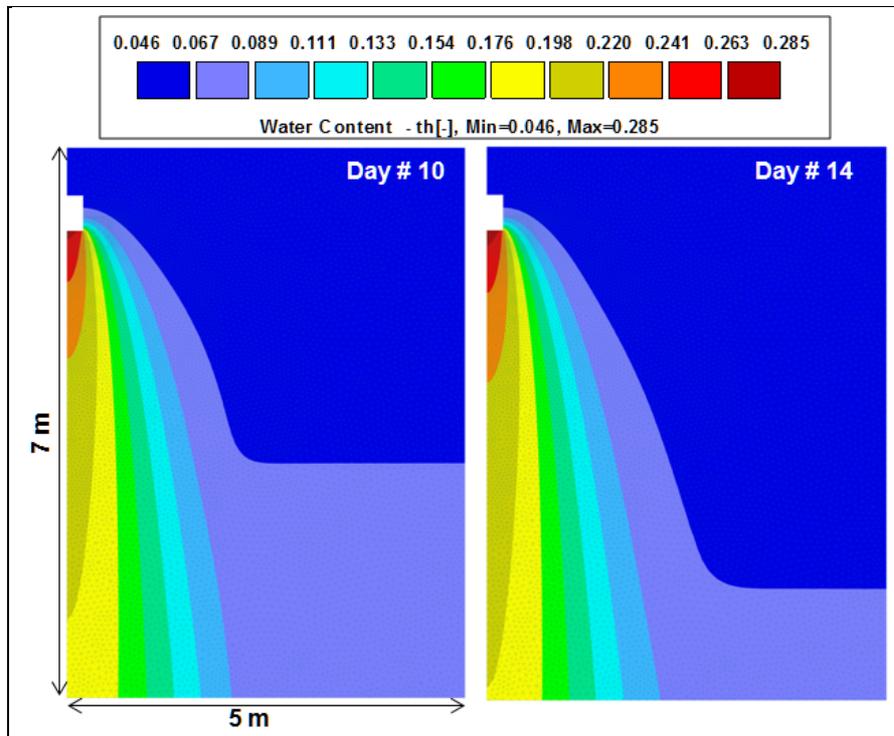
Figure 21 Predicted distribution of soil water contents for the cross-section model on Days 10 and Day 14.

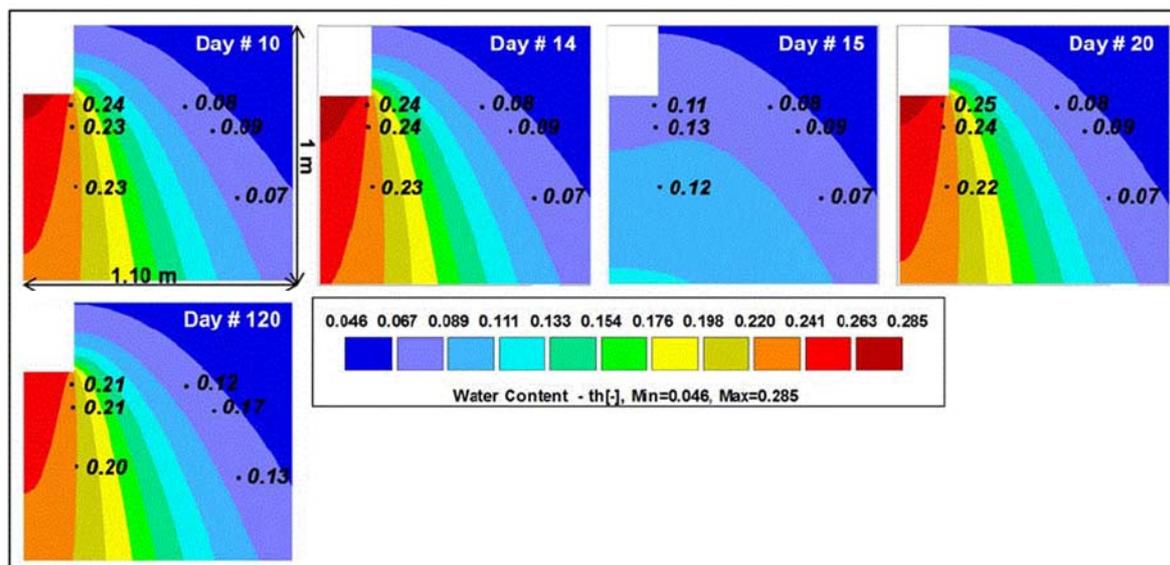
Figure 22 Close-up view of model output at several times, showing a predicted time series of soil water content from the HYDRUS model. Superimposed on the model results are point measurements. Note, MAR commenced on Day 6.

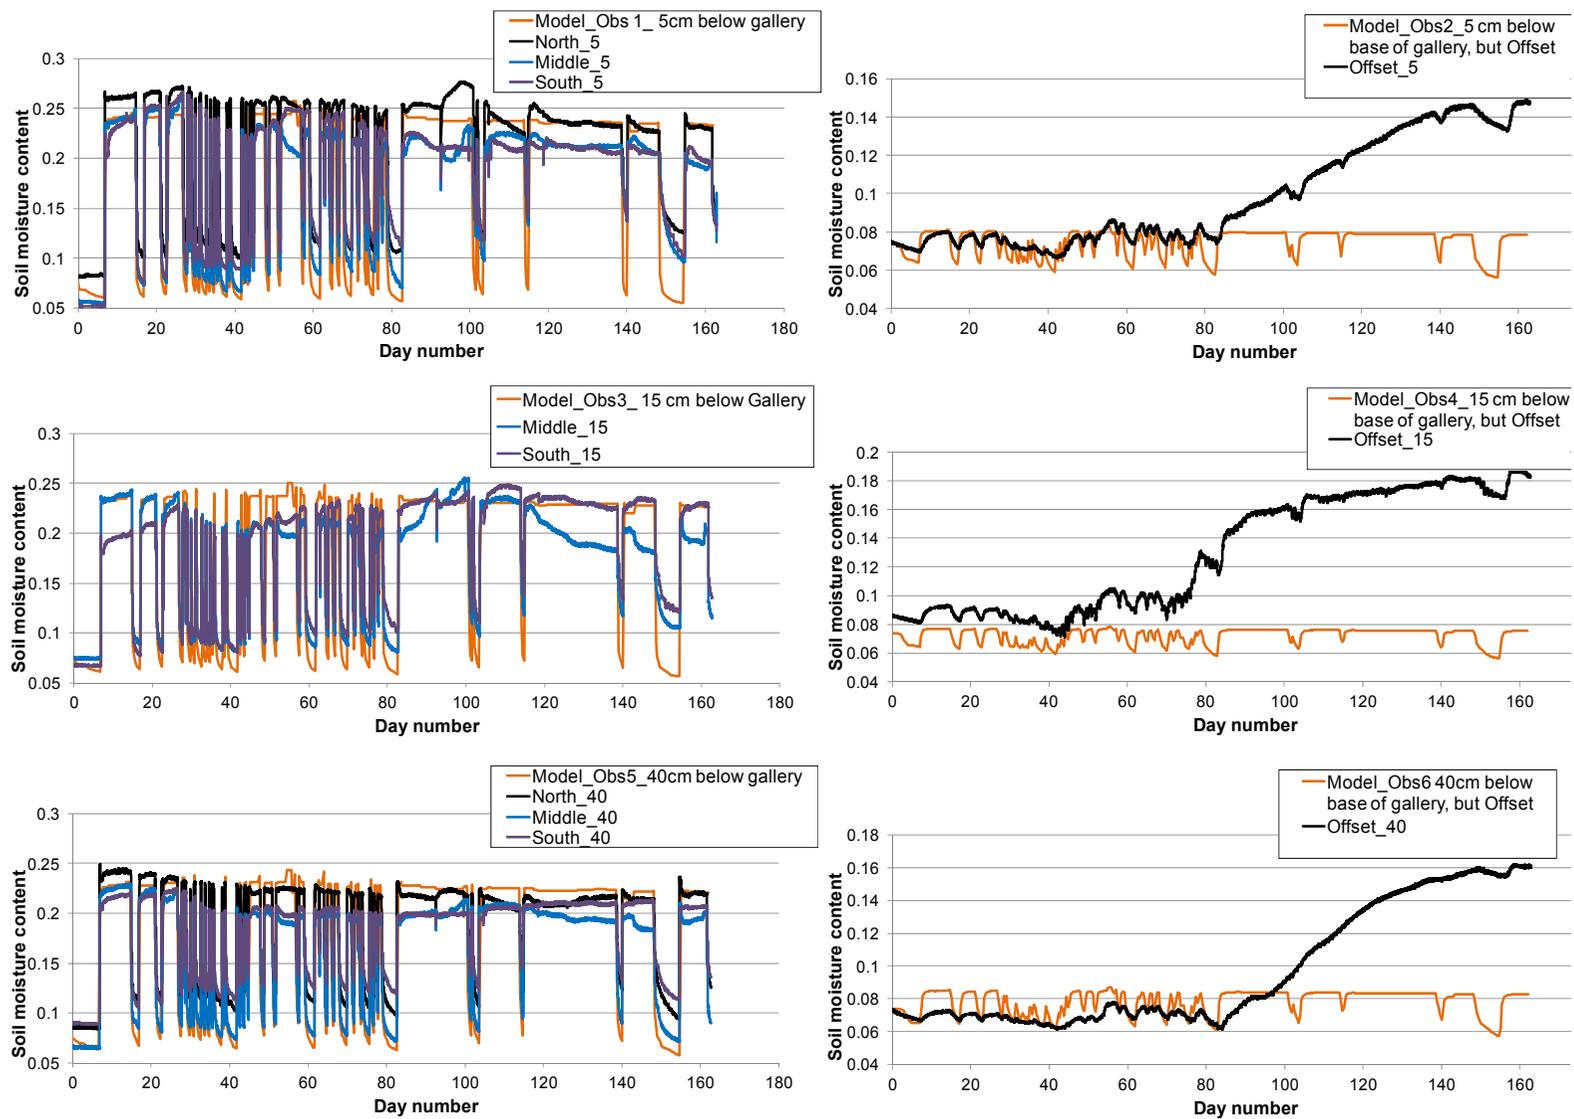
Figure 23 Comparison of HYDRUS model results and observed data from soil moisture probes. The hydraulic model is based on soil hydraulic properties derived from the analysis of soil moisture retention data from Vermooten (2002) for Perth, Western Australia.

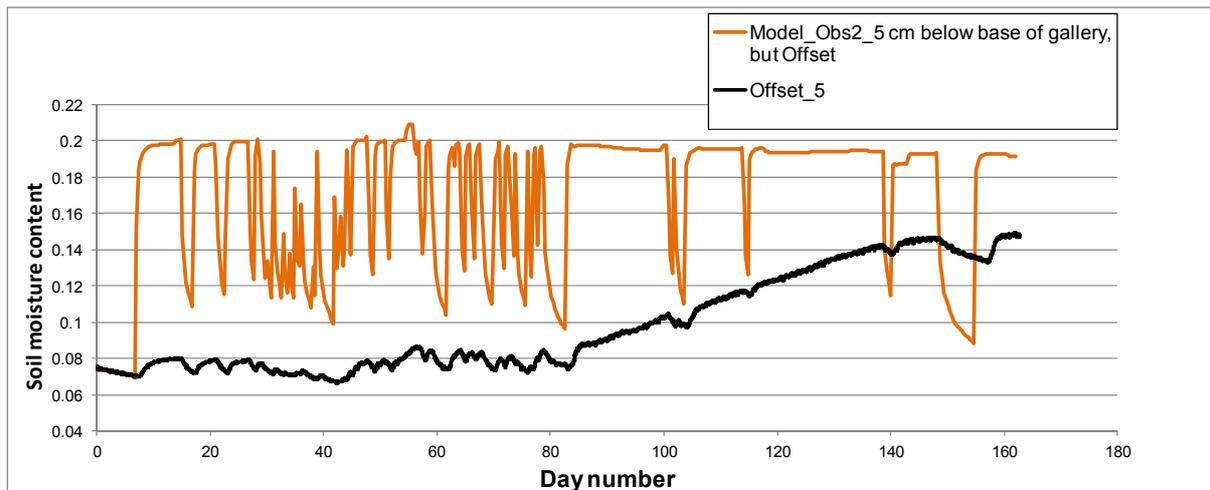
Figure 24 Comparison of Hydrus model results and observed data from monitoring the Offset probe located 5 cm below the base of the gallery. Soil moisture retention data to underpin the hydraulic model were obtained by analysing Spearwood samples collected from the Floreat MAR site, post-experiment.
