Managed Aquifer Recharge and Recycling Options: Understanding clogging processes and water quality impacts

A report of a study funded by the
Australian Water Recycling Centre of Excellence

Managed Aquifer Recharge and Recycling Options (MARRO)

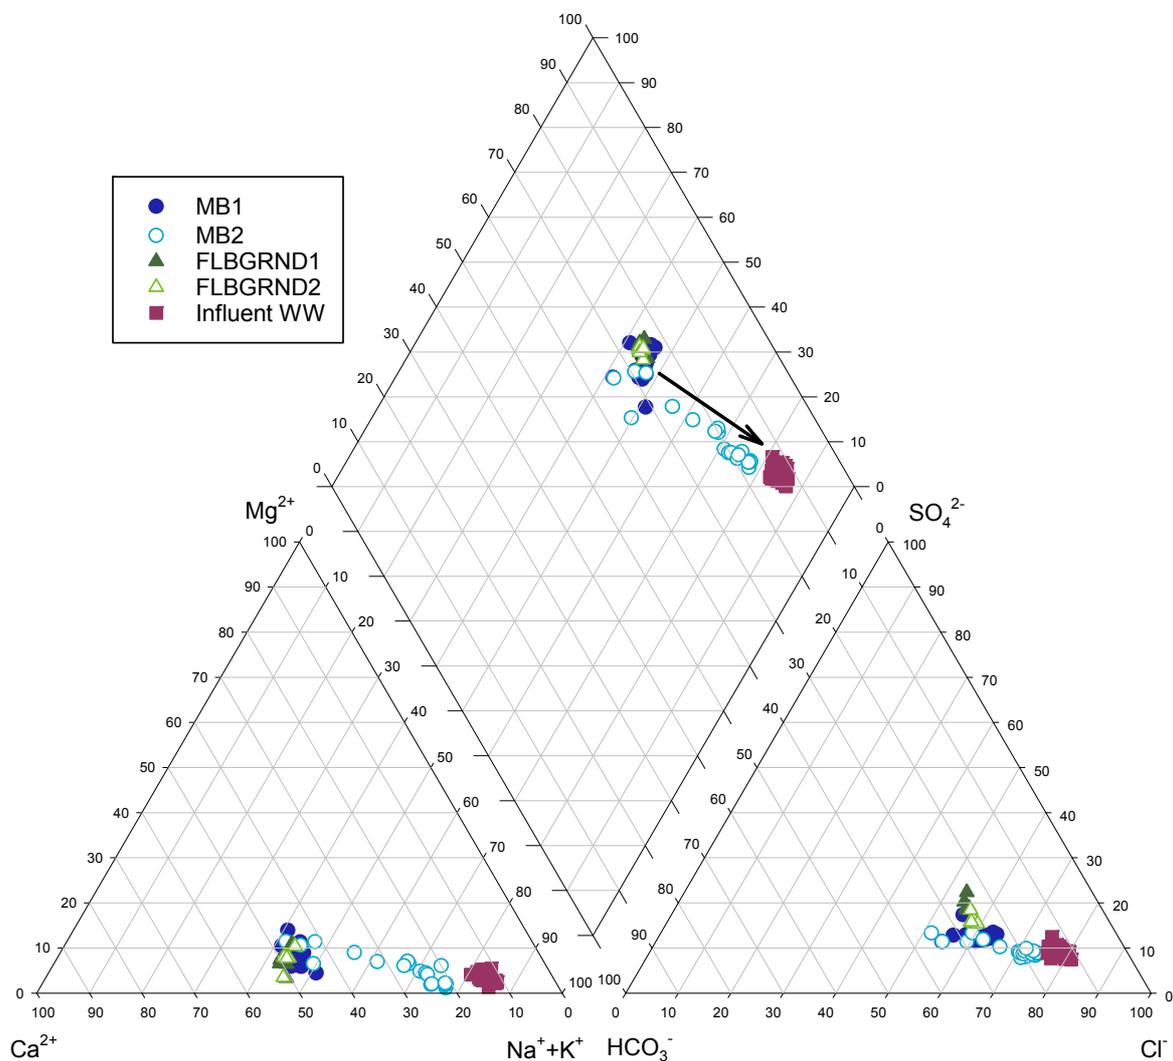
Figure 25 Piper diagram illustrating the transition in major ion chemistry (shown by arrow) in the groundwater down-gradient of the infiltration gallery (MB2) from ambient groundwater (FLBGRND1, FLBGRND2, MB1) toward the infiltration gallery source water (Influent WW).

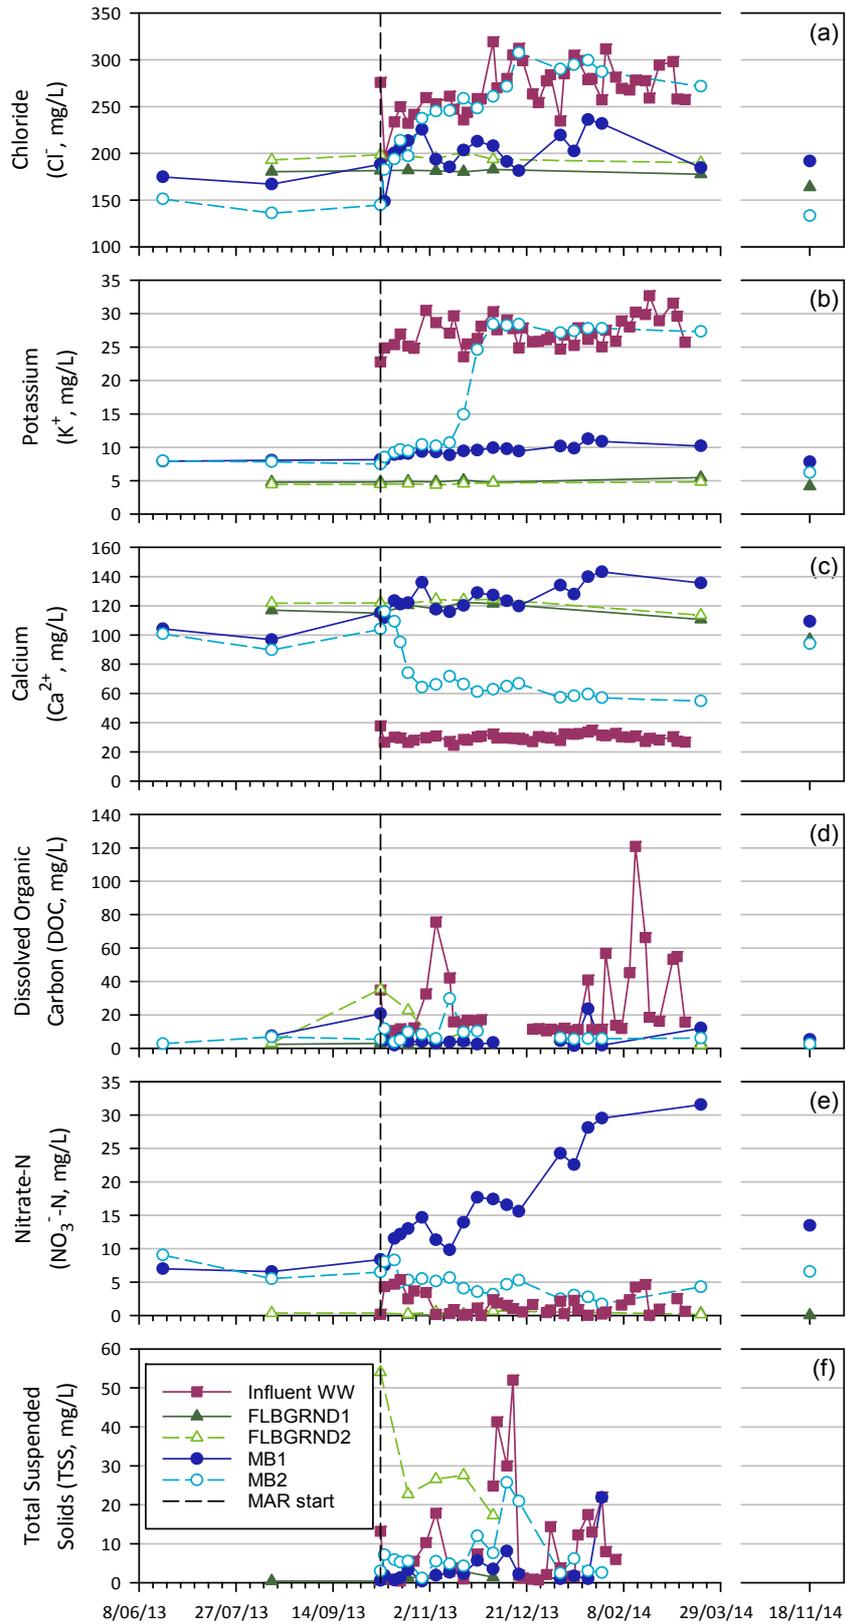
Figure 26 (a) Chloride, (b) potassium, (c) calcium, (d) dissolved organic carbon (DOC), (e) nitrate-N, and (f) total suspended solids concentrations in the infiltration gallery source water (Influent WW), groundwater down-gradient from the infiltration gallery (MB2) and ambient groundwater (FLBGRND1, FLBGRND2, MB1).

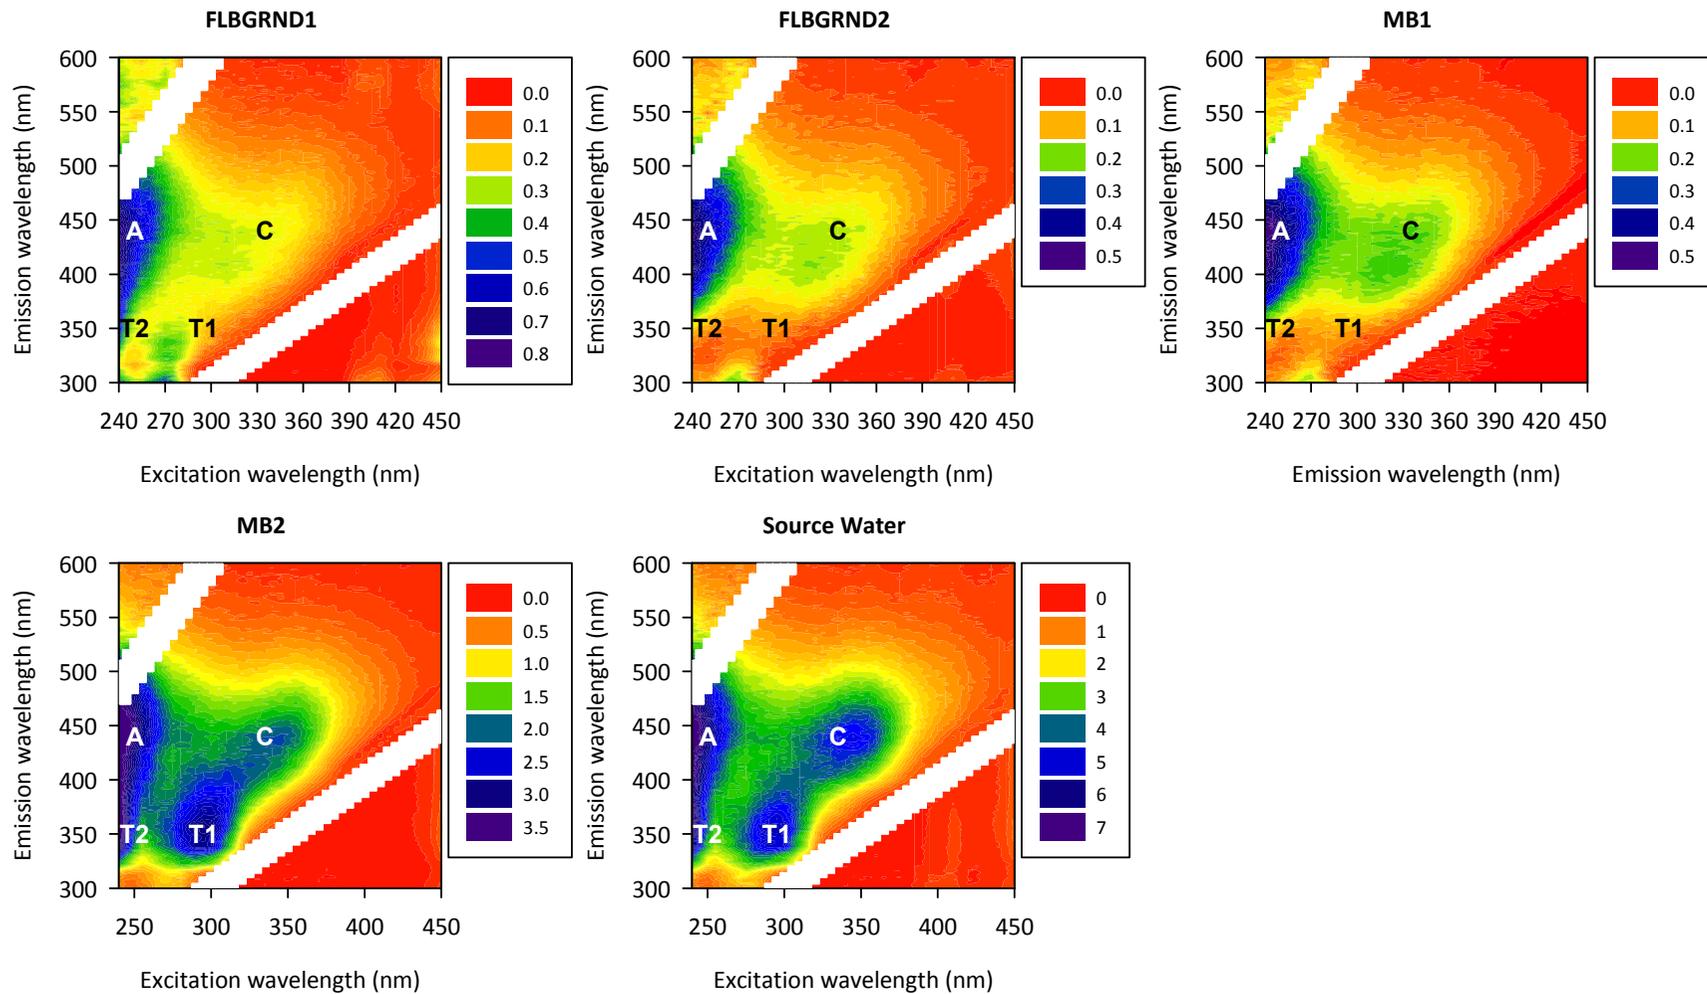
Figure 27 Fluorescence excitation-emission matrices (EEMs) of dissolved organic carbon for: groundwater sampled from the background bores (FLBGRND1 and FLBGRND2), up-gradient monitoring bore (MB1), down-gradient monitoring bore (MB2) and influent recycled water (Source Water), where A = humic-like, C = humic- and fulvic-like, T1 and T2 = typtophan-like fluorescence. The colours represent the fluorescence intensity expressed in Raman units. Note the different fluorescence intensity scales are used to enable comparison of samples. The white areas mask the Rayleigh scatter peaks of water.

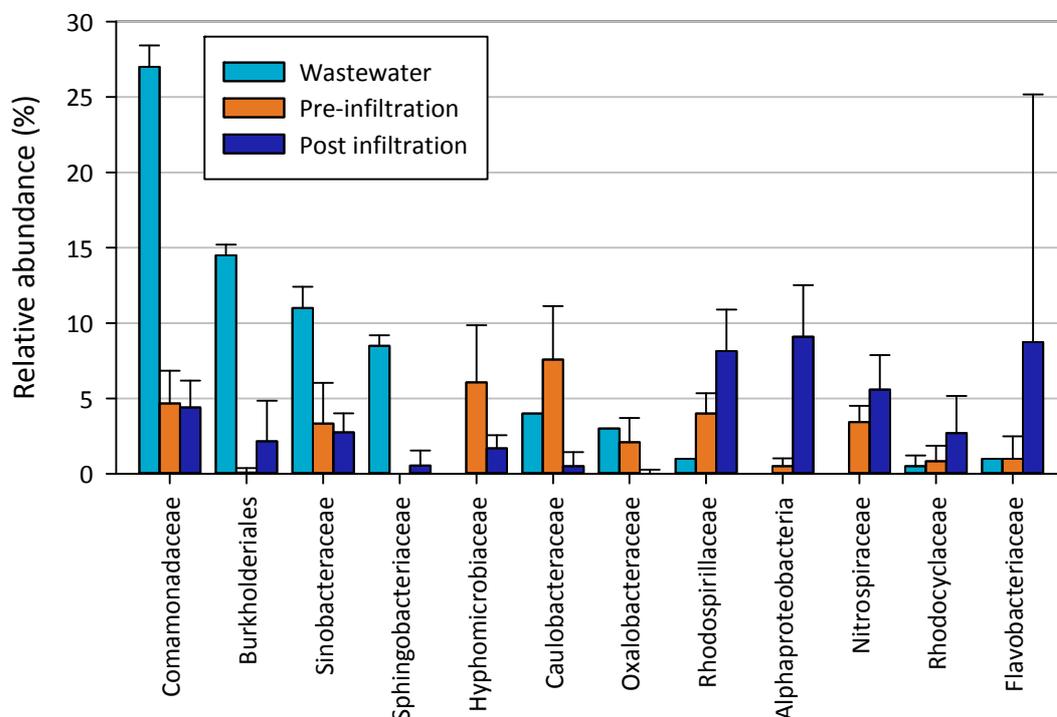
Figure 28 Relative abundance (mean) of selected bacterial families present in the filtered Subiaco wastewater and pre-infiltration and post-infiltration soil samples taken from the Floreat infiltration gallery. Error bars represent one standard deviation.

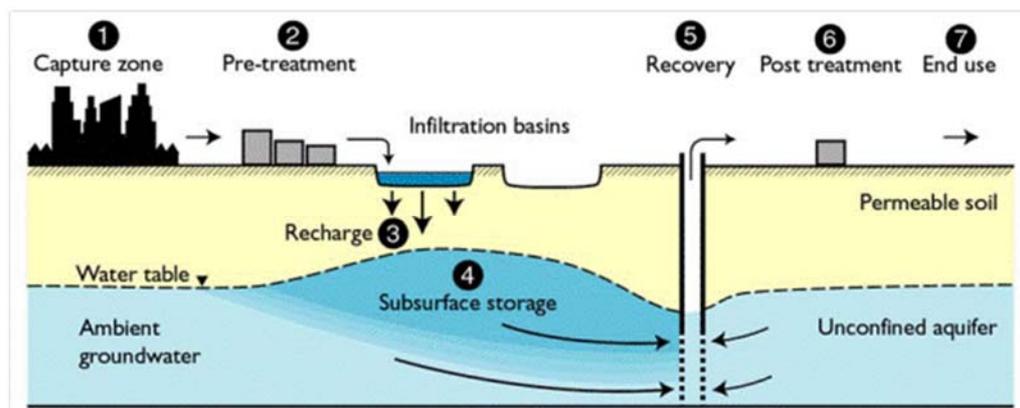
Figure 29 Soil Aquifer Treatment System infiltrating water to an unconfined aquifer (MAR Guidelines NRMCC-EPHC-NHMRC 2009).

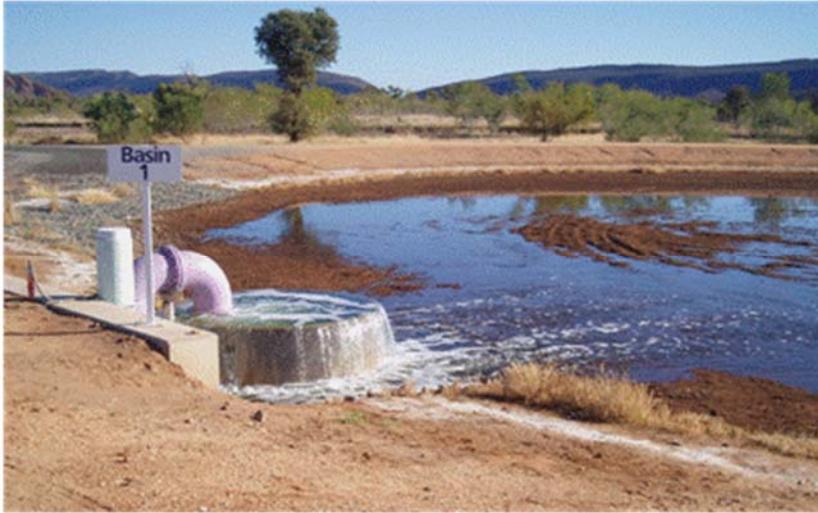
Figure 32 SAT basin RB1 during filling on 22 July 2009.

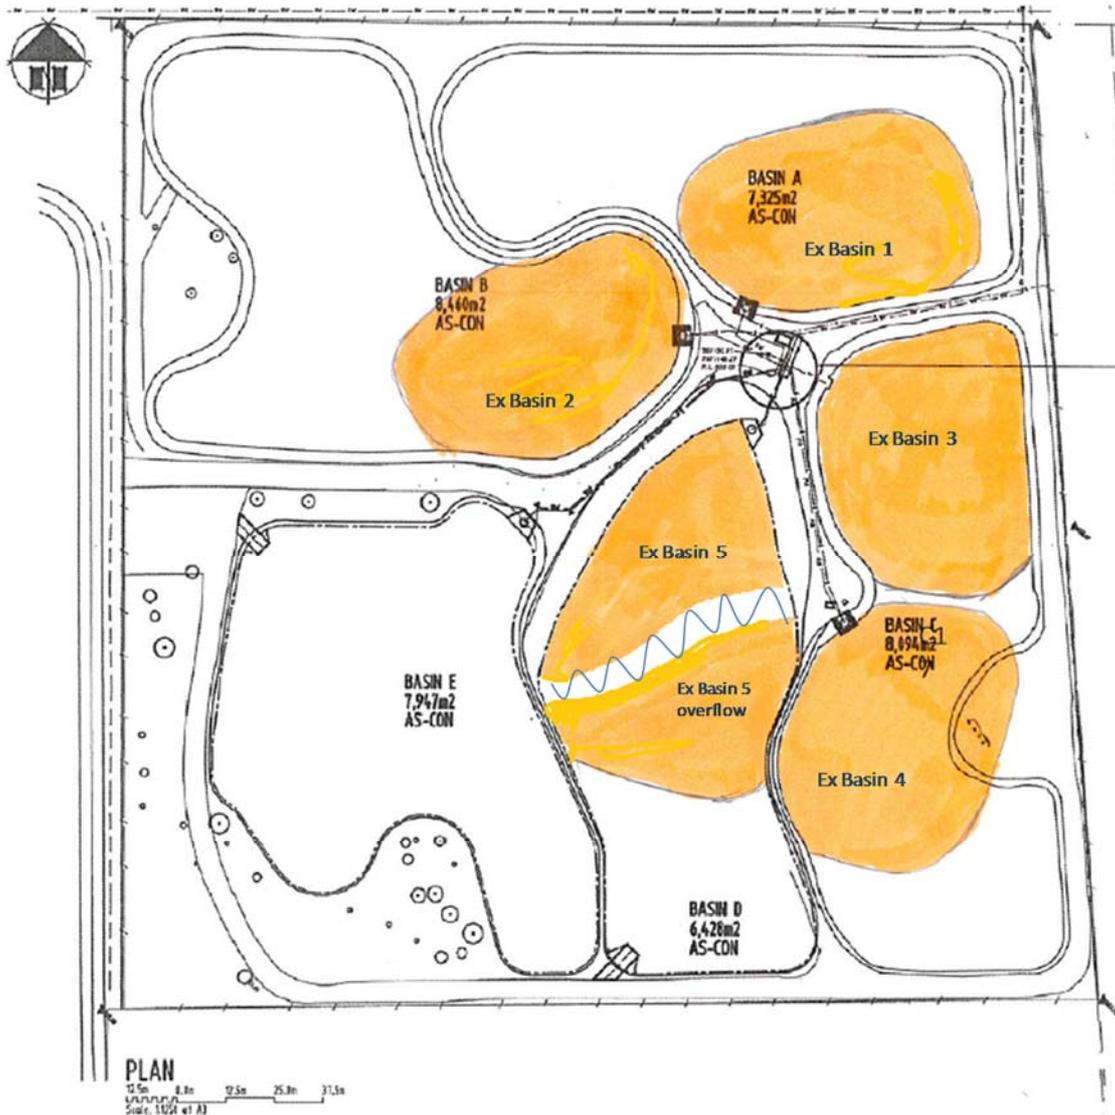
Figure 33 Expansion of old recharge basins 1, 2, 3, 4, 5 (highlighted), into basins A, B, C, D, E.

Expansion of the basins started at the beginning of 2011. The operation of the first basin to be expanded, Basin B, commenced on 29/09/2011. This was followed by Basin A (18/11/2011), Basin C (16/12/2011), Basin D (18/08/2012), and Basin E (19/10/2012). The current configuration involves five recharge basins (A, B, C, D, and E) and a total area of 38,473 m². Basins A and B were established by expanding old basins 1 and 2, respectively; Basin C incorporates old basins 3 and 4; while Basin D is an expansion of the original basin 5. Basin E was established in an area that had not previously contained an infiltration basin (Figure 33). The construction of basins C, D, and E involved lighter machinery than that had been used previously to help prevent compaction of the basin floor. The floor of basin B was compacted by machinery during construction and this had a marked impact on infiltration rates.

The highest organic carbon content was found on the surface of Basin D, but it was highly variable. In July 2012, the Basin D had not yet been expanded; it was still in the Basin 5 configuration (Figures 33 and 35) with approximately a third of the surface area of the final Basin D. All seven sample locations from this time were located within 40 to 50 m of the inlet. In 2013 and 2014, two more locations were added which were in the southern half of the completed Basin D (~ 100 to 150 m away from the inlet).

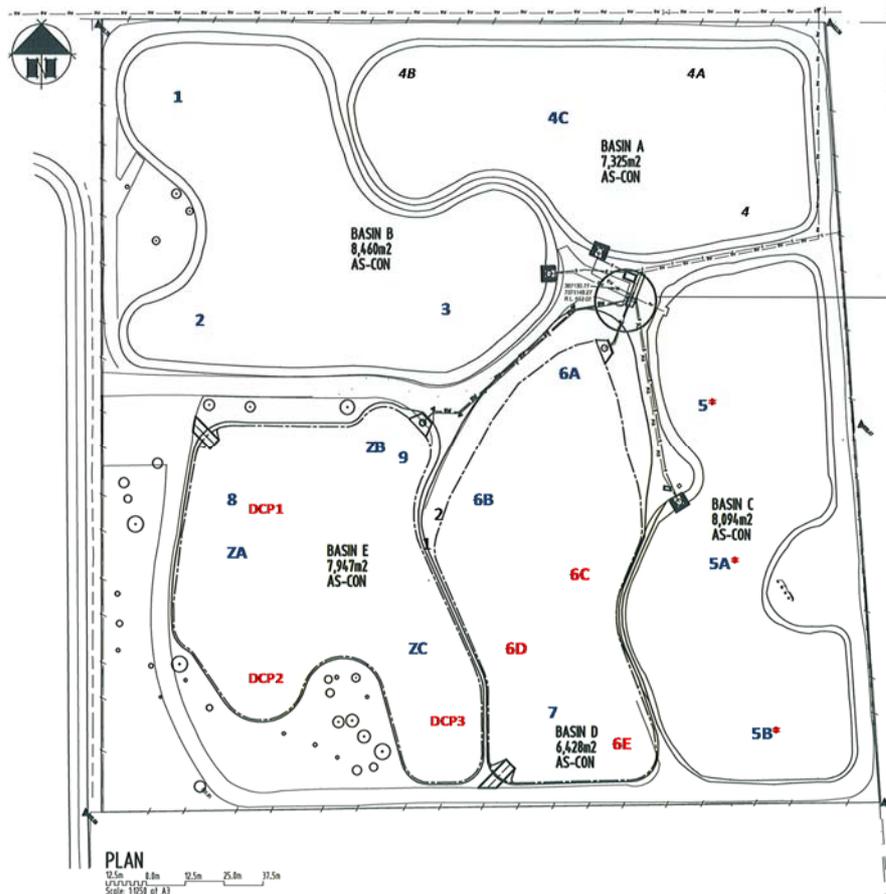
Figure 34 Sampling locations for geotechnical study. Nuclear densometer tests were done at locations: 4C in Basin A; 1, 2, 3 in Basin B; 5, 5A, and 5B in Basin C; 6A, 6B and 7 in Basin D; and 8, 9, ZA, ZB and ZC in Basin E. Cone penetrometers tests were done at locations 5, 5A, 5B in Basin B; 6C, 6D, 6E in Basin C and DCP1, DCP2, DCP3 in Basin E (Source: Alice Materials Testing).

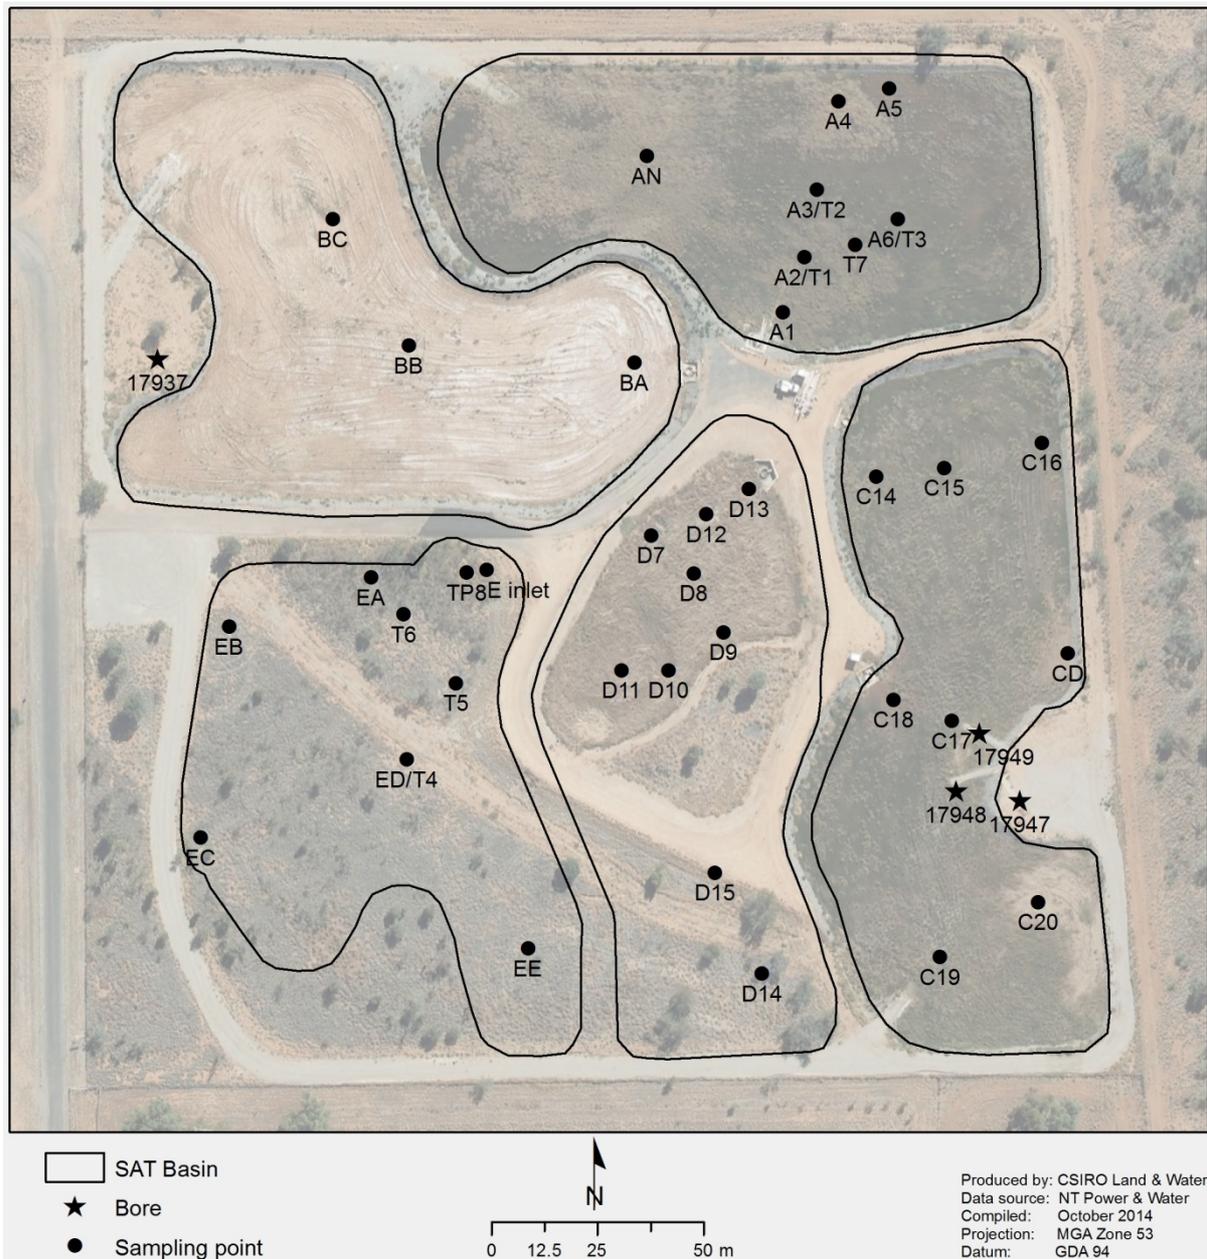
Figure 35 Overview of soil sampling, instrument locations and near basin monitoring bores used throughout the study.

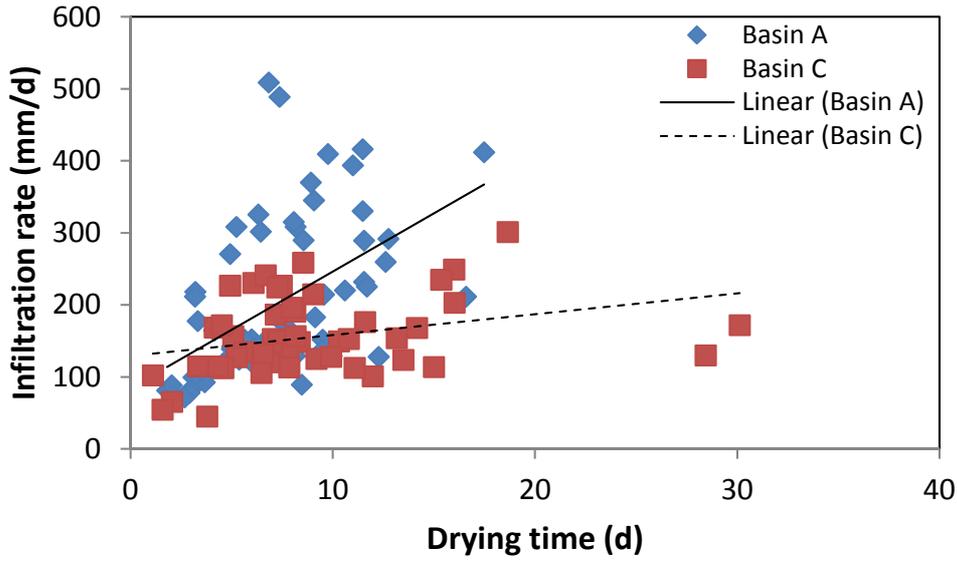
Figure 38 Relationship between infiltration rate and drying time for Basins A and C.

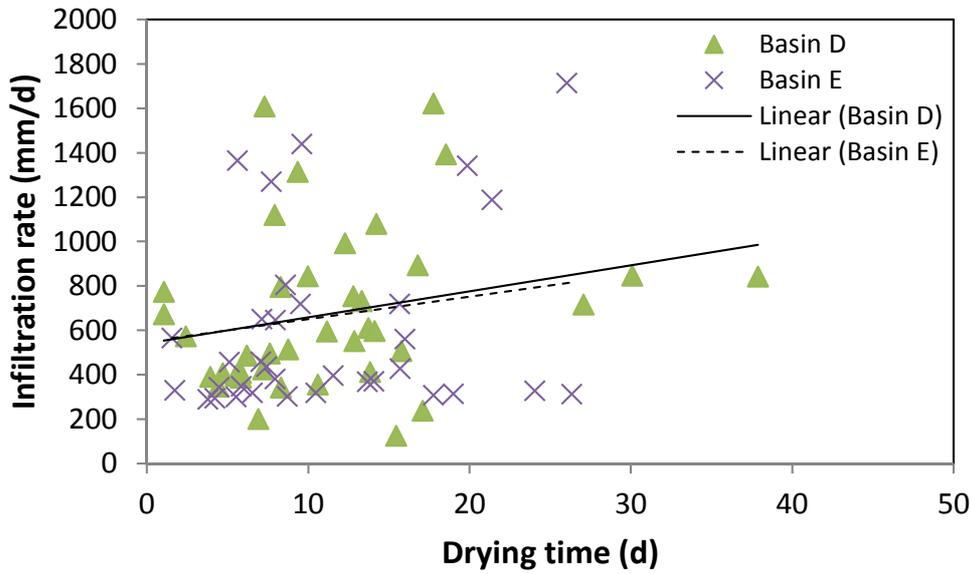
Figure 39 Relationship between infiltration rate and drying time for Basins D and E.

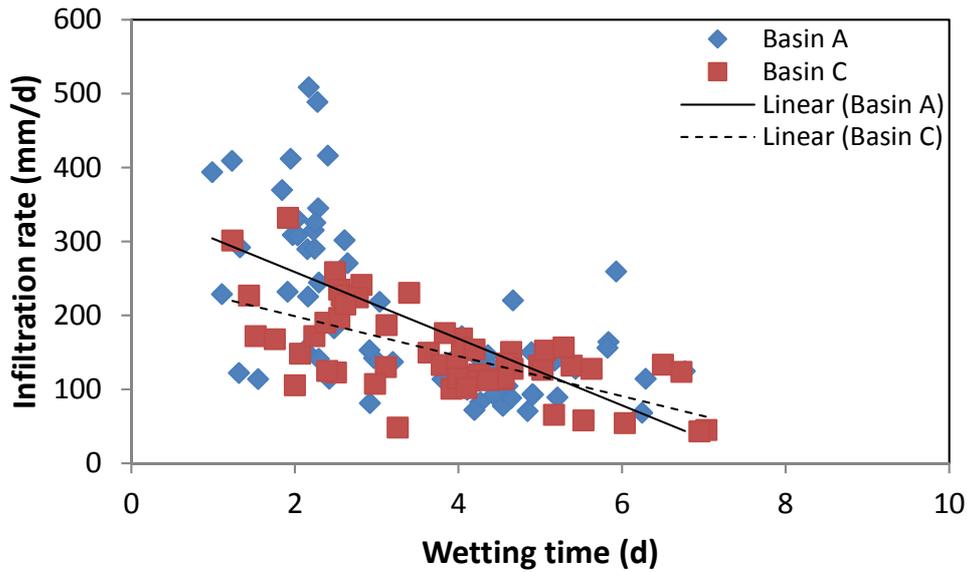
Figure 40 Relationship between infiltration rate and wetting time for Basins A and C.

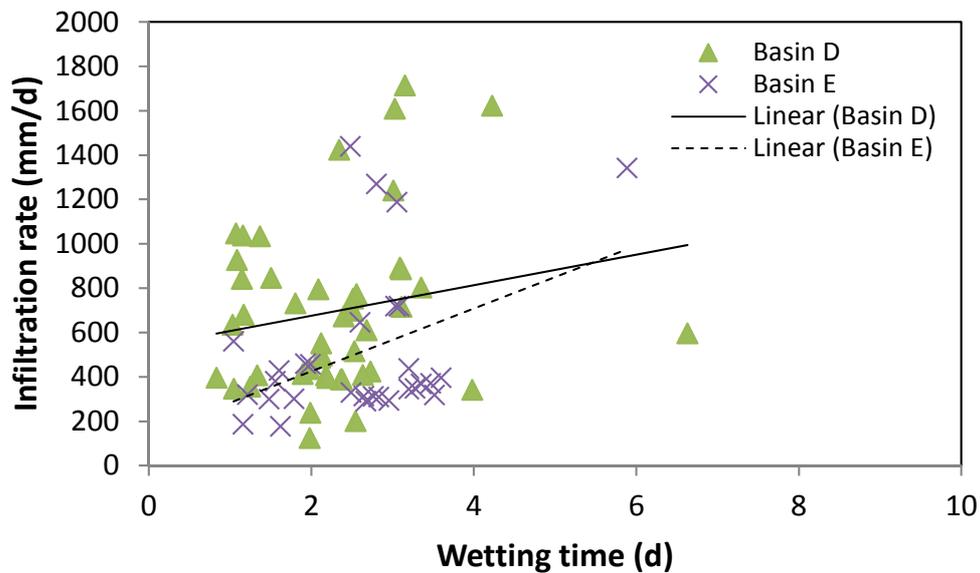
Figure 41 Relationship between infiltration rate and wetting time for Basins D and E.

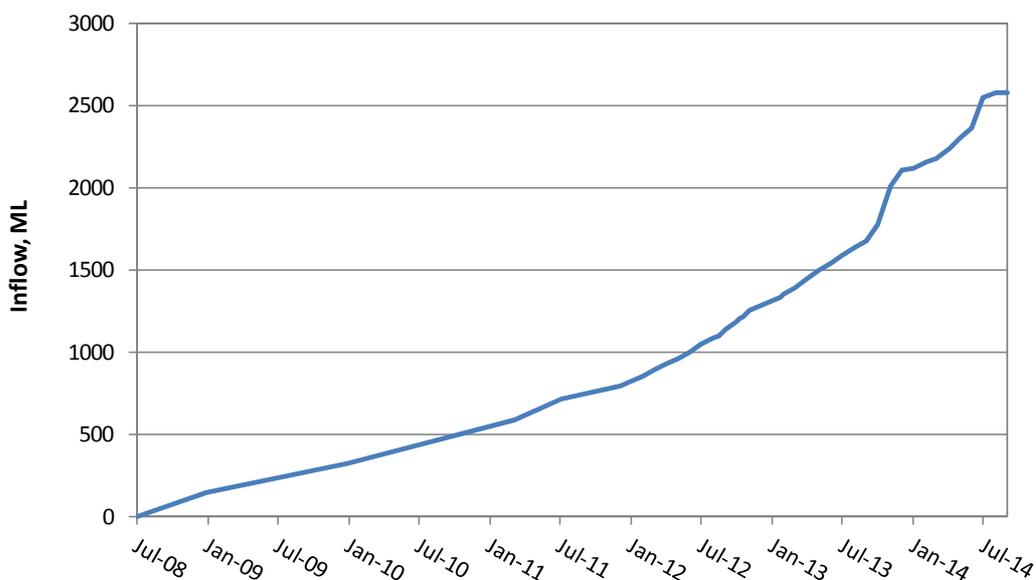
Figure 42 Total volume of water released to the SAT system in its history (Jun 2008- Sep 2014).

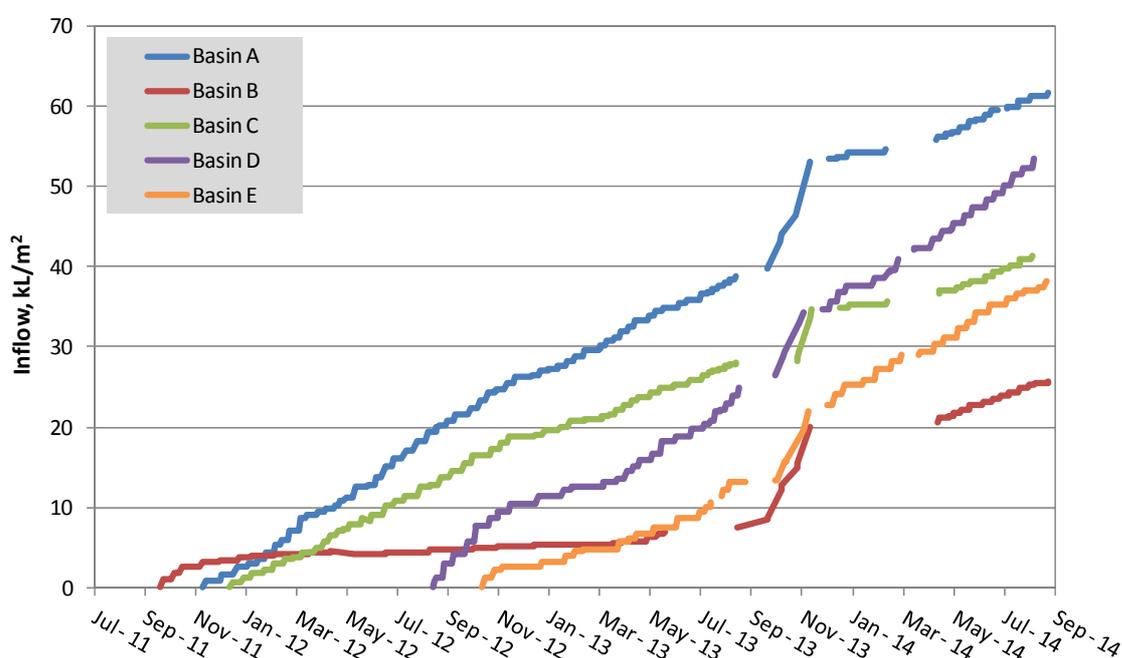
Figure 43 Volumes of recharge water released to the individual basins from October 2011 to September 2014. Interruptions in inflow for all basins relate to treatment plant stoppages (August 2013, November 2013) and loss of data (March 2014). Additional interruptions in inflow for Basin B represent periods when the basin was not in use.

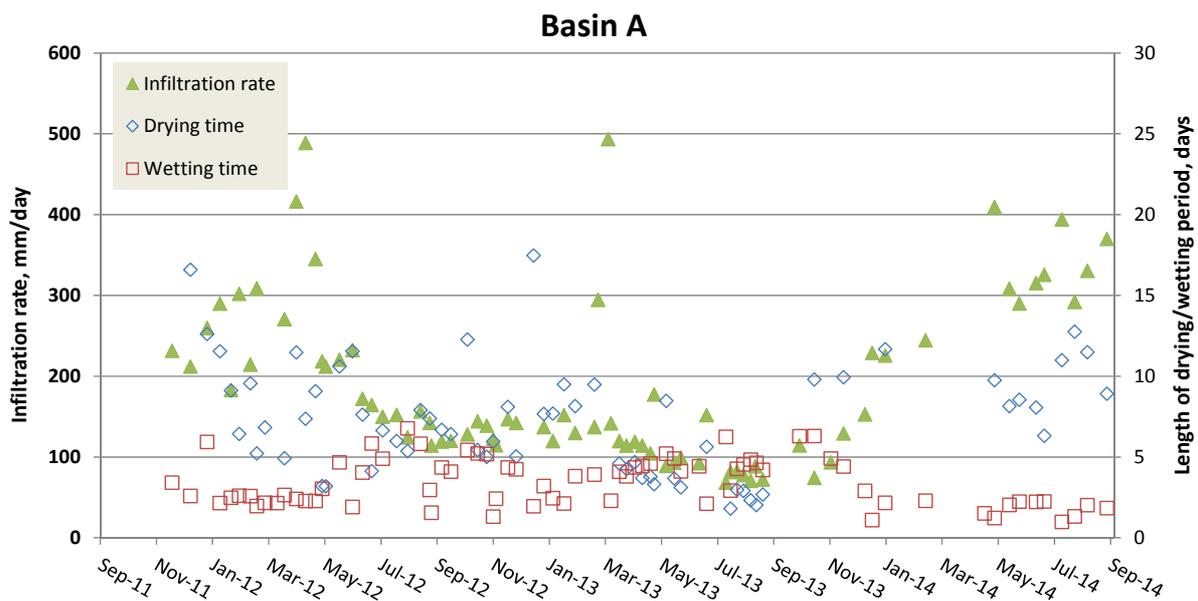
Figure 44 Infiltration rates and lengths of drying and wetting cycles in Basin A.

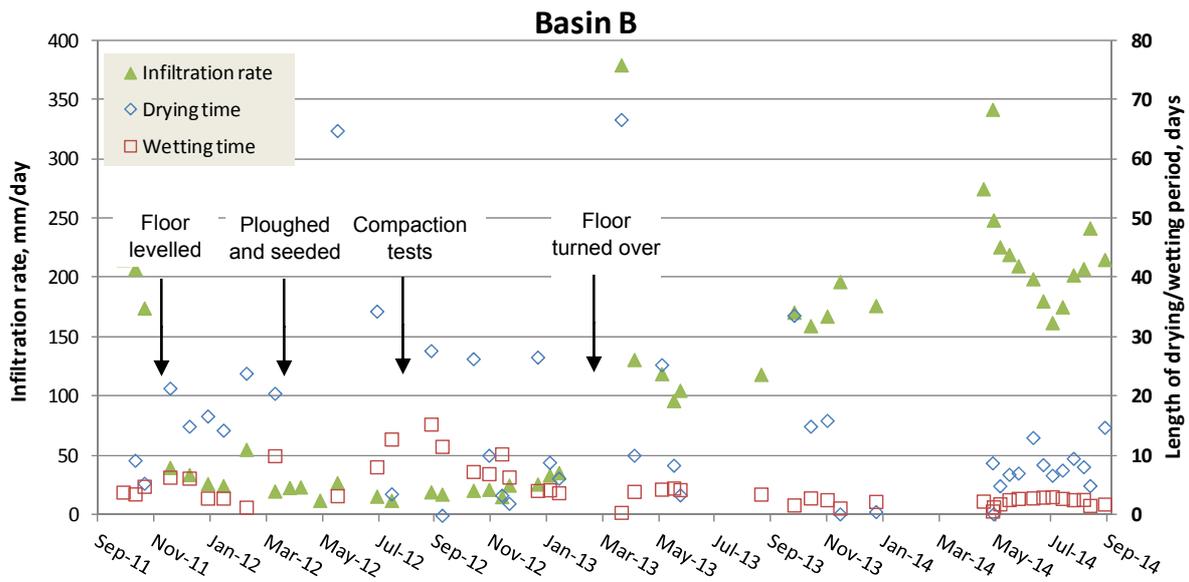
Figure 45 Infiltration rates and lengths of drying and wetting cycles in Basin B.

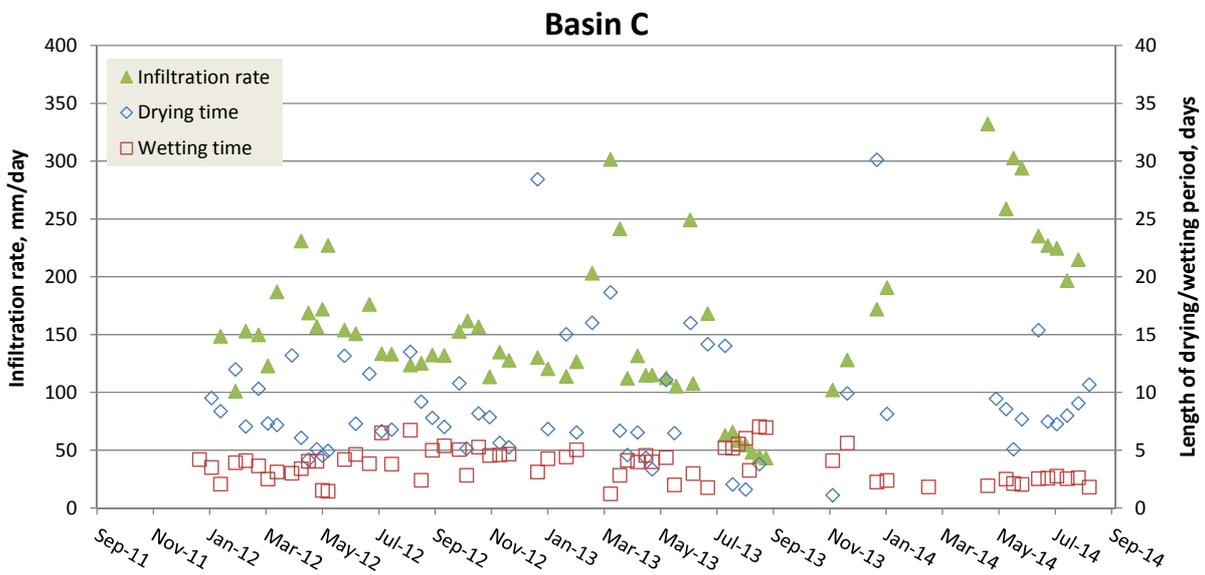
Figure 46 Infiltration rates and lengths of drying and wetting cycles in Basin C.

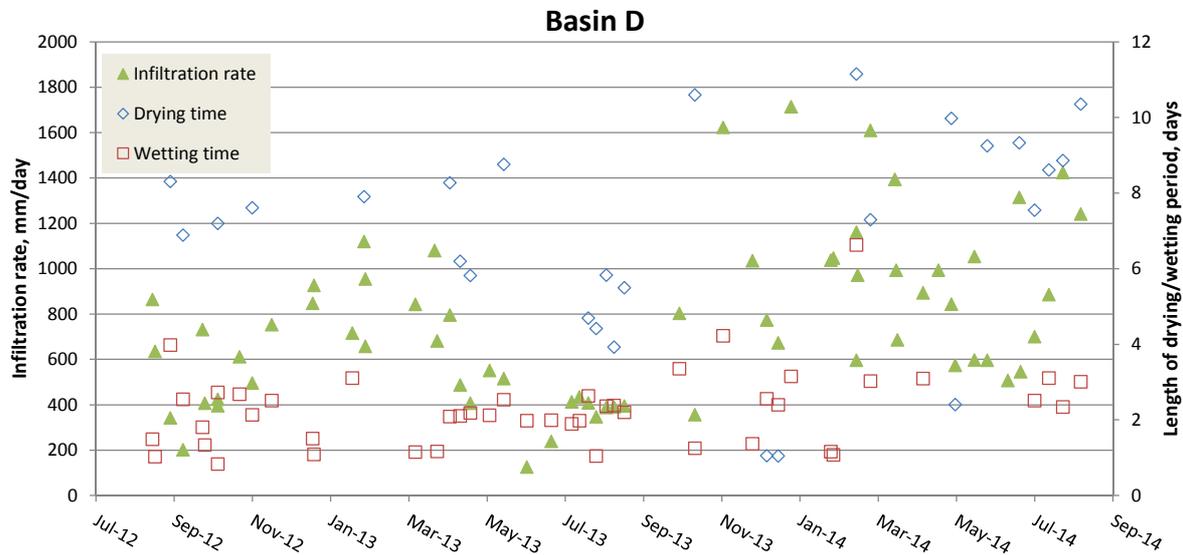
Figure 47 Infiltration rates and lengths of drying and wetting cycles in Basin D.

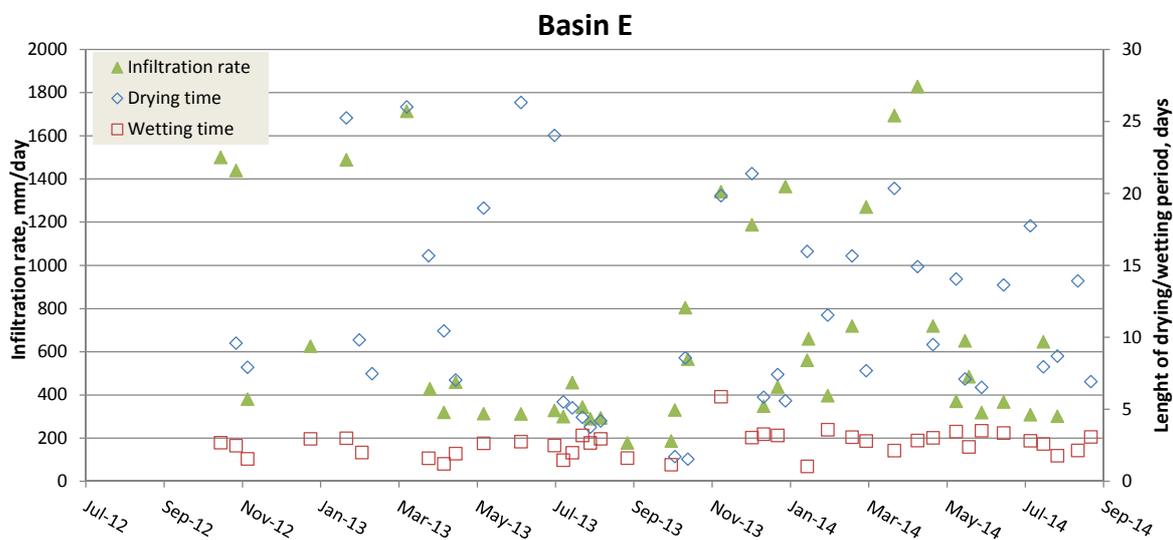
Figure 48 Infiltration rates and lengths of drying and wetting cycles in Basin E.

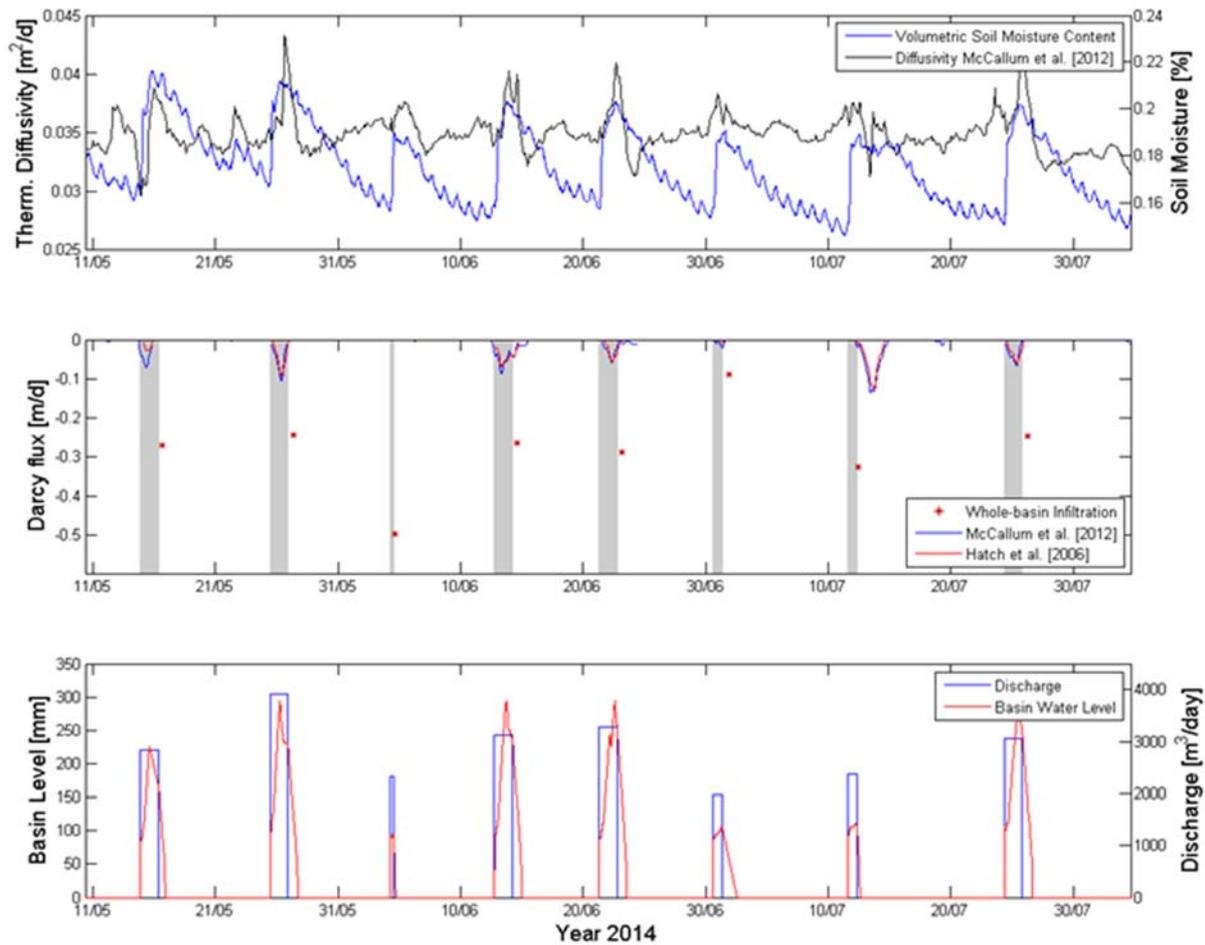
Figure 49 Overall flux comparison at T2 (Basin A) (Gunatunge 2014). The grey shaded area denote recharge events.

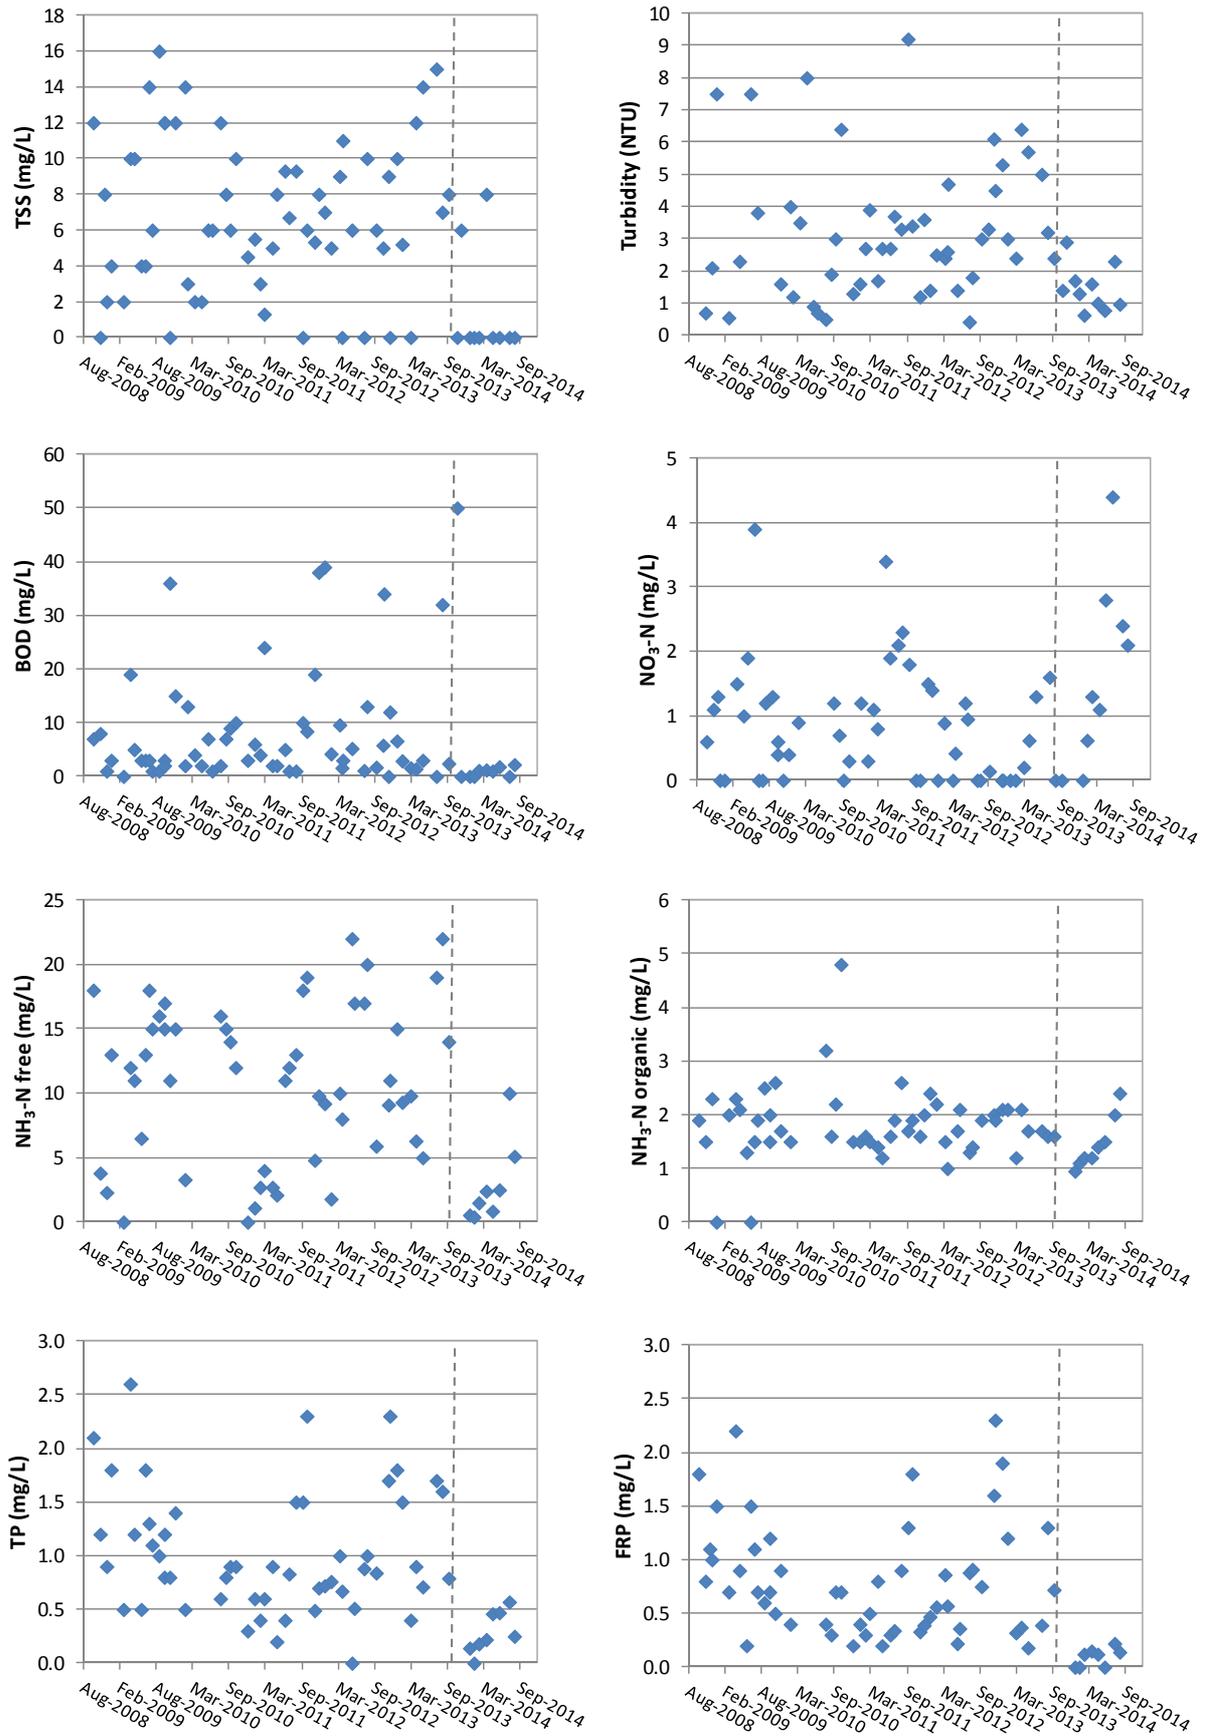
Figure 51 Water quality of recharge water sampled at the SAT site. The vertical dashed line marks the WRP upgrade to DAFF treatment in September 2013.

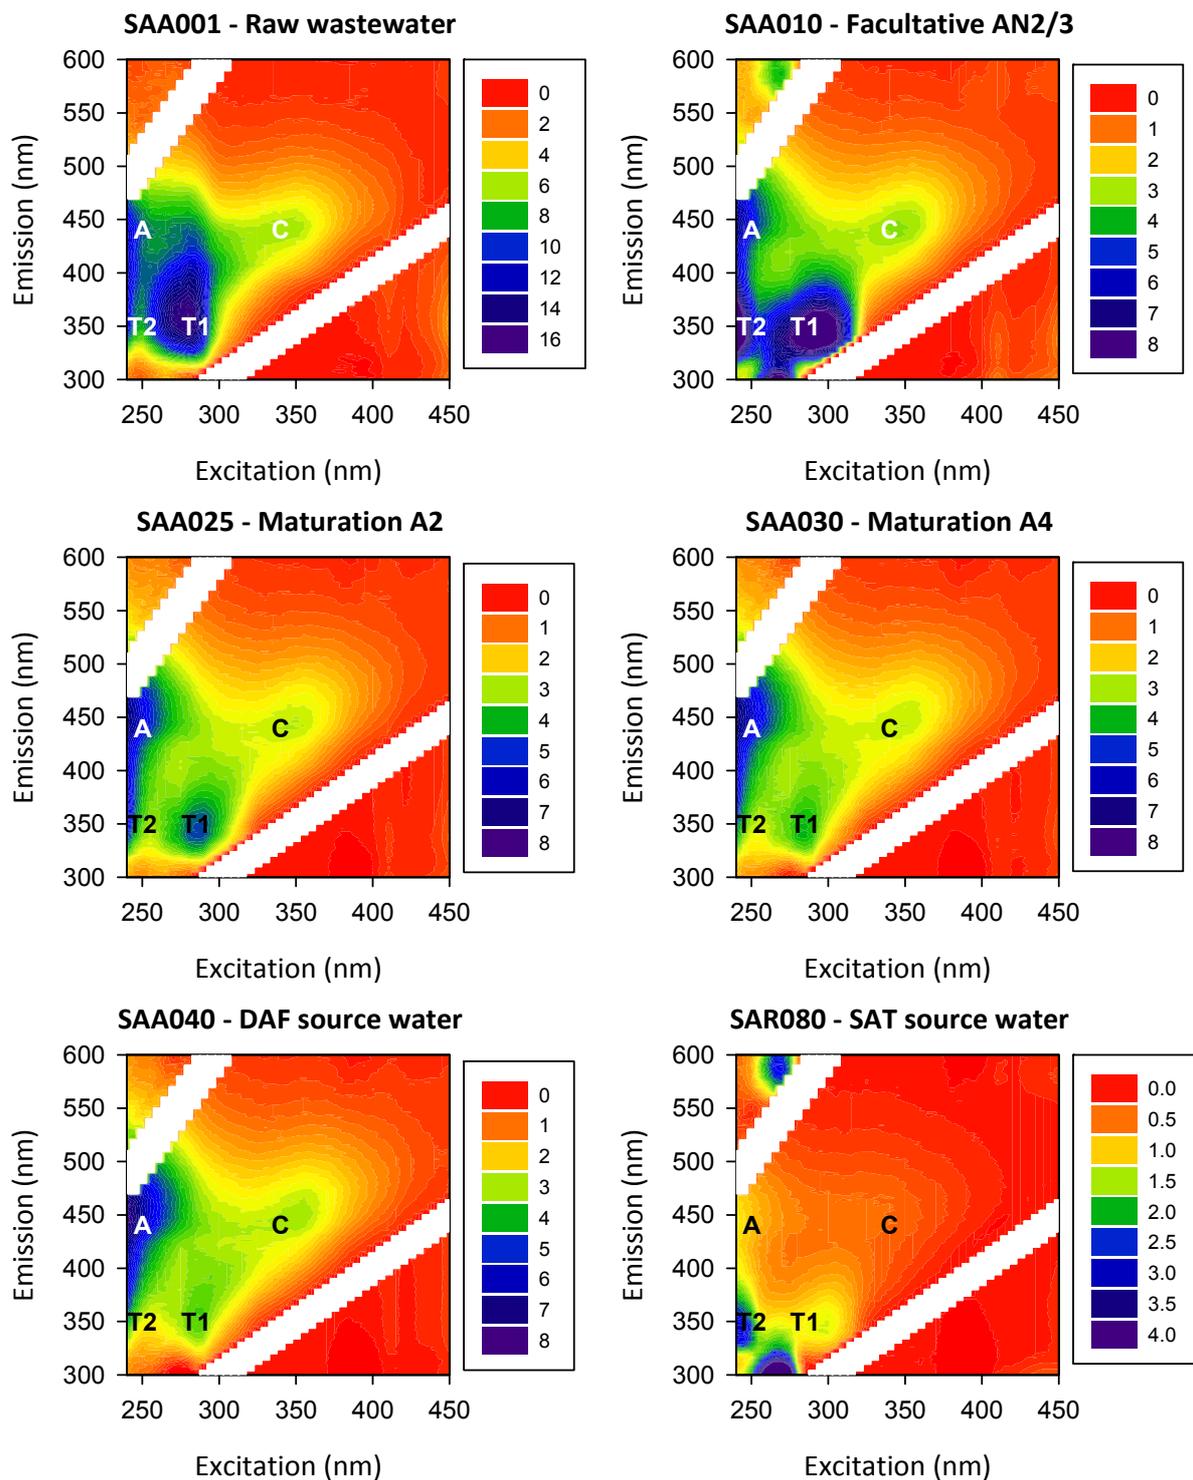
Figure 52 Fluorescence excitation-emission matrices (EEMs) of dissolved organic carbon during wastewater treatment for: sewer inlet (Saa001), facultative pond AN2/3 (Saa010), maturation pond A2 (Saa025), maturation pond A4 (Saa030), DAFF source water (Saa040) and SAT source water (Sar080) sampled in September 2014, where A = humic-like, C = humic- and fulvic-like, T1 and T2 = typtophan-like fluorescence. The colours represent the fluorescence intensity expressed in Raman units. Note the different fluorescence intensity scales are used to enable comparison of samples. The white areas mask the Rayleigh scatter peaks of water.
