Managed Aquifer Recharge and Recycling Options: Understanding clogging processes and water quality impacts

A report of a study funded by the
Australian Water Recycling Centre of Excellence

Managed Aquifer Recharge and Recycling Options (MARRO)

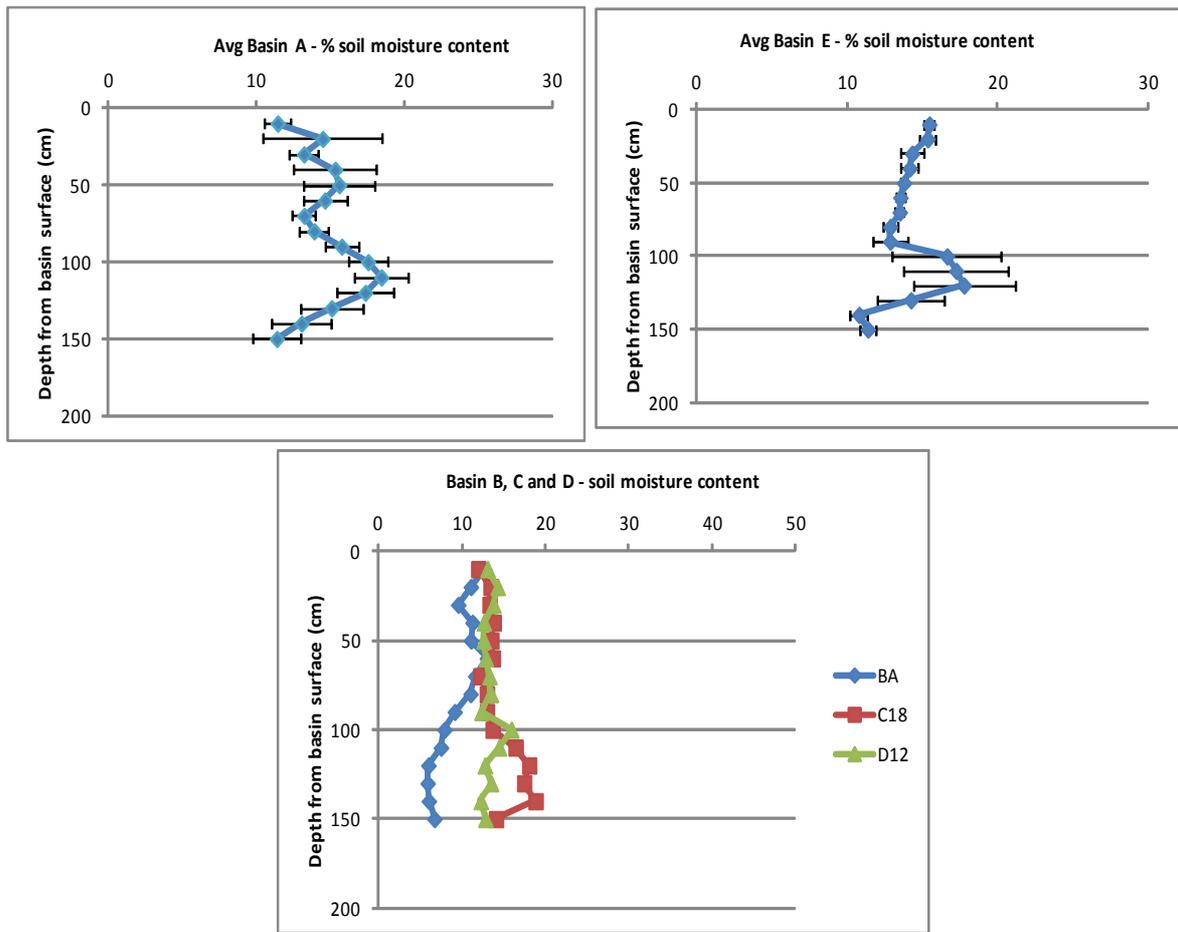
Figure 54 Average soil moisture to 1.5 m depth in basin A and D and at locations BA, C18 and D12 from samples collected in 2014.

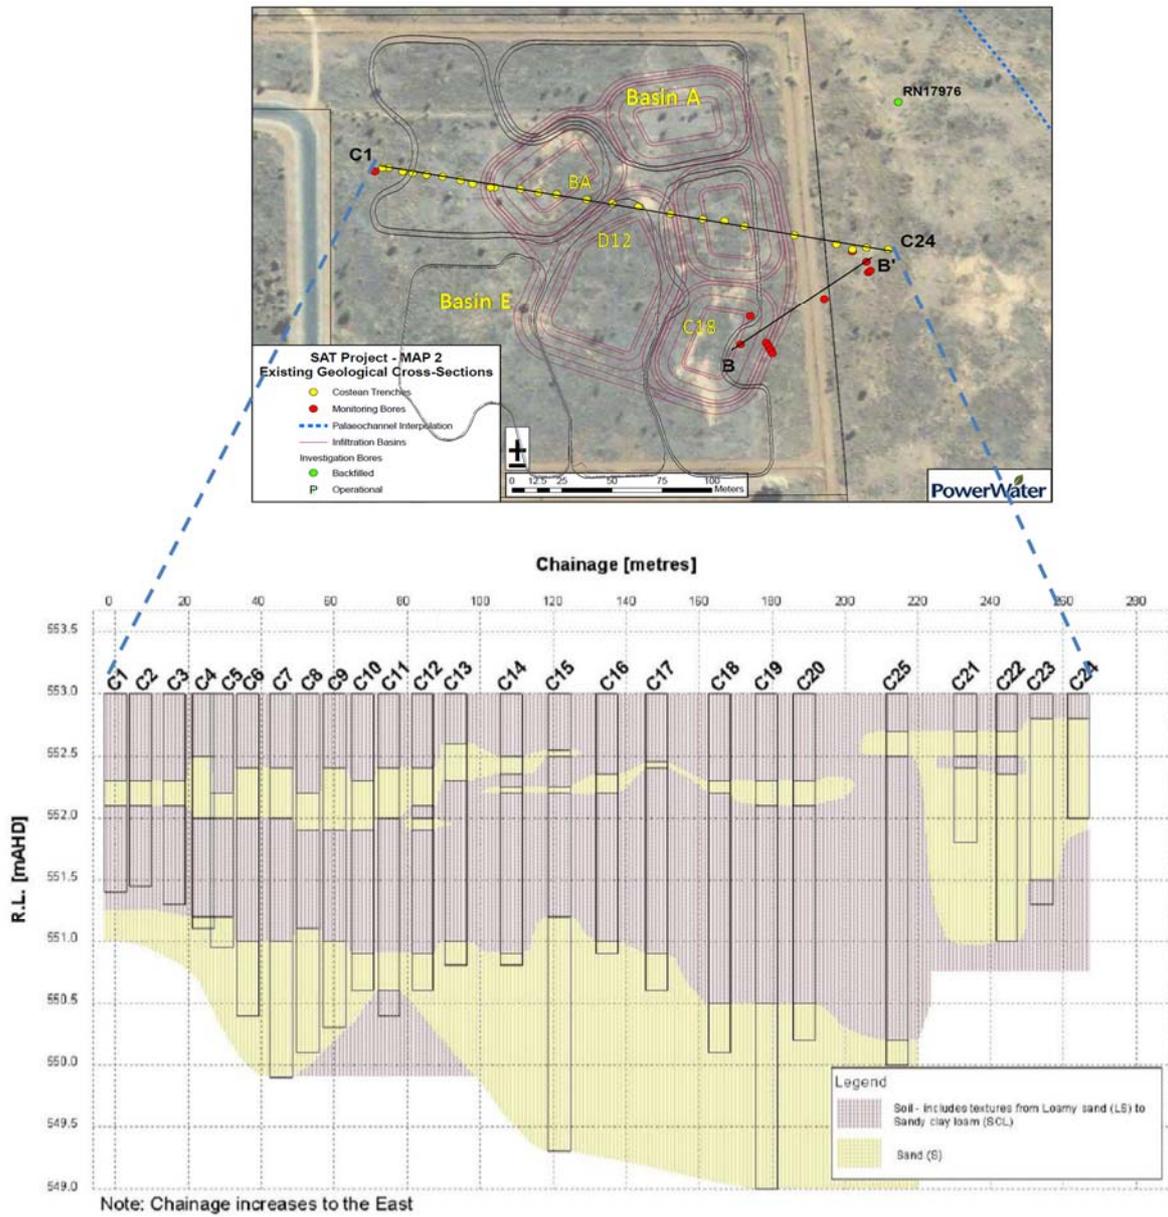
Figure 55 Soil texture previously determined by Costean Trench (C1-C24) (Knapton and Lennartz 2005).

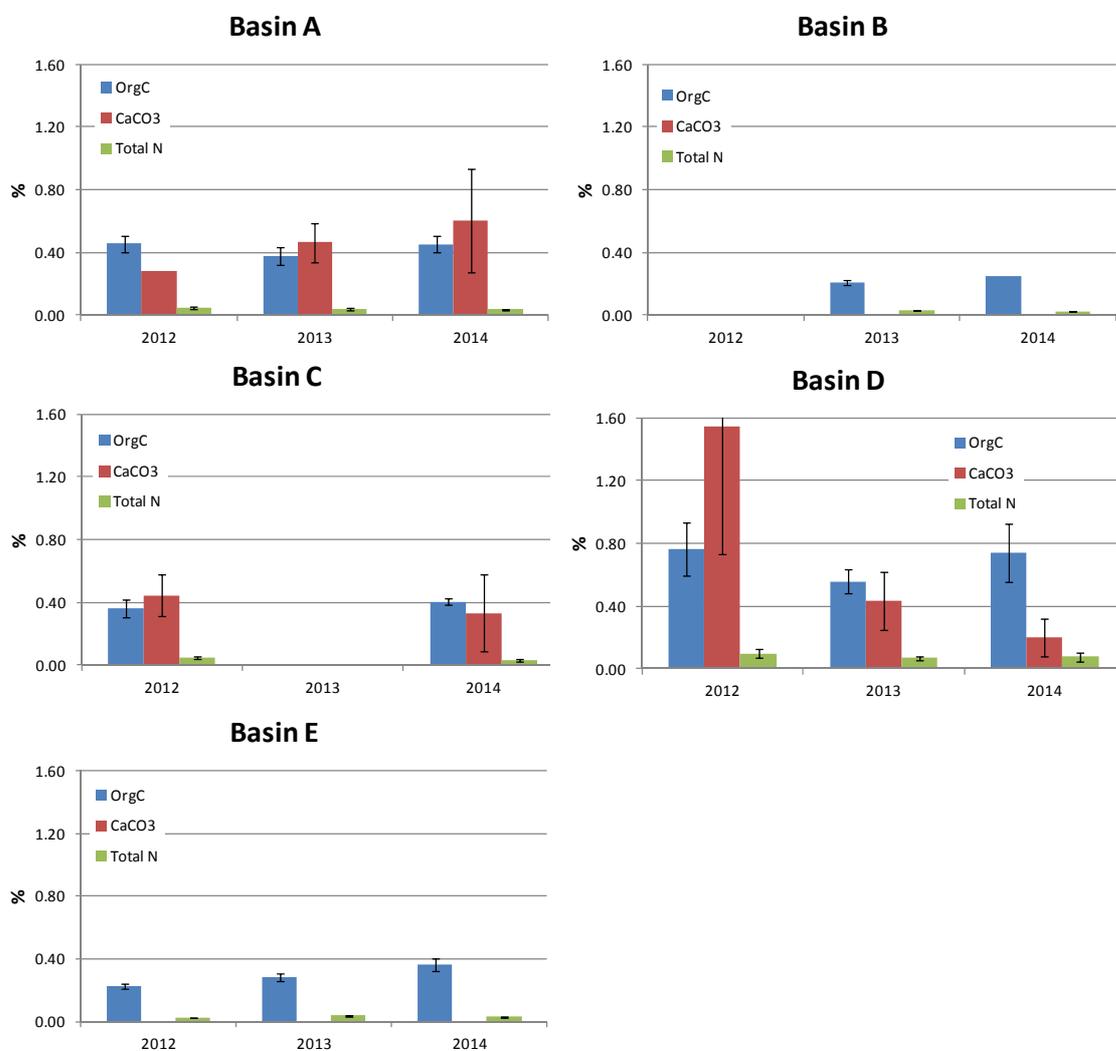
Figure 56 Comparisons of organic carbon (OrgC), calcium carbonate (CaCO₃) and total nitrogen (Total N) in the top 2.5 cm layer over three successive years.

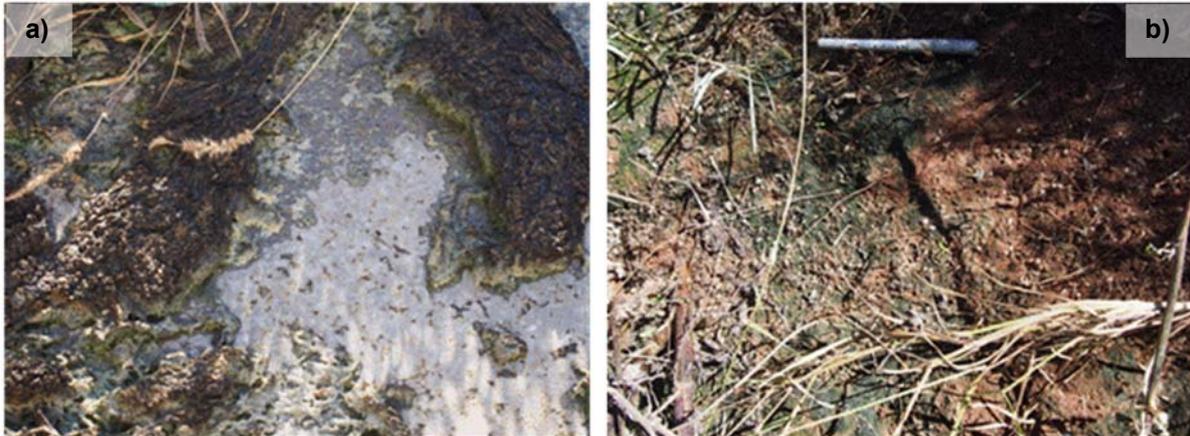
Figure 58 a) Accumulated matter near inlet of basin; and b) dried schmutzdecke on surface of basin.

Samples of accumulated algal material and schmutzdecke were collected from in Basin A, D and E in July 2013. Samples collected near the inlet of the basins appeared to be an accumulation of algae and organic matter from the source water (Figure 58a), often quite wet and gelatinous with some evidence of a drier crust developing over time. Samples collected from further into the basins were from areas of dried out schmutzdecke ~1-3 mm thick (Figure 58b).

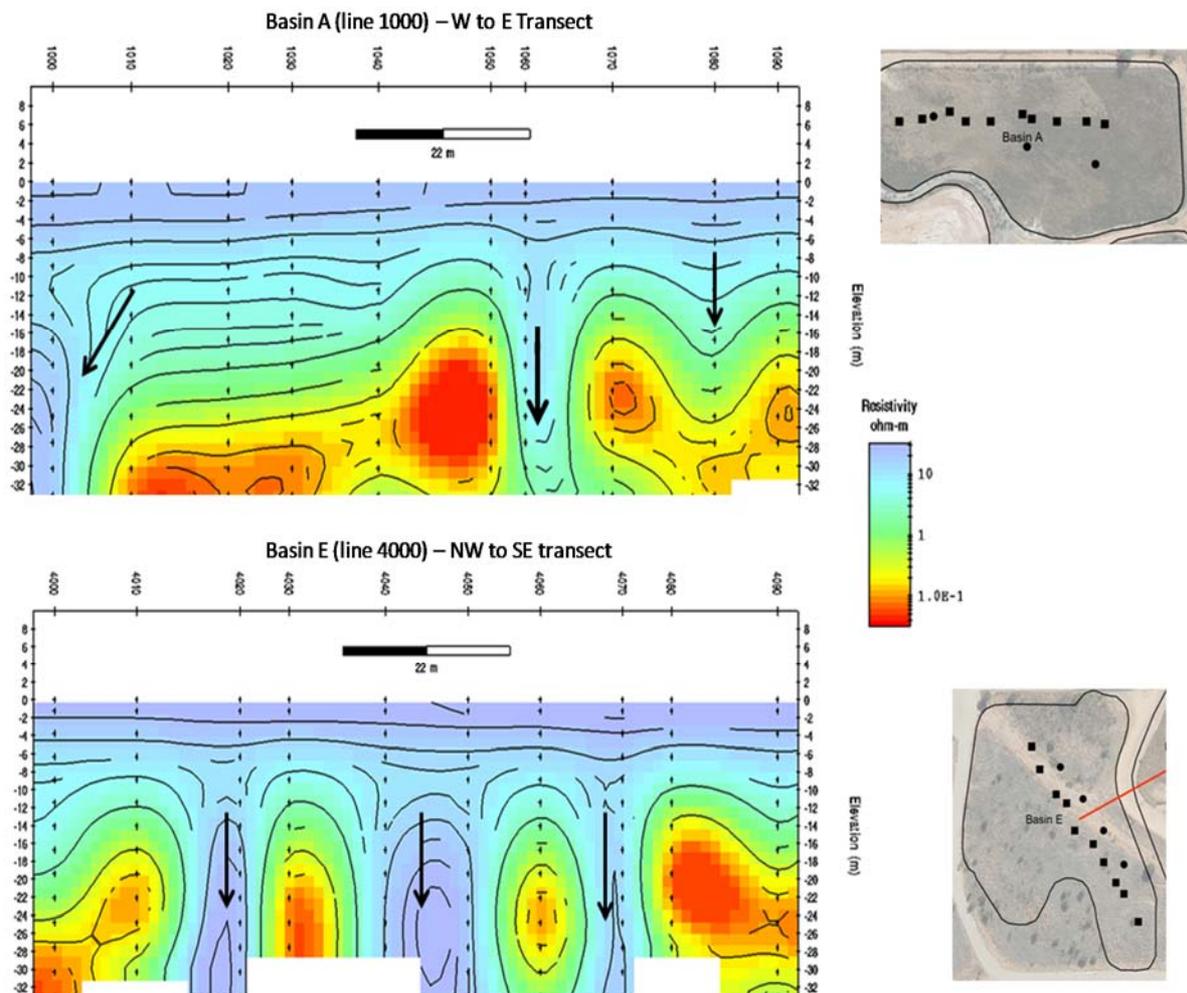
Figure 62 Groundwater flow beneath Basins A and E interpreted from time-domain EM (NanoTEM).

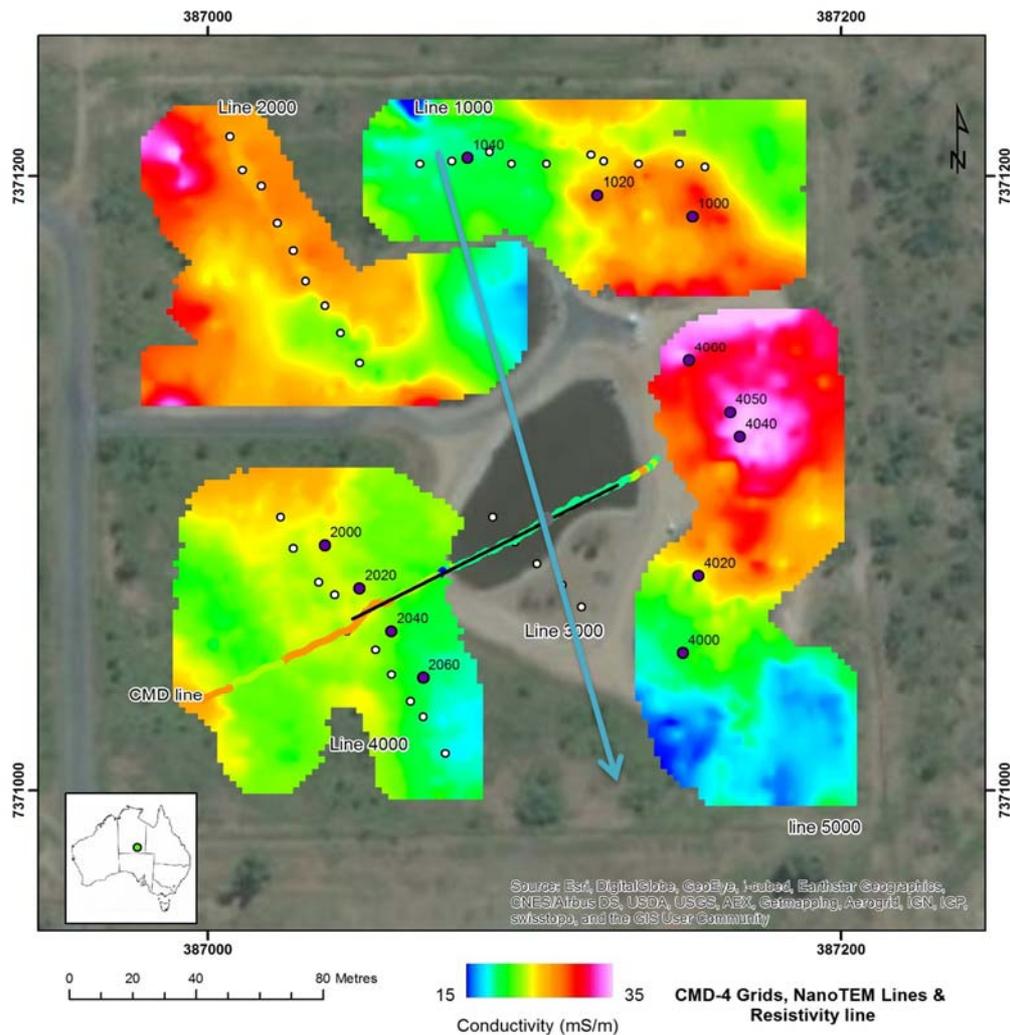
Figure 63 Interpreted CMD (apparent electromagnetic conductivity) survey results for Basins A, B, C and E at 6-6.5 m depth below basin surface after recent wetting (week prior) August 2014. The black line shows the location of the resistivity transect and this line represents the location of high resistivity at surface and at 10 m depth. The blue line represents groundwater flow which occurs at a depth of ~20m. The arrow represents a possible flow direction based on lower conductivities on Lines 1000, 3000 and the resistivity transect and the interpolated groundwater hydraulic gradient.

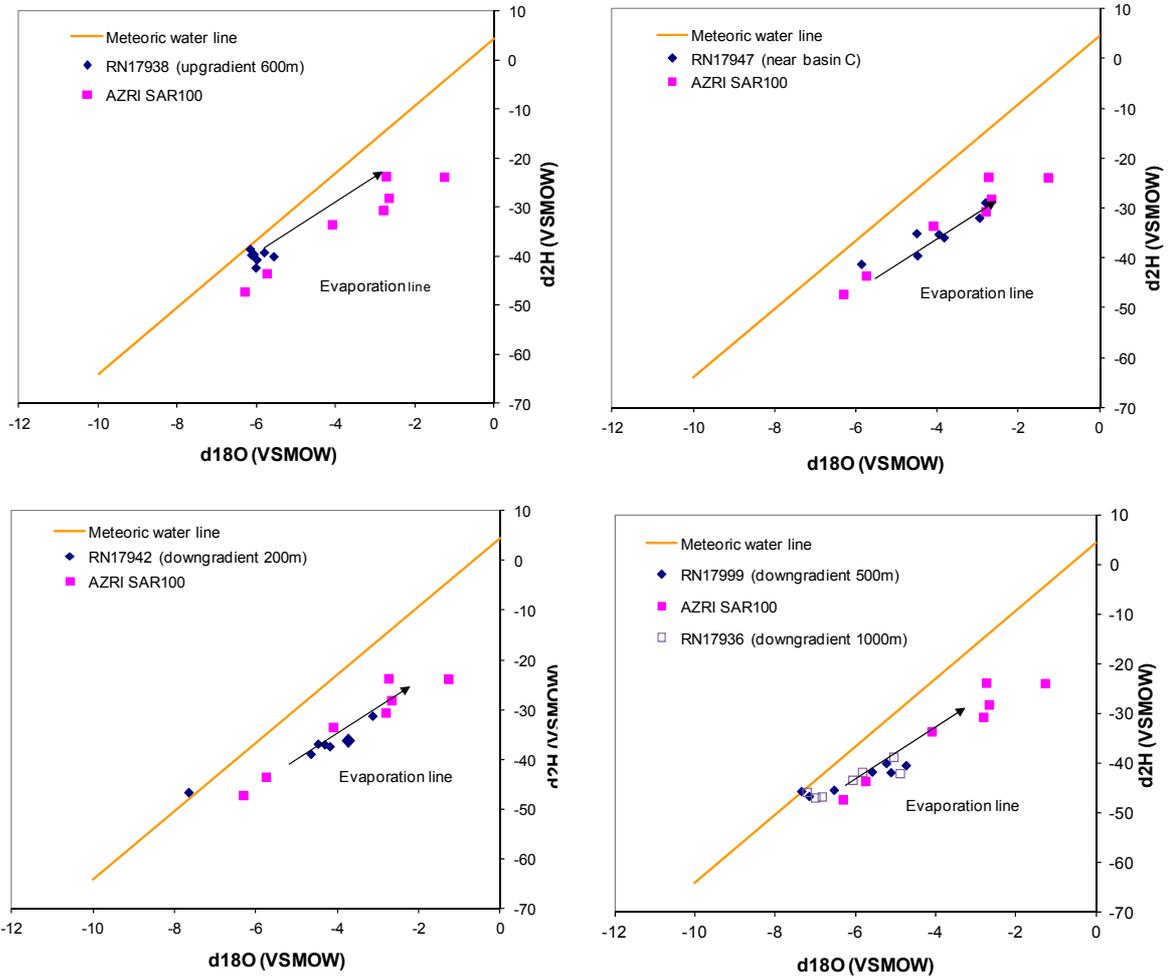
Figure 70 Average annual stable isotopes of water in groundwater sampled from April 2008 to December 2014 compared to the recharge water (AZRI SAR100) and the meteoric water line.

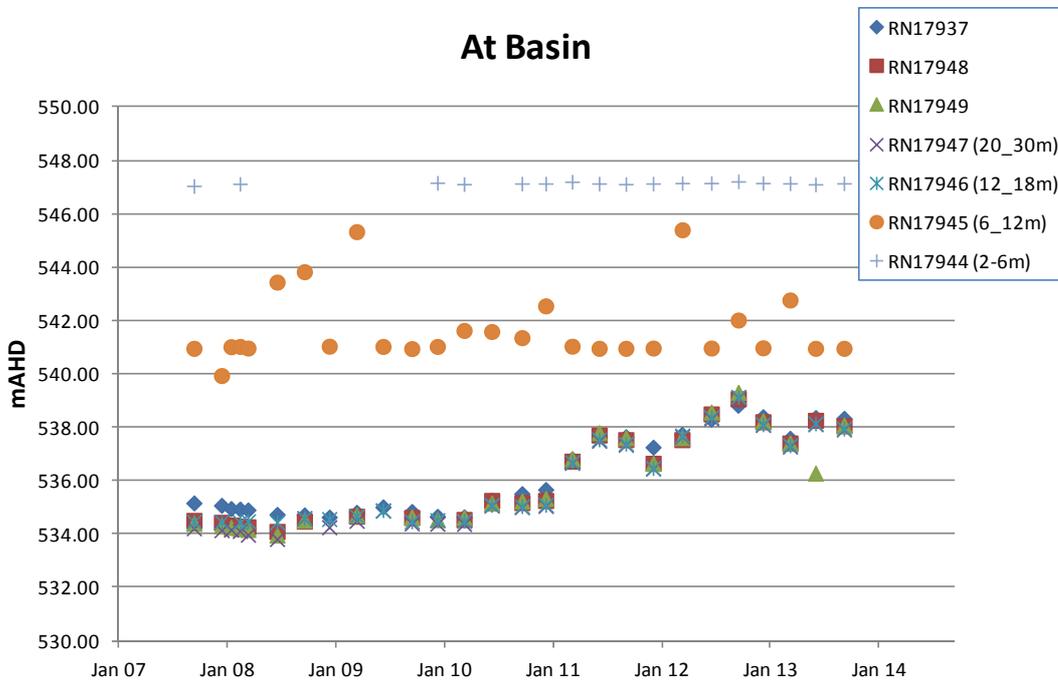
Figure 73 Groundwater levels (mAHd) of open hole monitoring bores next to Basin B and in Basin C during SAT operation.

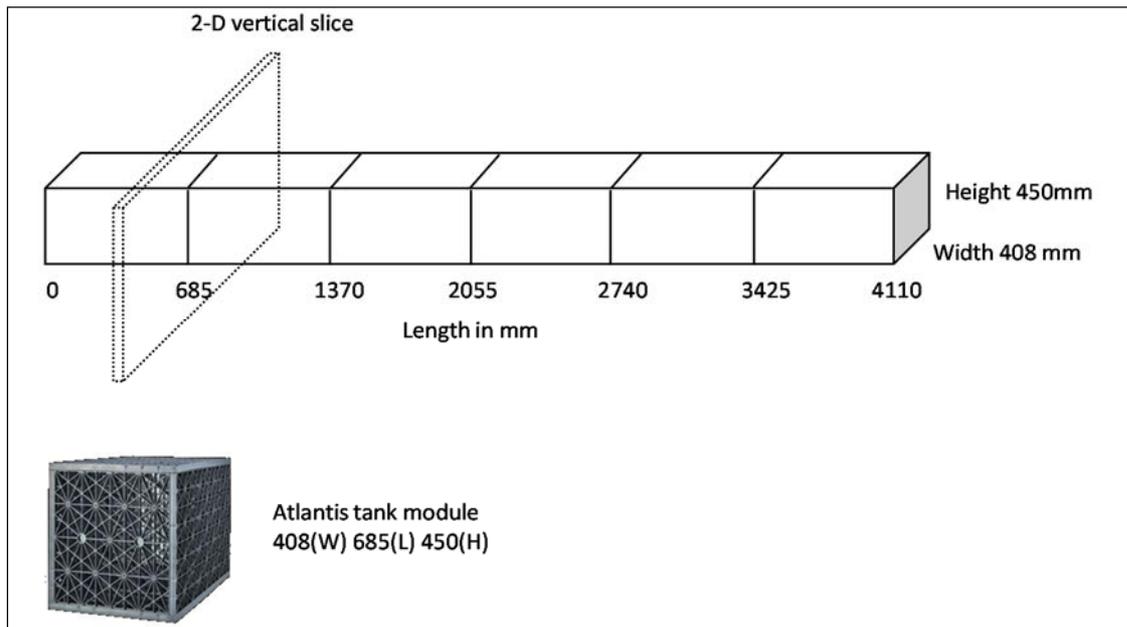
Figure 74 Schematic of proposed installation of six Atlantis Flo-Tank® modules. The dimensions of the linear gallery are approximately 4.0 m by 0.4 m. Vertical slices taken along the long dimension of the gallery will be used for HYDRUS modelling.

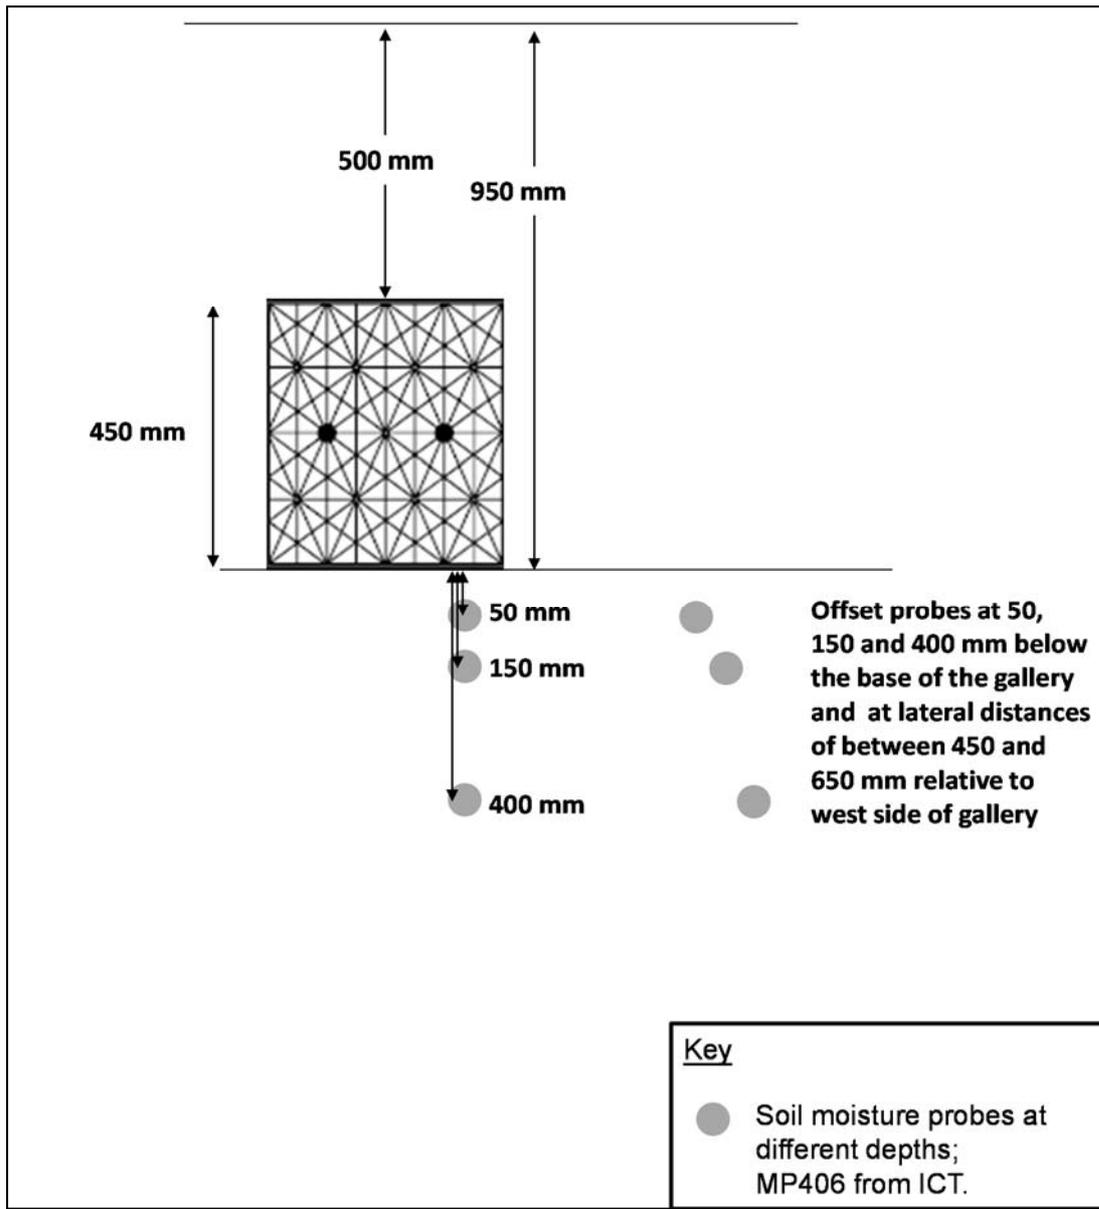
Figure 77 Cross-section view depicting the placement of soil moisture probes relative to the base of the gallery. For the probes directly under the gallery, the lateral distances relative to the edge of the gallery are approximate and varied (~2 to 4 cm) for the North, Middle and South sets of probes and the three depths.

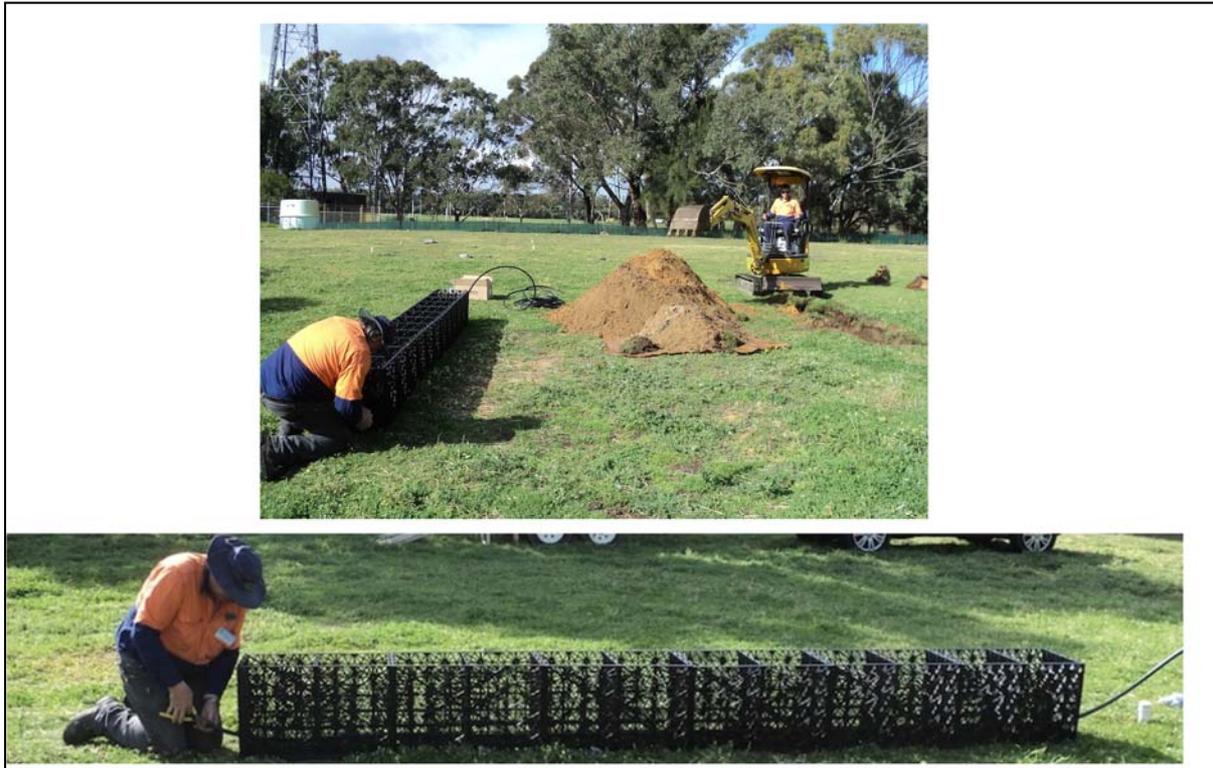
Figure 79 Trench excavation for the infiltration gallery (top) and assembly of the reticulated system for dispersing treated wastewater within the Atlantis Flo-Tank® modules (bottom).

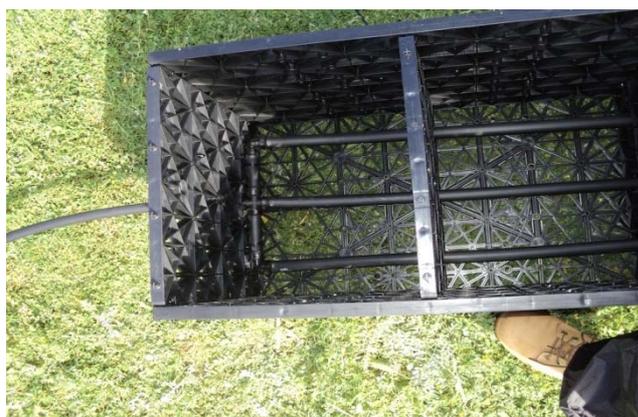
Figure 80 Close up view of the south end of the gallery, showing the inflow poly pipe connecting to three sections of poly pipe, each approximately 10 cm apart. This photo was taken before the 42 Netafim drippers were inserted and shows the gallery upside down. Three lengths of poly pipe pass laterally through incisions in the partitions within the Atlantis® modules and are terminated at the distal end of the gallery (4m to the north). The pipes were cable-tied to the top panels on the underside of the tanks.

Small sections of the Atlantis® modules were cut away to make space for the reticulated system to pass through laterally. Three lengths of poly pipe were used to disperse the wastewater from a 4-way joiner at the inflow (south) end of the gallery (Figure 80) and 42 Netafim™ pressure-compensating drippers were pierced into the pipe at fairly regular intervals (4). The reticulated system within the Atlantis® modules was tested with potable water above-ground before placing the system within the trench.

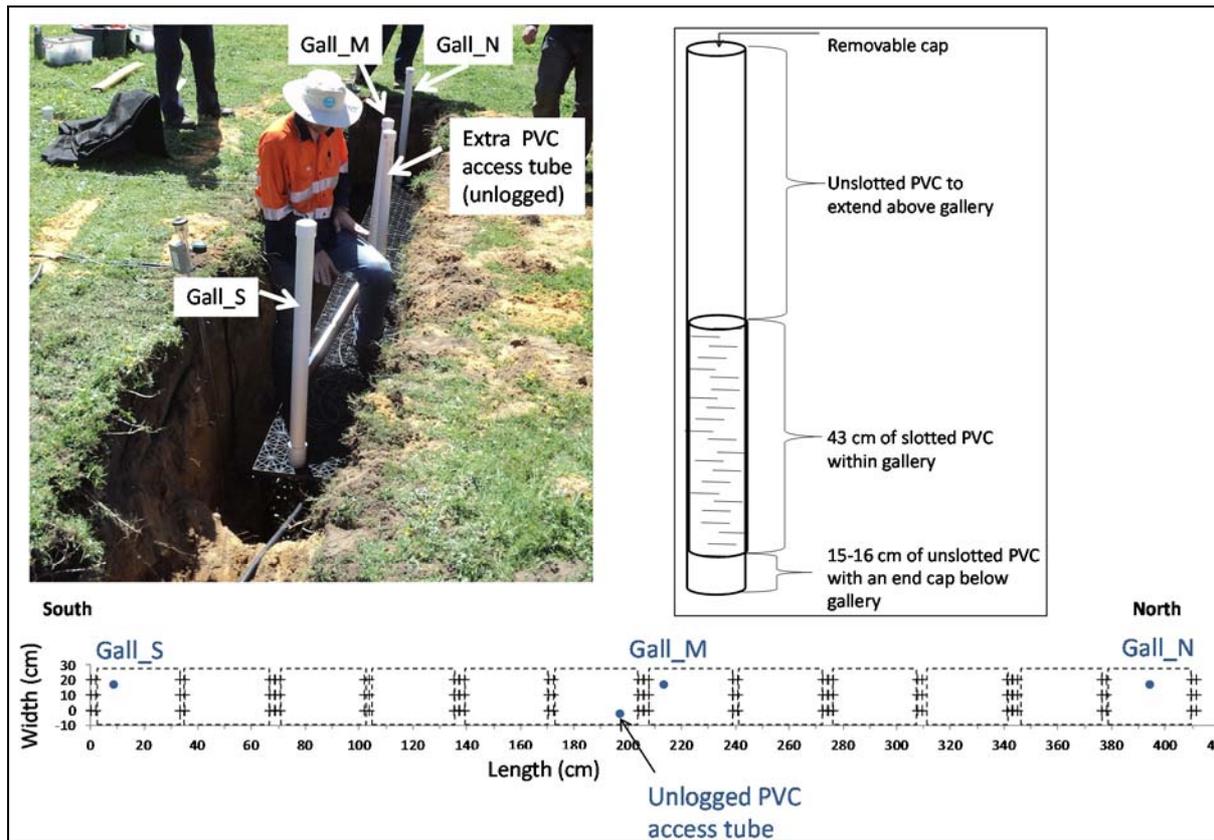
Figure 83 Locations of water level logging within the infiltration gallery. The diagram on the right (not to scale) shows the design of the PVC tubes used to monitor water levels in the gallery. Geofabric (not shown) was used to cover the top and upper few cm of the gallery to lessen the opportunity for roots to grow into the gallery.

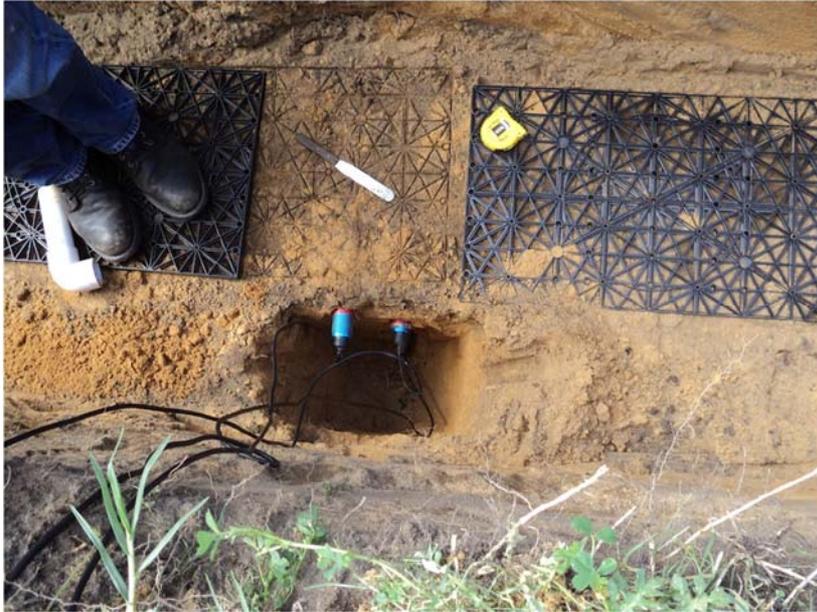
Figure 84 Michael Donn standing on a spare Atlantis® plate to distribute his weight while installing the soil moisture probes below the intended base level of the gallery. The foot plates indicate the approximate location of the gallery relative to the sensors. He is standing at a depth of 105 cm below ground. Small temporary trenches were used to insert the probes laterally from the sidewall by first augering a hole using a small piece of PVC tubing (shown on the left) and which were then backfilled. Soil moisture probes at 5 cm, 15 cm and 40 cm below base level were installed at slightly offset positions to avoid side-wall collapse.

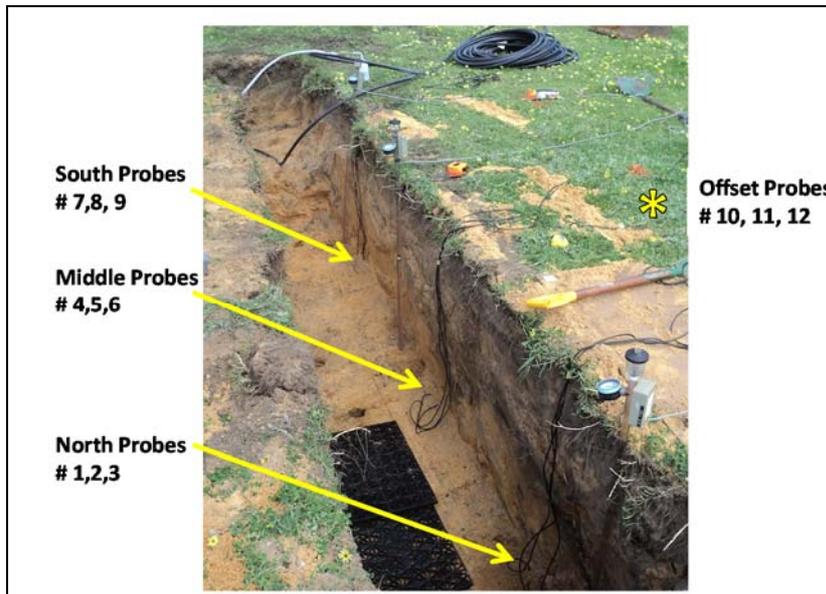
Figure 85 Placement of South, Middle and North soil moisture probes buried below the base level of the gallery with logging cables extending to the ground surface. The cables connect to a Campbell logger in a weather-proof box. Offset Probes # 12, 10 and 11 located 45, 55 and 65 cm, respectively west of the gallery were installed by augering at an angle to depths of 110, 120 and 145 cm, respectively below ground at roughly the position marked in the photo.

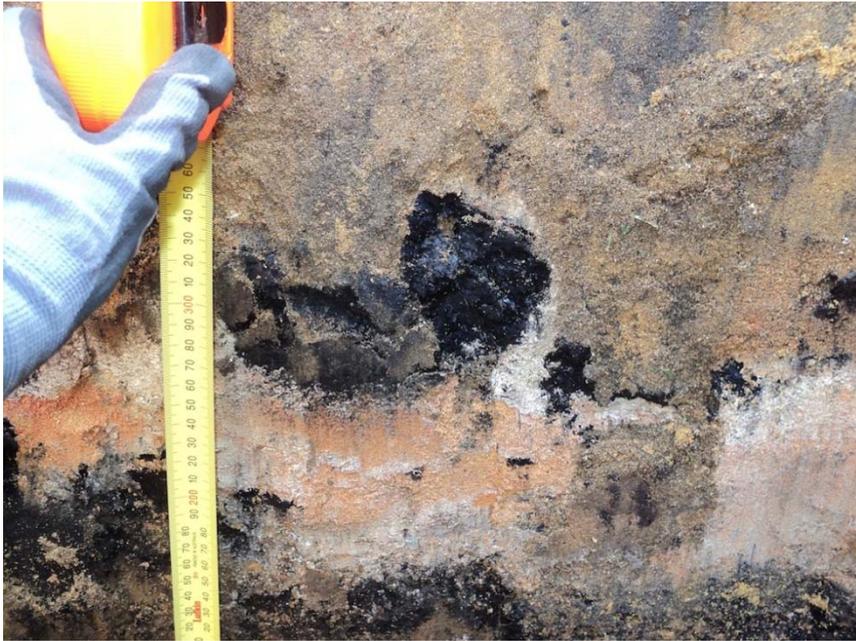
Figure 86 Close up view of charred material observed while developing the trench for the infiltration gallery.

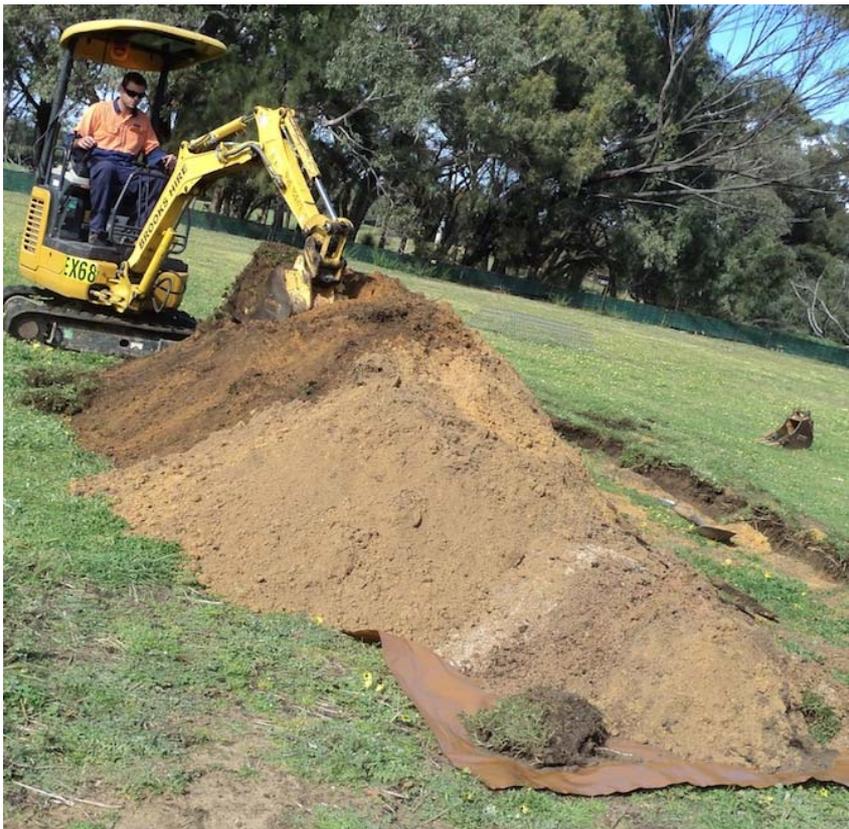
Figure 87 Sand removed from the trench during installation of the infiltration gallery.

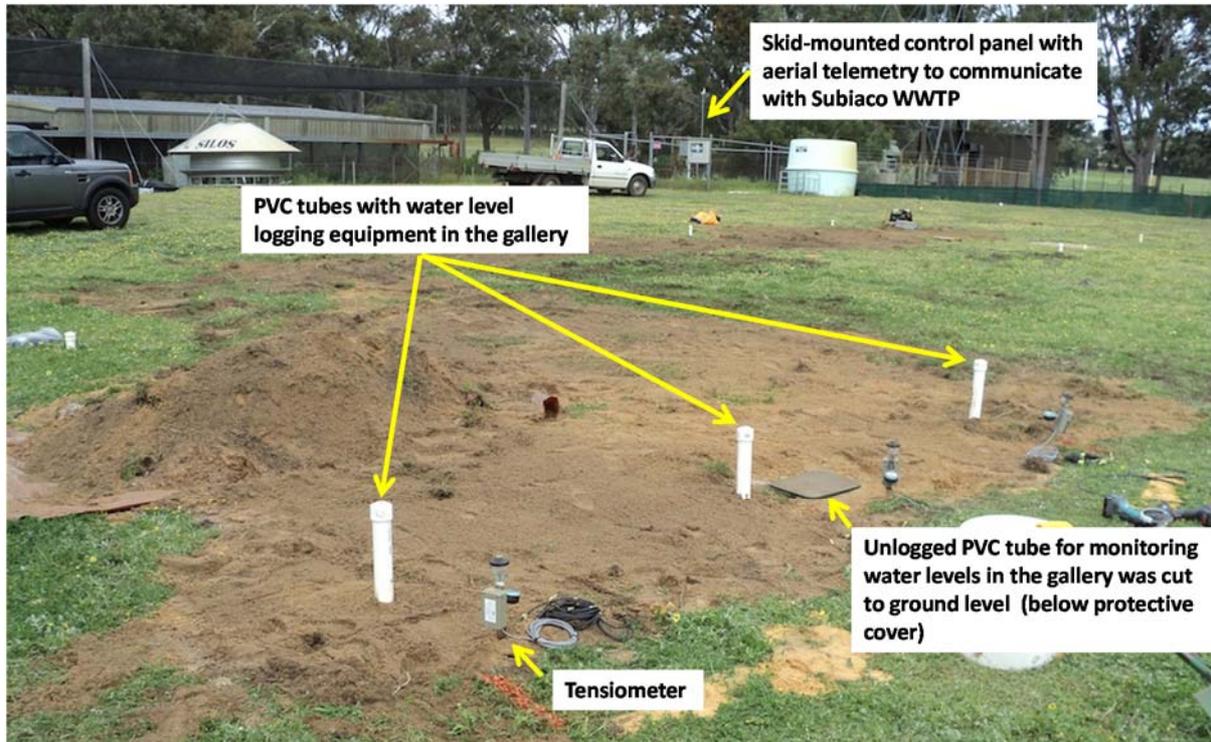
Figure 88 Backfilled site on 17-September 2013, showing the skid-mounted control system that regulates flow to the gallery. The PVC tubes for monitoring water levels are shown in the foreground. The tensiometers failed to provide reliable results once installed and are no longer being monitored. The grass has been allowed to grow back over the surface.

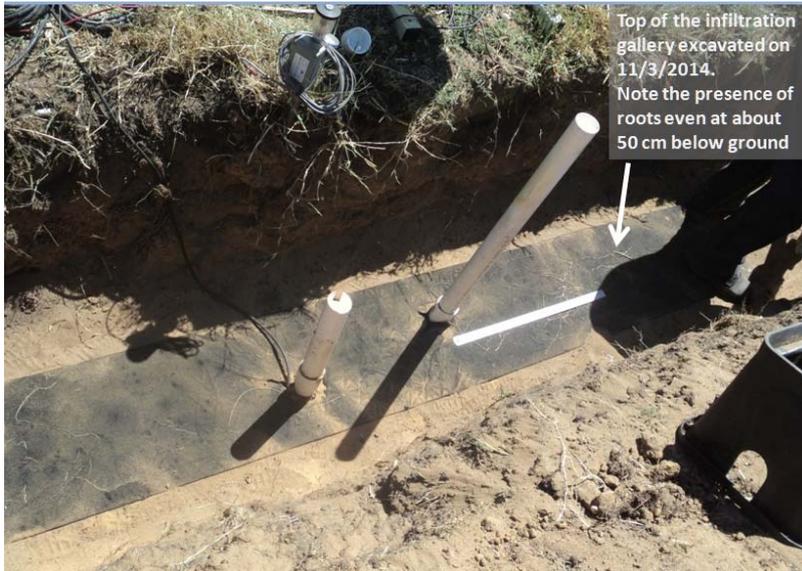
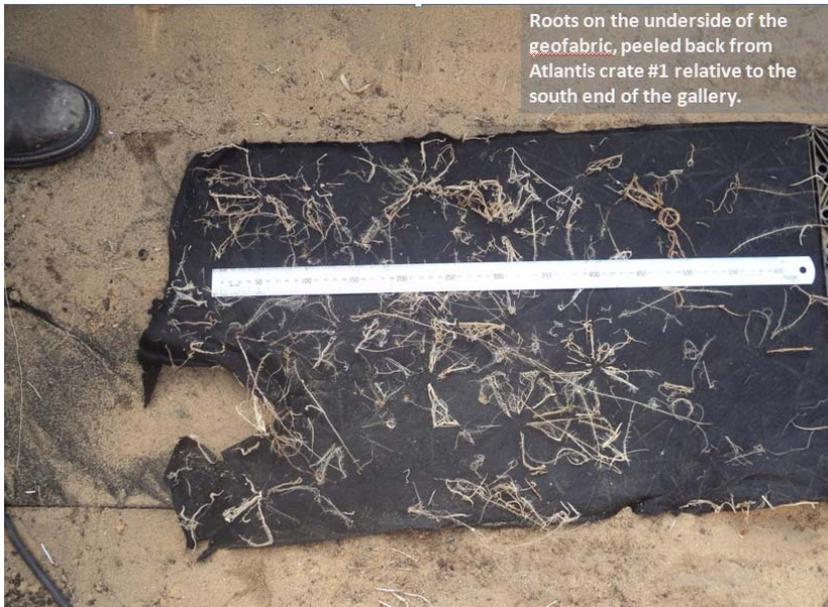
Figure 89 Photo of the excavated surface of the infiltration gallery and a close up of the roots embedded in the geofabric.

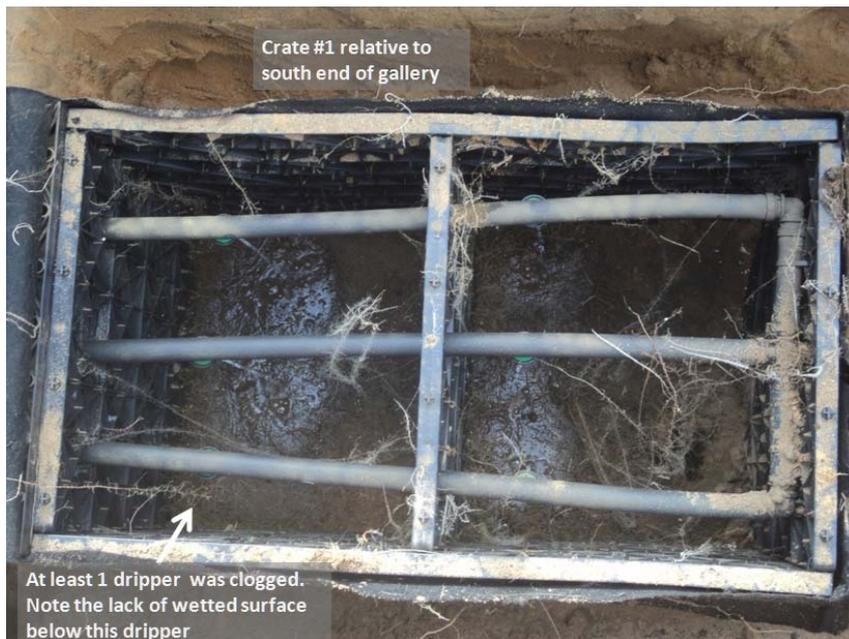
Figure 90 View of crate 1 (numbered consecutively with respect to the south end of the gallery).

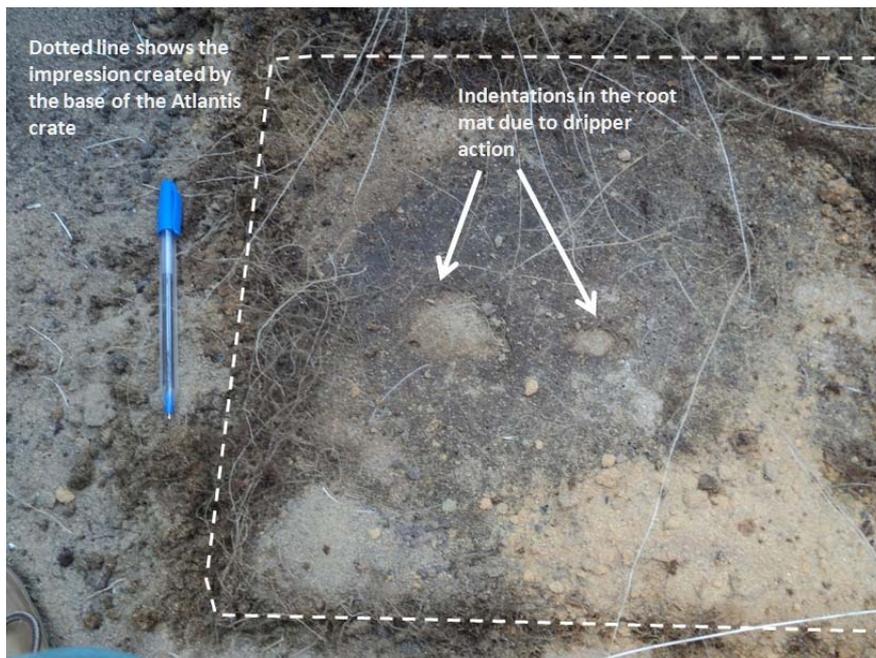
Figure 91 View of the soil layer below one of the crates.

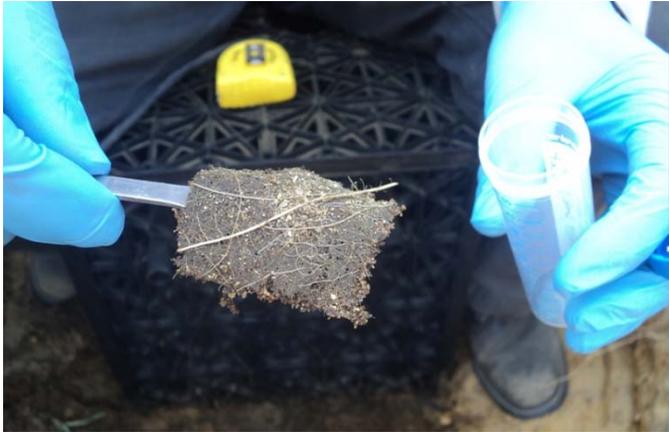
Figure 92 Root mat sample collected for microbial analysis.

Sediments were sampled for soil moisture content. These were from the eastern sidewall of the trench at different depths relative to the top of the gallery. We commenced collection of samples for microbial analysis from beneath Atlantis® crate #2 relative to the south end. As shown in Figure 92 below Crate #2, the root mat was very thin (several mm).

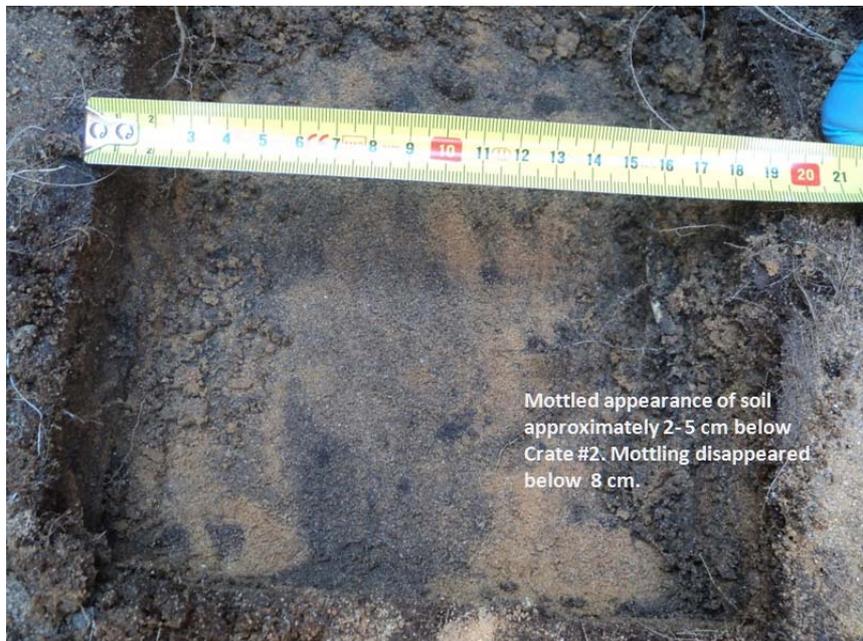
Figure 93 Discolouring or mottled appearance of soil below the gallery.

Soil samples for other analyses were taken successively deeper below this location. The depth intervals for sampling were 0.5- 1 cm; 1-2 cm, 2-5 and 5-10. A microbial sample was collected at 5-10 cm. The soil was very mottled with organic material (Figure 93). The mottling disappeared at 8 cm depth below Crate #2.

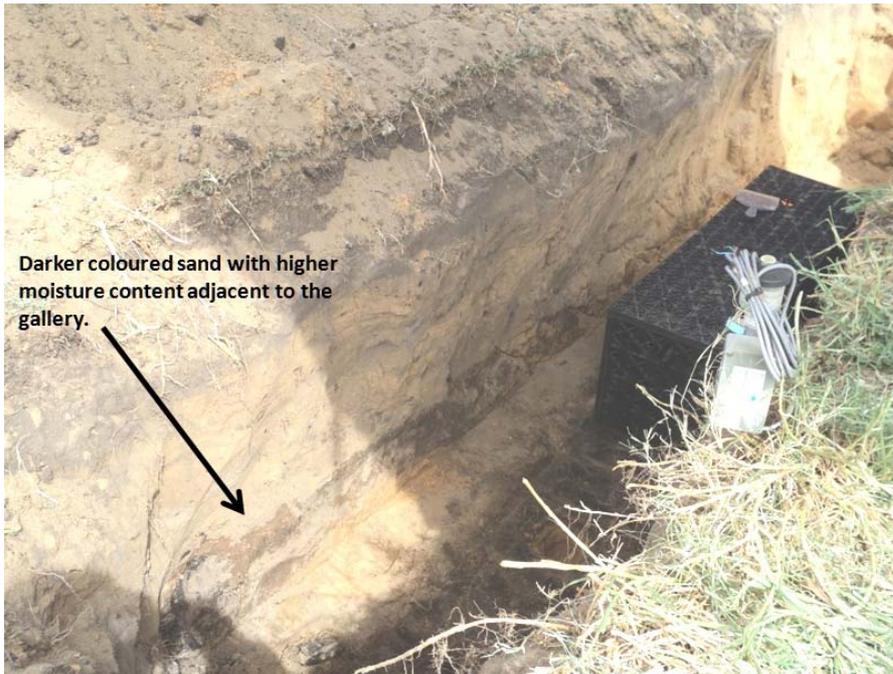
Figure 94 Variations in soil moisture content observed during excavation to remove the gallery.

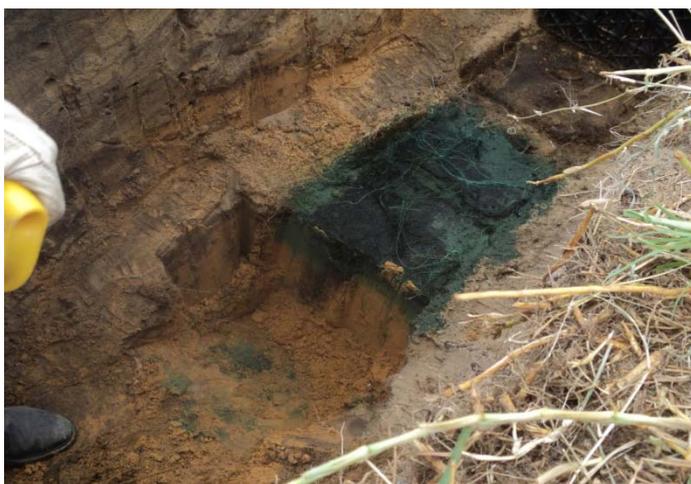
Figure 95 Dye-stained surface showing darker coloured soil due to organic debris and fairly uniform (matrix) flow in the vertical direction.

On Day 3 (13/3/2014) of dismantling the site, 5 Litre of a 1 g/L Brilliant blue dye solution were applied via watering can in approximately 5 minutes: 40 seconds. We did not try to get the rate to be exactly like the previously applied rate of wastewater, which was on the order of 4.3 L/minute. The dye was applied to the area below Crate #4. After dye application, slices of soil were progressively removed from the north-facing wall, which immediately revealed a tree root and organic debris that was likely pre-existing and unrelated to wastewater. We took slices from the east-facing wall to try to avoid the tree root. It appears that matrix flow rather than preferential flow existed. The presence of the root did not enhance flow. Although flow appears to be predominantly vertical, there is some evidence of lateral from away from the east and west sides of Crate #4, but it was not possible to quantify the relative amount of lateral versus vertical flow as it may have depended on the distribution and quantity of dye applied over the surface.

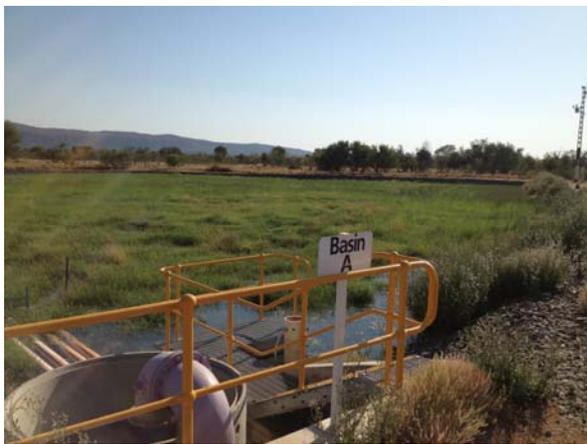
Figure 98 The inlet and pipes distributing recharge water in Basin A, which is covered with self-seeding Love Grass (*Eragrostis spectabilis*) (photo 23/10/2012).

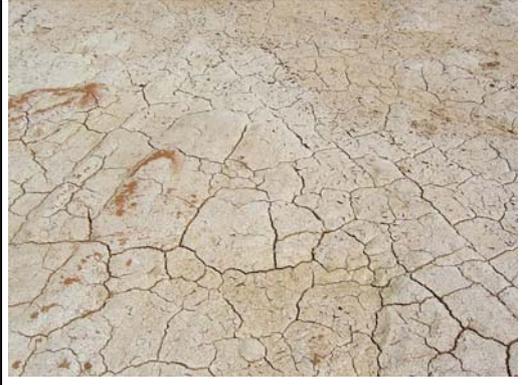
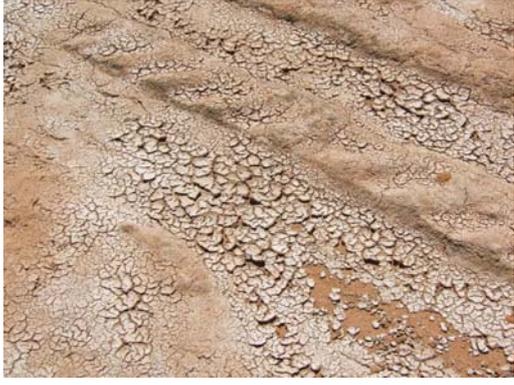
<p>Figure 101 Best bed surface. Bare dry soil to 3 cm depth – deep cracking (Breton 2009).</p>	<p>Figure 102 Acceptable bed surface. Bare dry soil to 3 cm depth – small cracking – complete crumbling of clogging layer to brownish thin material (Breton 2009).</p>

Breton (2009) provided guidance on the appearance of the basin surface prior to recharge (Figure 101-Figure 104).
