Managed Aquifer Recharge and Recycling Options: Understanding clogging processes and water quality impacts

A report of a study funded by the
Australian Water Recycling Centre of Excellence

Managed Aquifer Recharge and Recycling Options (MARRO)

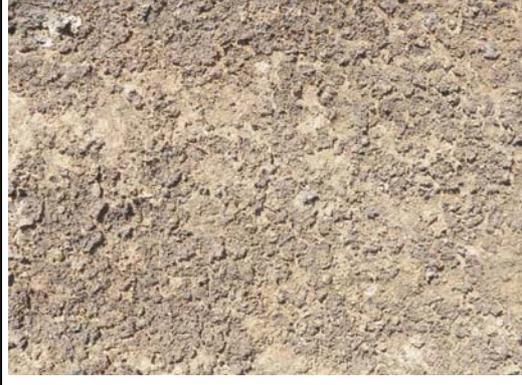
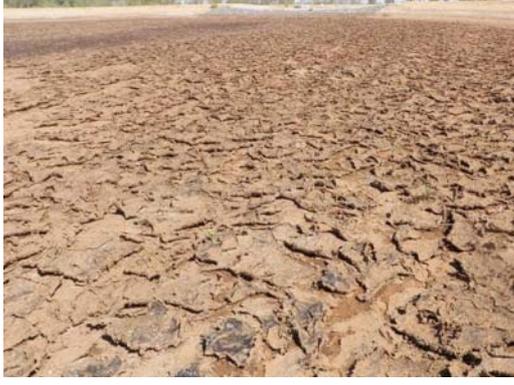
<p>Figure 103 Tolerable bed surface. Bare dry soil to 3 cm depth – complete crumbling of clogging layer to flaky thin greenish material (Breton 2009).</p>	<p>Figure 104 Inadequate bed surface. Inefficient cracking – thick white greenish algae with fibrous texture that do not break down or crumble during drying period and cover most of the basin area – soil moist for extended periods (Breton 2009).</p>

Breton (2009) provided guidance on the appearance of the basin surface prior to recharge (Figure 101-Figure 104).
