Guerrieri, Maurice, Lee, Duffy, Lee, Vern and Haines, Luke (2024) Effect of uniaxial loading on the spalling of concrete panels for Melbourne's Metro Tunnel Project. *Structural Concrete*, 25 (3). pp. 1676-1701. ISSN 1464-4177

Effect of uniaxial loading on the spalling of concrete panels for Melbourne's Metro Tunnel Project

concrete, fire resistance, polypropylene fibers, spalling, tunnel fire, uniaxial loading

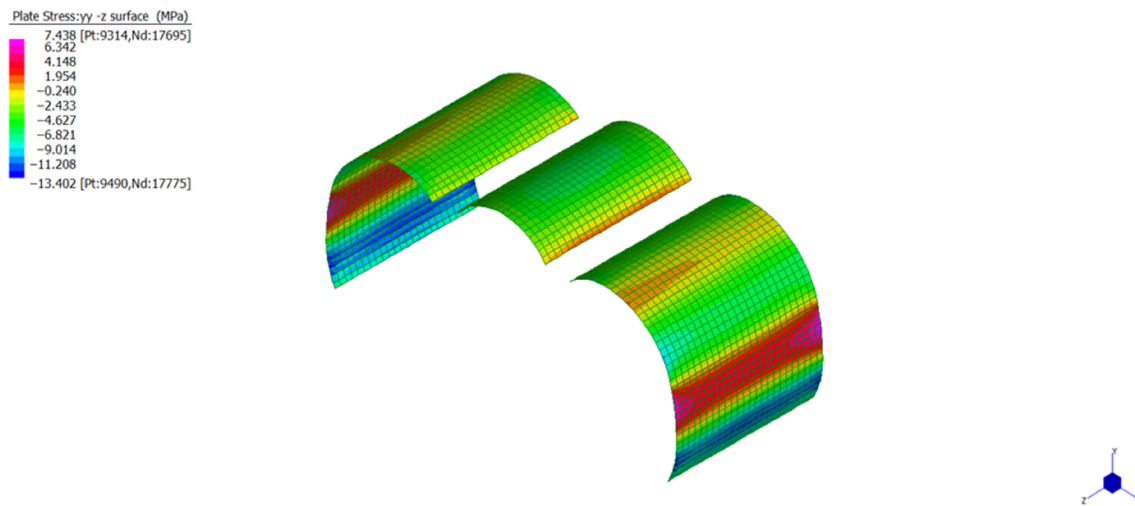
FIGURE 3 Serviceability limit state load combination 80B.

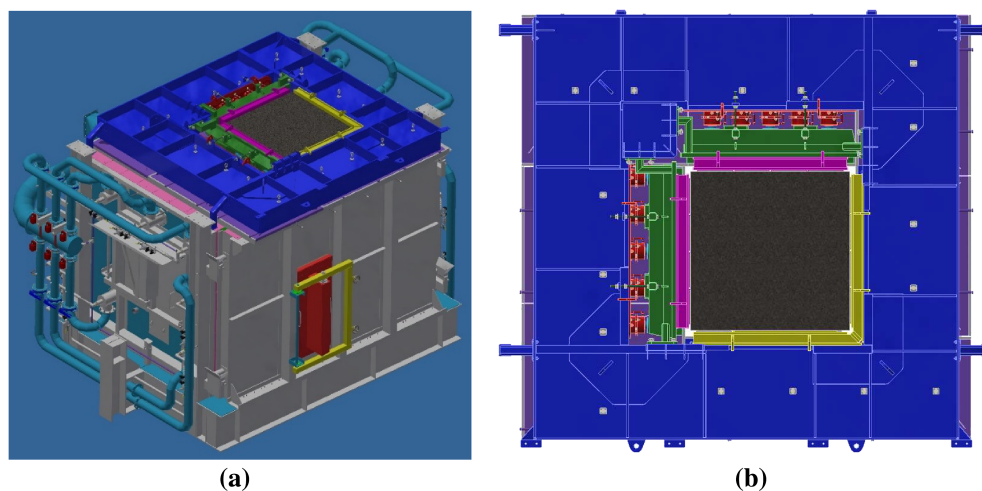
FIGURE 4 Schematic illustration of (a) flat panel testing assembly on top of furnace and (b) birdseye view of biaxial structural frame with specimen.

The structural fire testing furnace is outfitted with 12 gas powered burners (3GJ/h each) and the furnace is assembled in a modular format to provide the ability of testing beams, columns, floors/ceilings, ducts, and walls in both an unloaded and loaded arrangement.¹⁸ The inner sizes of the furnace are 4500 × 3700 × 3000 mm, and the furnace has the capability to run any international fire curve including clientele specific designed curves. For example, only the RABT ZTV (Train/Car) fire curves involve the furnace temperatures to achieve 1200°C and then decrease to ambient temperatures linearly.¹⁸ This linear cooling stage can be designed to be implemented when the user chooses, including at the end of a 2-h modified hydrocarbon fire test.¹⁸ The furnace is also outfitted with 12 viewing ports and a furnace endoscope providing real-time 4 k video footage of the combustion chamber. The furnace time temperature program is controlled by eight Type K (National Association of Testing Authorities [NATA] Certified up to 1350°C; 3-mm diameter, 310 stainless steel mineral insulated metal sheathed) thermocouples that are positioned in the furnace relevant to the testing standard specified.¹⁸ Whilst the furnace has been used previously for testing four unloaded flat panels simultaneously with plan dimensions of 1550 × 1550 × 260 mm and full-scale structural loaded tunnel elements as previously published,¹⁸ the furnace is also able to test panels up to 1800 × 1800 × 400 structurally loaded biaxially (up to 500 t at 50% yield) as

shown in Figures 4 and 5 respectively. The self-reaction frame transmits the side loading via five horizontal hydraulics rams on one side (uniaxial loading) and two sides (biaxial loading). The load is monitored by three NATA Certified load cells (on each side) which are placed on the horizontal axis on two sides when needed. The side loading can either be applied and locked allowing the load to change as a function of time during the test or it can be helped via a programmable logic controller. The specimen is simply supported on four ledges which are 1550×30 mm yielding a fire-exposure area of 1490×1490 mm (approximately 2.2 m^2).

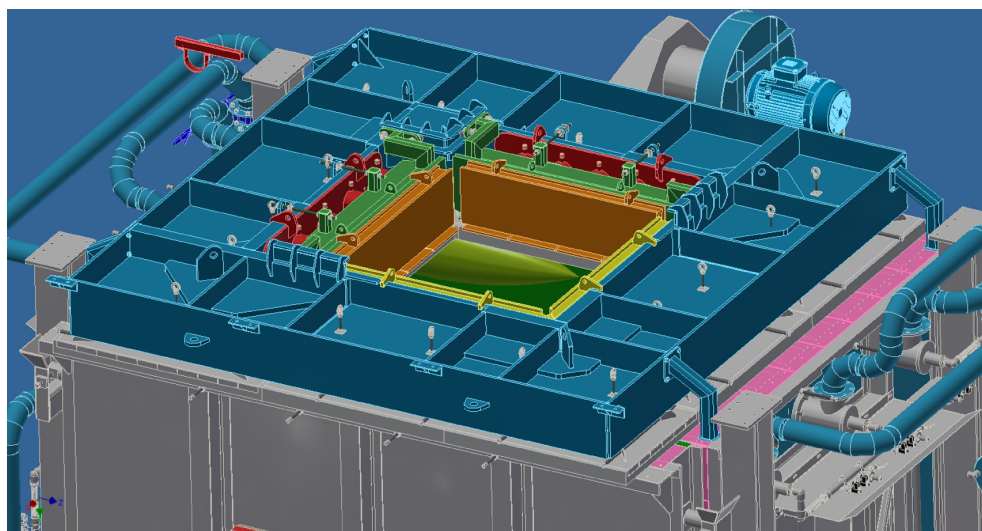
FIGURE 5 Schematic illustration of the biaxial rig structural frame exposure area.

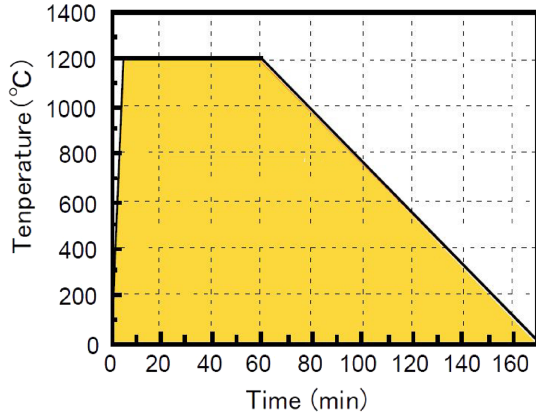
FIGURE 6 RABT ZTV (rail) temperature versus time curve (modified from ref. 43)

concrete spalling due to high thermal shock.^{12,13} During the RABT ZTV (rail) time temperature curve, the furnace temperatures increase by 200°C per minute until 1200°C is reached. This temperature is then held for a further 55 min where then the furnace temperature decreases linearly for a duration of 115 min where it reaches temperatures below 90°C.¹⁸

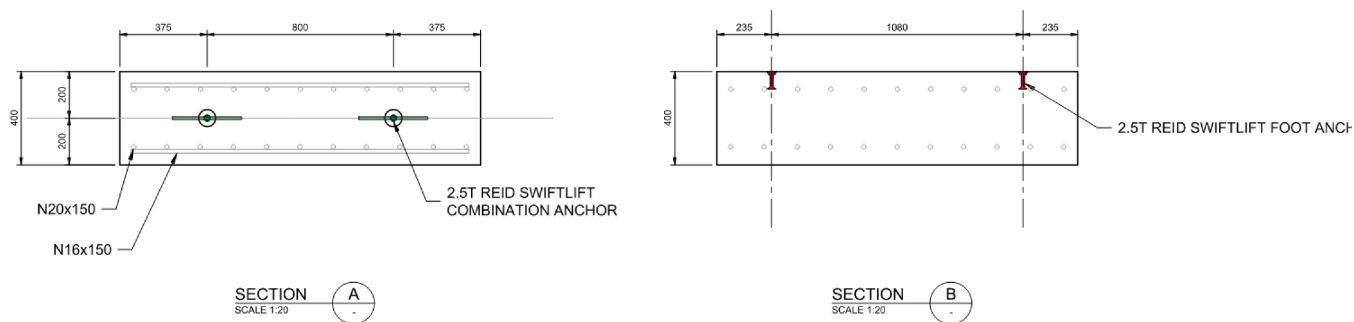
FIGURE 8 Reinforced panels geometry and reinforcement.

50 mm from the top and bottom face and N16 × 150 bars. The mix design and specimen strength details along with their client ID are shown in Table 3. Limited details on the mix design can be provided due to intellectual property. Three different dosages of polypropylene fiber content were investigated (1.2, 1.4, and 1.6 kg/m³) whilst the base concrete mix was consistent. Although Eurocode 2²⁹ recommends a fiber dosage rate of at least 2.0 kg/m³, it has been shown by McNamee et al.²⁸ that reducing the dosage to 0.2 kg/m³ can reduce the spalling by 50% provide the aggregate is stable. Each mix design had a total of four specimens cast, two samples for fire testing, one extra backup specimen and one specimen for curing purposes prior to the fire test in alignment with EFNARC 132F r3:2006.⁴¹

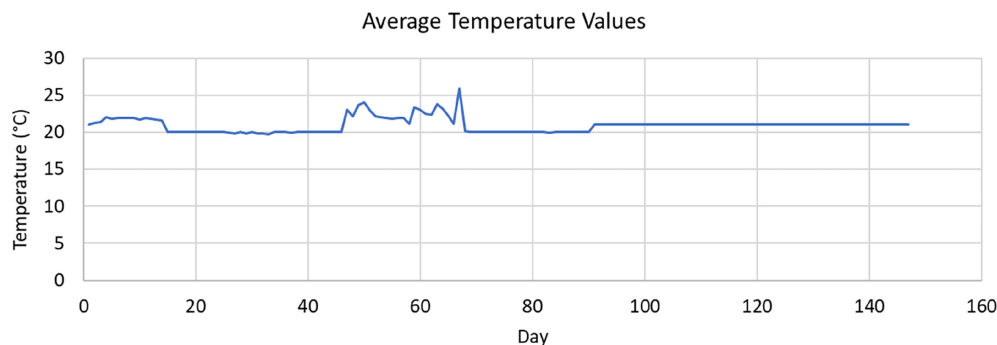
FIGURE 9 Average temperatures with curing container.

the specimens were transported to the Victoria University Structural Fire Testing Facility located in Werribee, Victoria, Australia, where they were placed in purpose built 40 ft shipping containers that were retrofitted to provide the require curing conditions. The specimens were cured for 28 days at 20 ± 2°C and at a relative humidity of greater than 90% ± 10%. After this initial curing period, the specimens were conditioned at 20 ± 2°C and at a relative humidity of greater than 95% ± 10% for 28 days followed by a further 56 days at 20 ± 2°C and at a relative humidity of greater than 50% ± 10%. The specimens were kept in these conditions, until the test date. The temperature and humidity control system were remotely monitored by mobile and the temperature and relative humidity curing profile are shown in Figures 9 and 10, respectively.

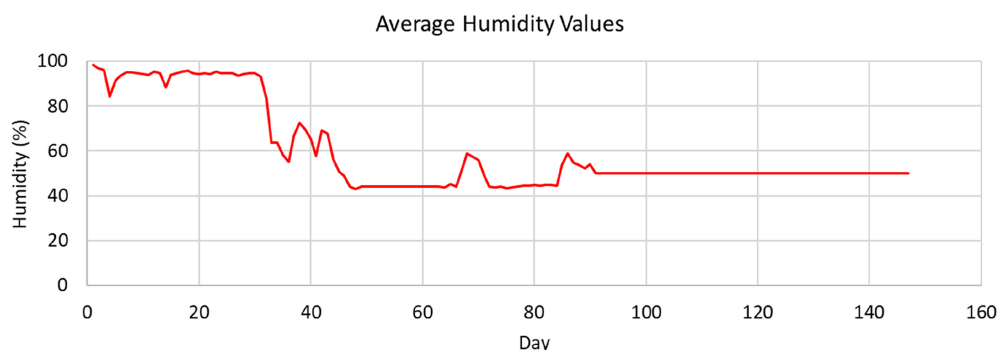
FIGURE 10 Average relative humidity with curing container.

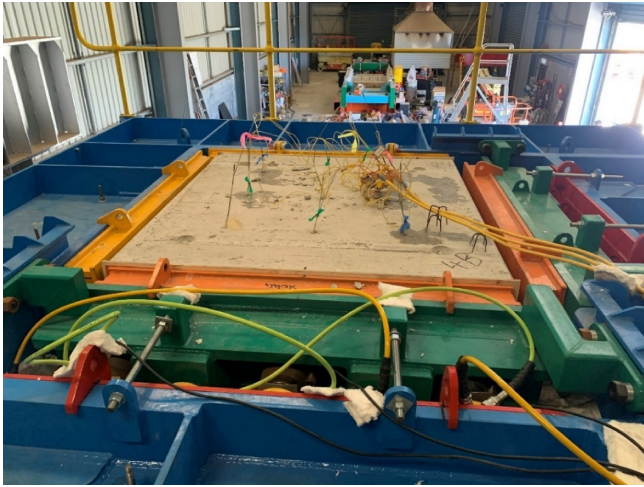
FIGURE 11 Photograph of the biaxial rig on top of the furnace.

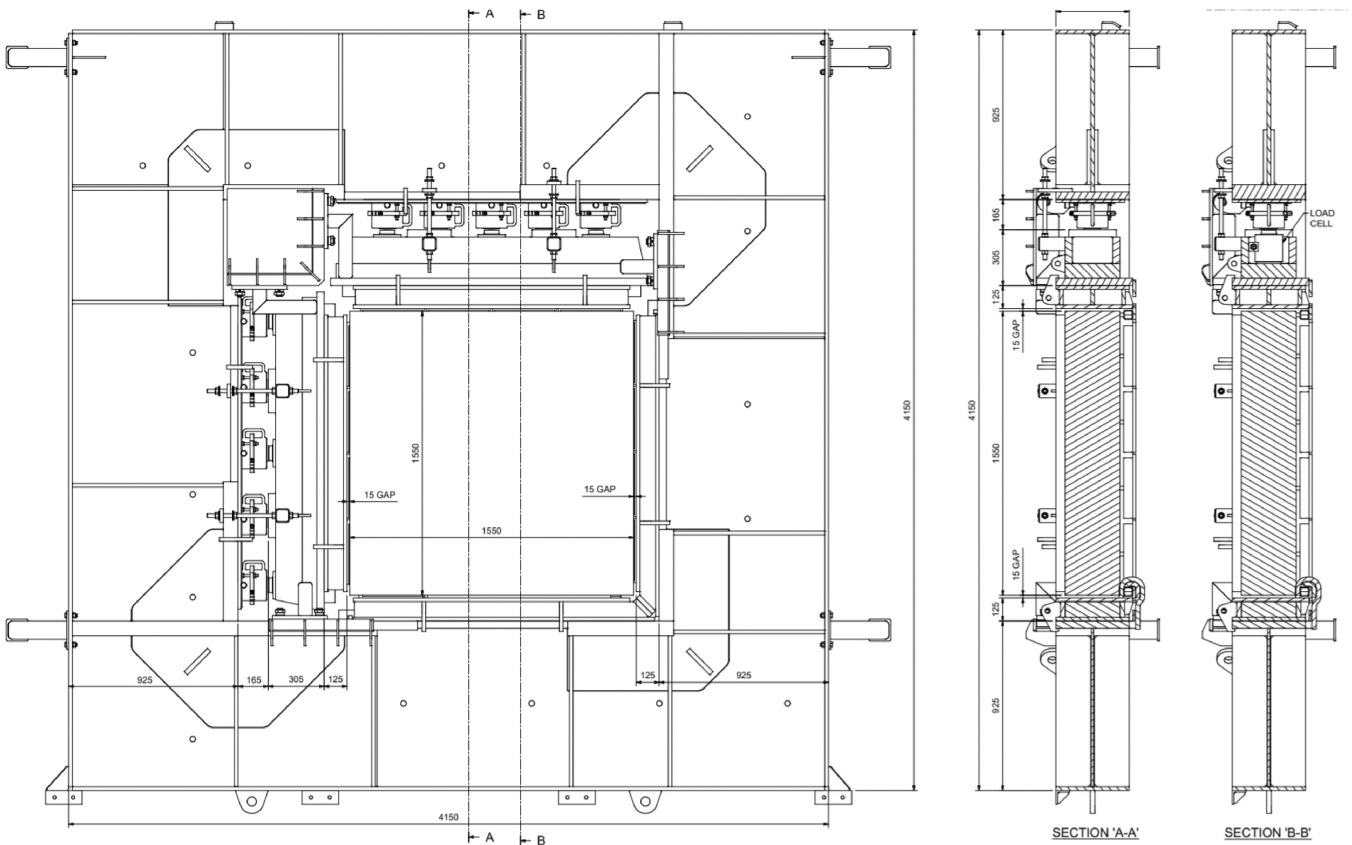
FIGURE 12 Structural testing rig design.

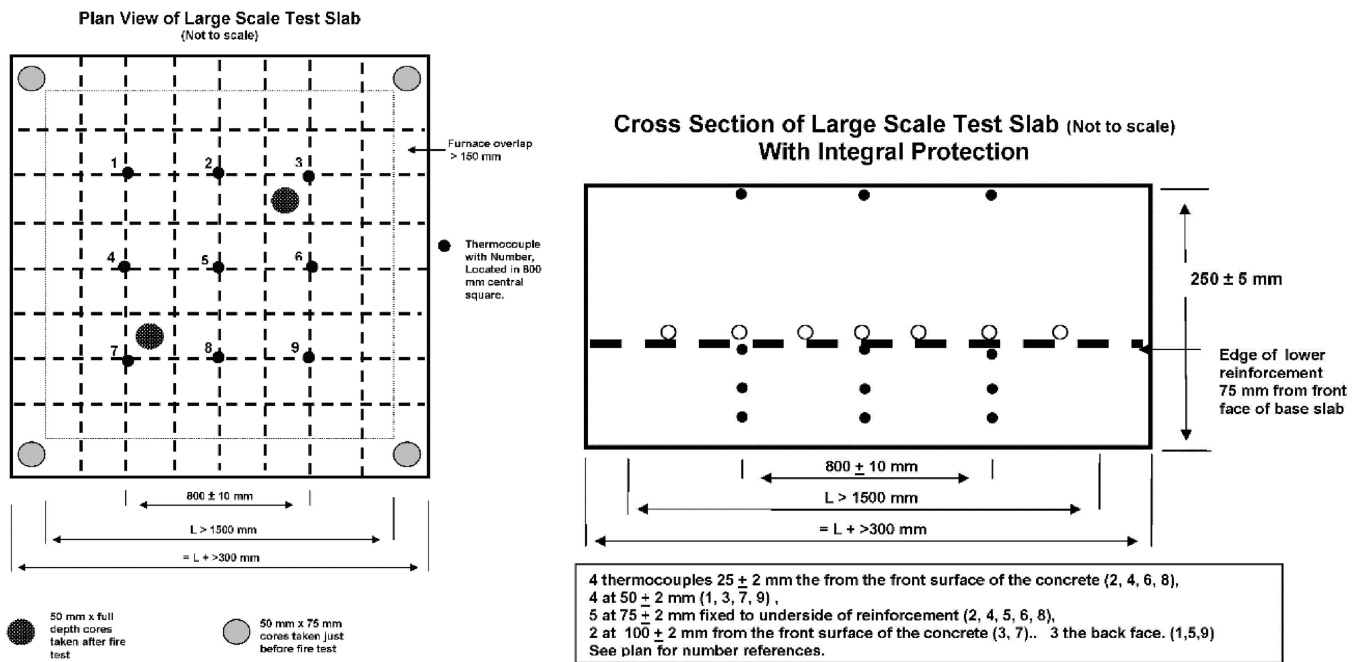
FIGURE 13 Specimens *in situ* thermocouple location in relation to EFNARC⁴¹ (extracted from EFNARC: 2006, Figures 3 and 4).

EFNARC 132F r3:2006⁴¹ defines a central area of 800 × 800 mm where nine locations are specified where thermocouples are placed at varying depth as shown in Figure 13. The *in situ* thermocouples consist of Type K (NATA-certified up to 1200°C; 3-mm diameter, 310 stainless steel mineral insulated metal sheathed). A total of 18 thermocouples were cast for each flat panel apart from the panels that cores prior to the fire test were to be taken, as shown in Figure 14. The *in situ* thermocouples were located at 50 and 300 mm from the fire surface at location T1 and T9, 25 and 75 mm from the fire surface at location T2, T4, T6, and T8, 50 and 100 mm from the fire surface at location T3 and T7, and 75 plus 300 mm from the fire surface at location T5. The location and depths of the thermocouples are

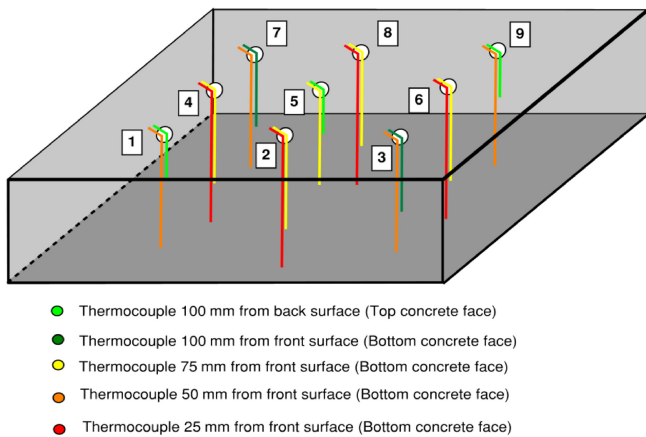
FIGURE 14 Schematic of the flat panel *in situ* thermocouple layout.

shown in Figure 14. An Agilent 34970a data logger was used to record the temperatures every 10 s for a period of 24 h.

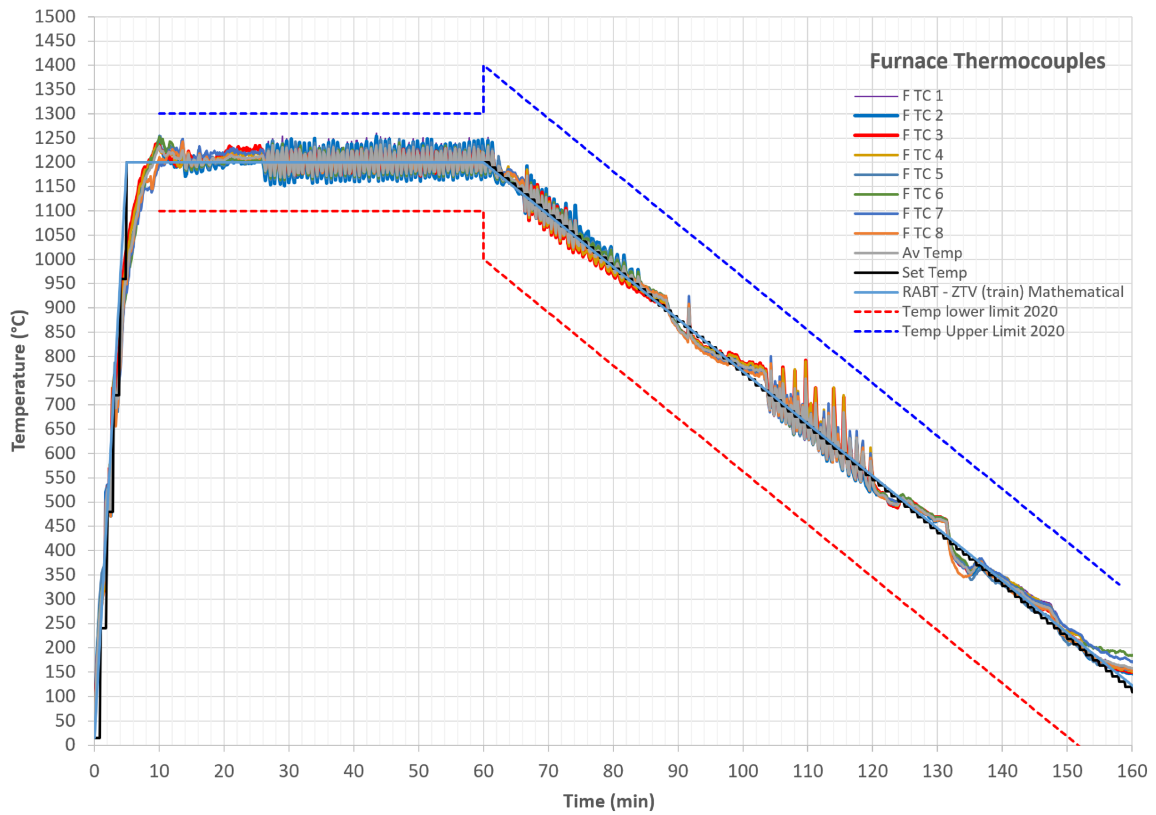
FIGURE 15 Temperature versus time for Specimen 4B.

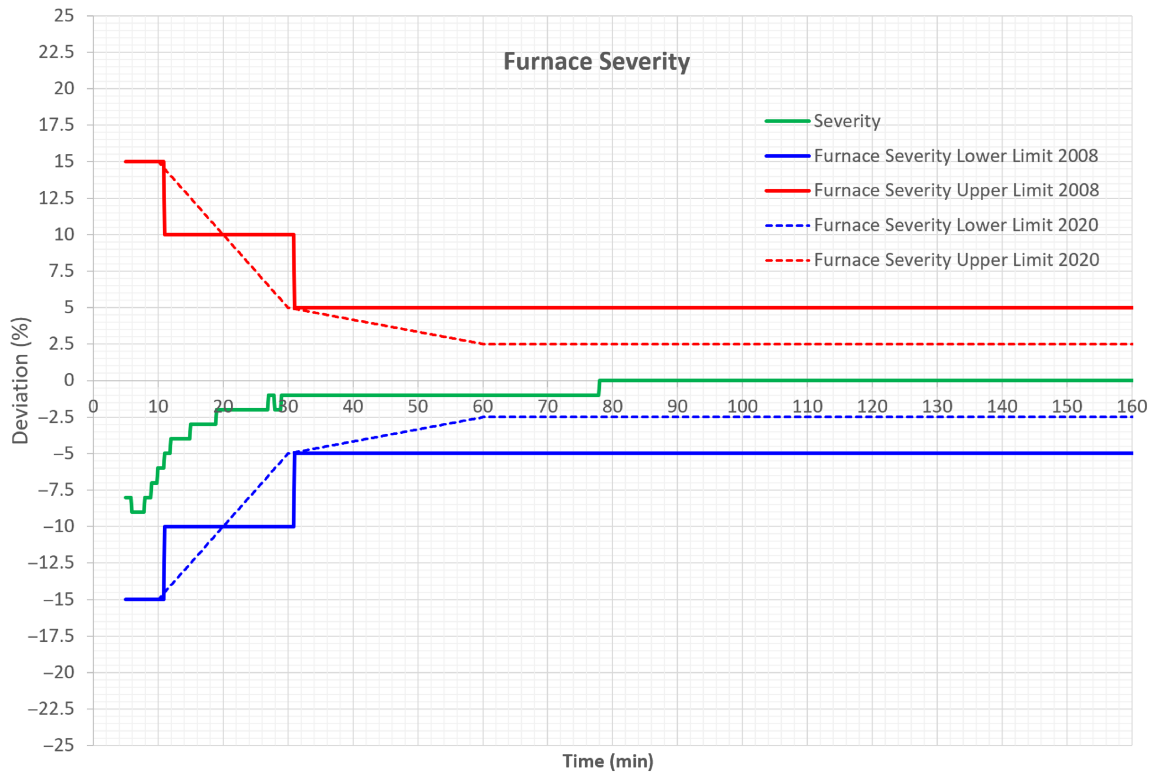
FIGURE 16 Furnace severity for Specimen 4B.

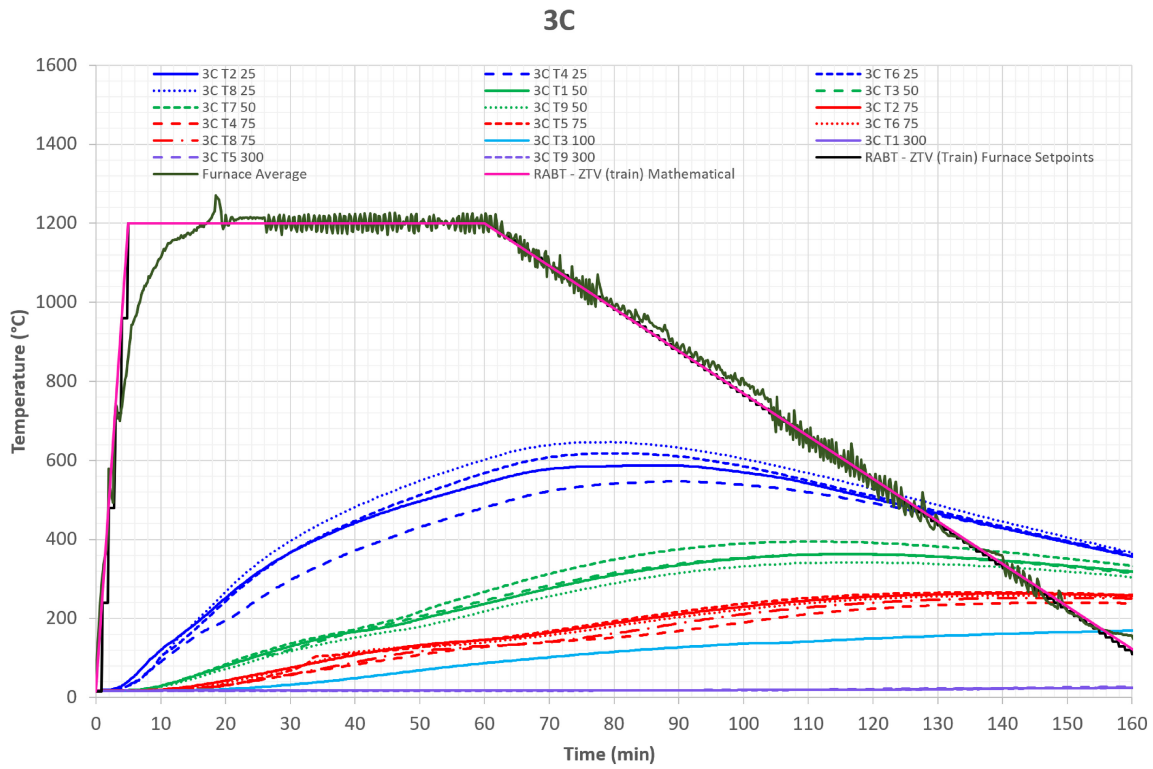
FIGURE 17 *In situ* time versus temperature measurements for Specimen 3C.

Figures 17–21 characterizes a collection of the *in situ* time temperature data at each thermocouple measurement depth and location for all the specimens. The

figures illustrate that the temperature profile follows the typical heat transfer between a hot and cold boundary as the *in situ* temperatures drops from the heated face

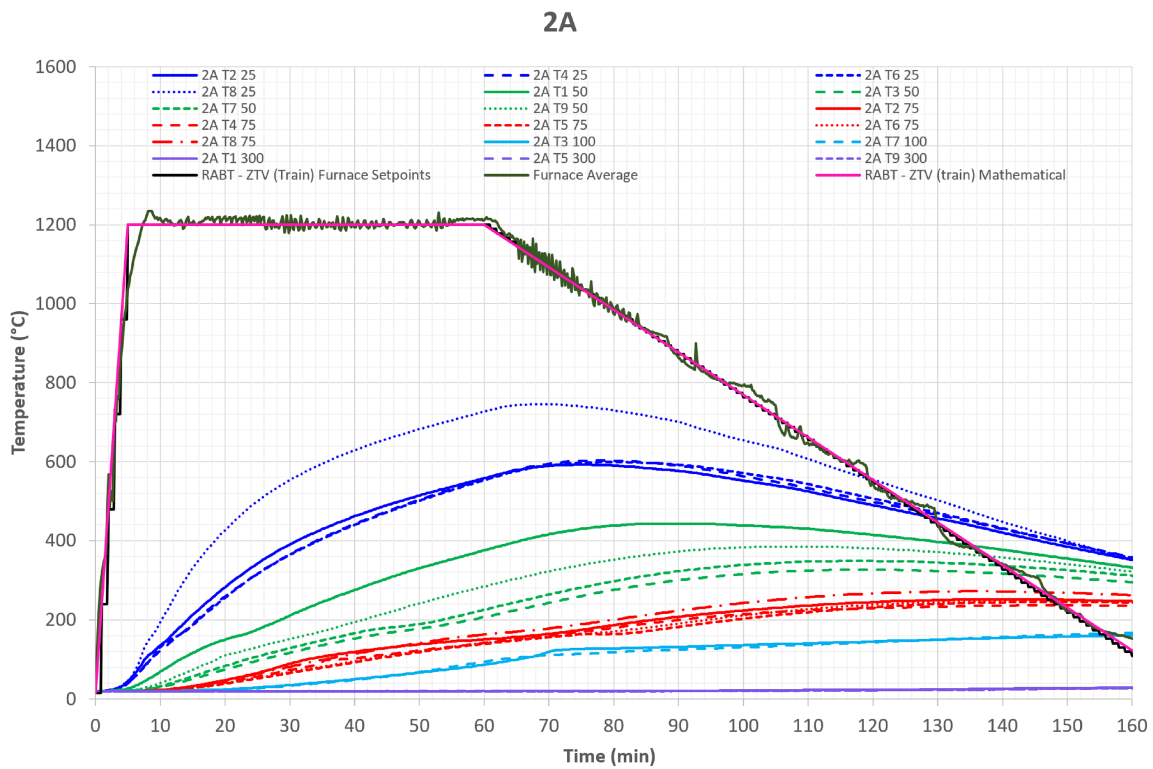
FIGURE 18 *In situ* time versus temperature measurements for Specimen 2A.

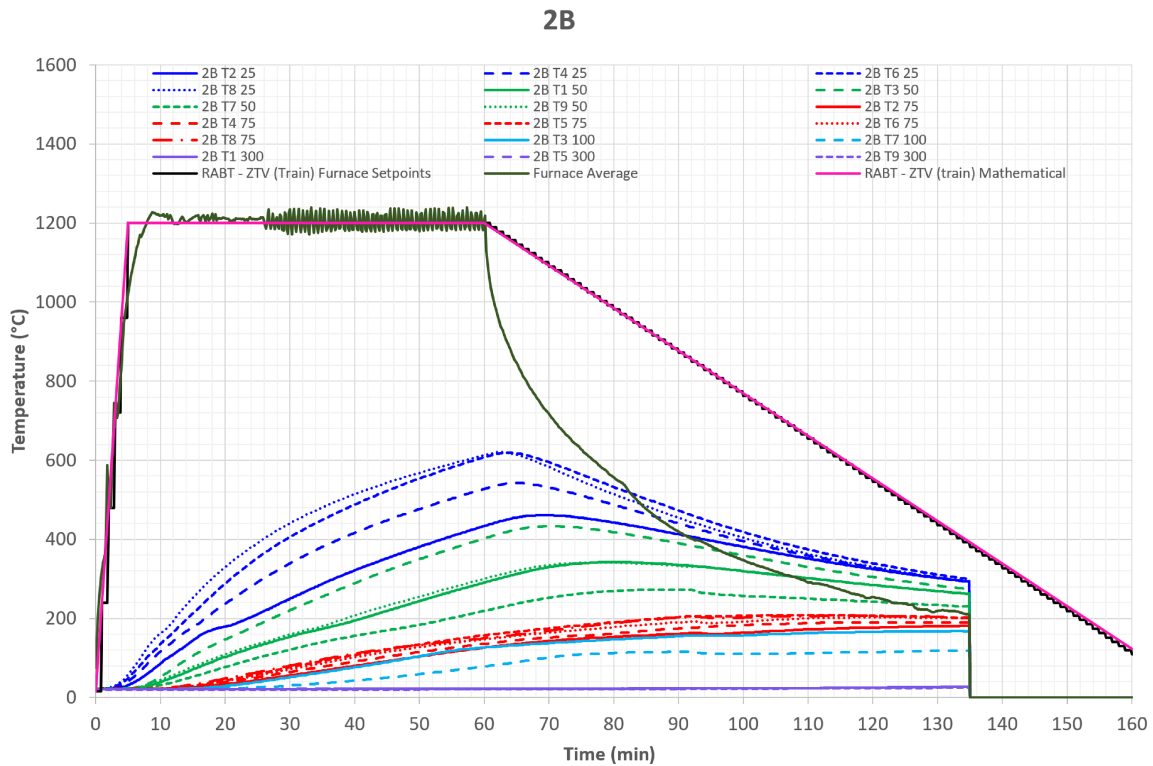
FIGURE 19 *In situ* time versus temperature measurements for Specimen 2B. Test was terminated at the conclusion of the heating phase (61 min) and no data was recorded after 134 min.

From Figure 20, Specimen 4A, one thermocouple located at T6 at a depth of 25 mm had a sharp temperature rise indicating that spalling occurs in this area. Given that the temperature did not asymptote to the furnace temperatures, this implies that at this location, spalling was confined to less than 25 mm. Similar findings can be seen in Figure 21, Specimen 4B, whereby at locations T2 and T4 at a depth of 25 mm, the *in situ* temperatures had a sharp temperature rise. The difference in spalling location for identical specimens is in alignment with the findings in the literature which state that there are discrepancies in spalling identical specimens and spalling is often sporadic in nature.^{18,56–60} In the third and fourth fire tests for Specimens 2B and 4A as shown in Figures 19 and 20, the test was terminated early, at the

start of the cooling phase due to the failure of the structural rig insulation, which could have jeopardized the loading frame. Given that spalling occurred within the first 30 min, the heating phase had completed, and no further spalling was noticed in Test 1, 2, and 5, so the early termination had no bearing on the results.

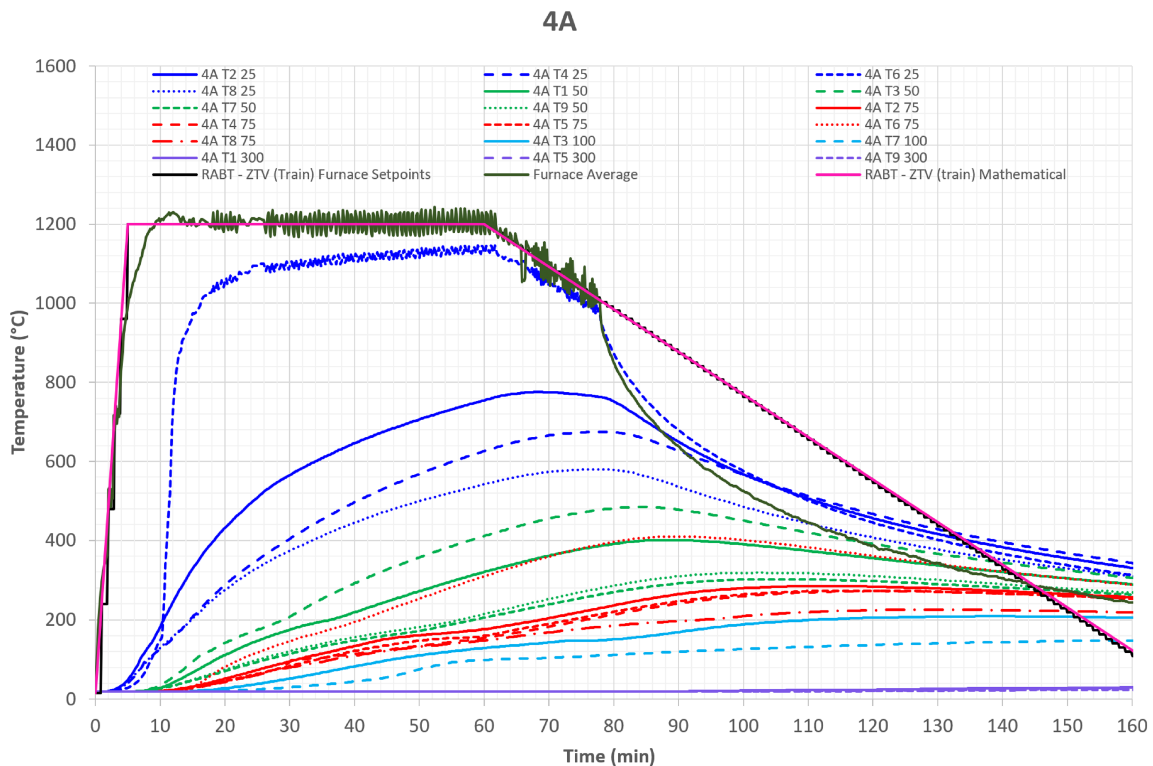
FIGURE 20 *In situ* time versus temperature measurements for Specimen 4A. Test was terminated at the conclusion of the heating phase and approximately 17 min during the cooling phase (77 min).

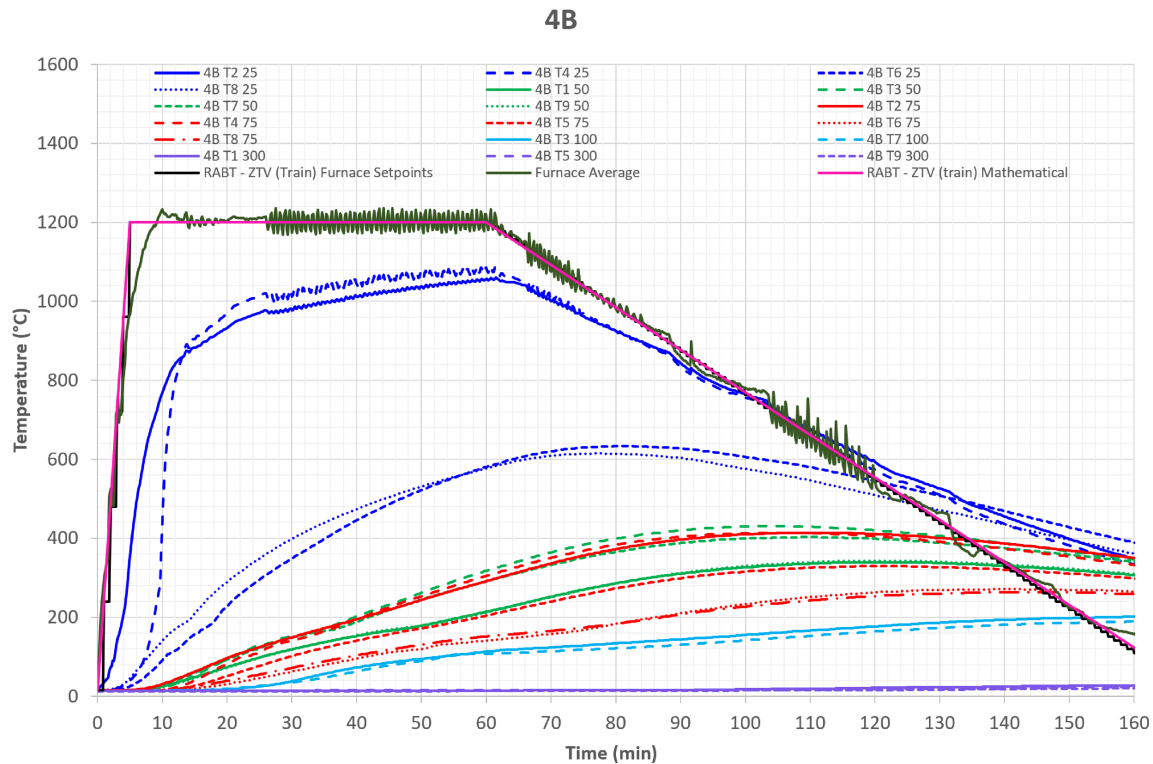
FIGURE 21 *In situ* time versus temperature measurements for Specimen 4B.

- T1 50—Represents a thermocouple embedded at location T1 at a depth of 50 mm from the heated face in accordance with the EFNARC procedure.
- T2 75—Represents a thermocouple embedded at location T2 at a depth of 75 mm from the heated face in accordance with the EFNARC procedure.
- T3 100—Represents a thermocouple embedded at location T3 at a depth of 100 mm from the heated face in accordance with the EFNARC procedure.
- T9 300—Represents a thermocouple embedded at location T9 at a depth of 300 mm from the heated face in accordance with the EFNARC procedure.

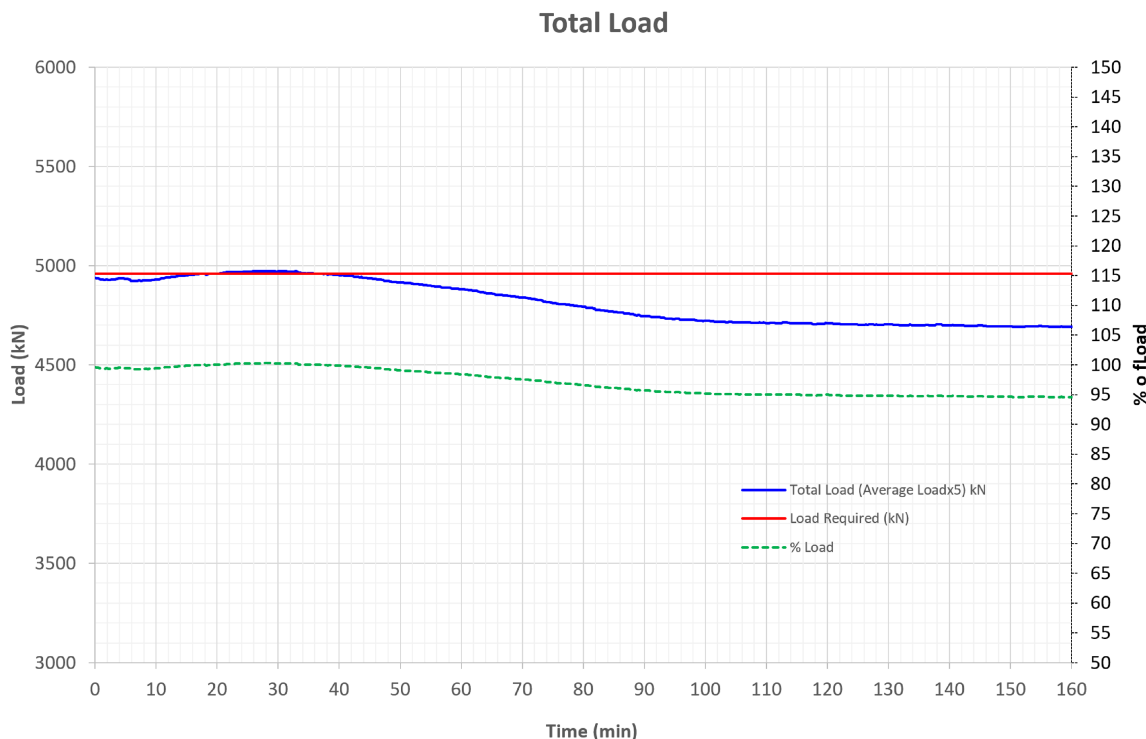
FIGURE 22 Structural load versus time for Specimen 4B.

Figure 22 represents the structurally applied uniaxial horizontal load versus time profile for Specimen 4B. These data are similar across all loaded fire tests and therefore they are not reproduced within this manuscript but are made available upon request. The average total load is the average of the loads applied by the five hydraulic rams. The differences between the loads of these five rams were a maximum of 1.3%. The load was applied 30 min prior to the commencement of the furnace firing and was locked by means of a hydraulic manifold. The load was not required to be maintained during the testing procedure. As shown in Figure 21 the load steadily dropped to 95% at the conclusion of the test (160 min). This drop in load is postulated to be caused by a hydraulic oil leak even though the manifold was closed. This is explained by the fact that the hydraulic rams reached a maximum temperature of 41°C during the test which thinned out the oil and caused an oil leak.

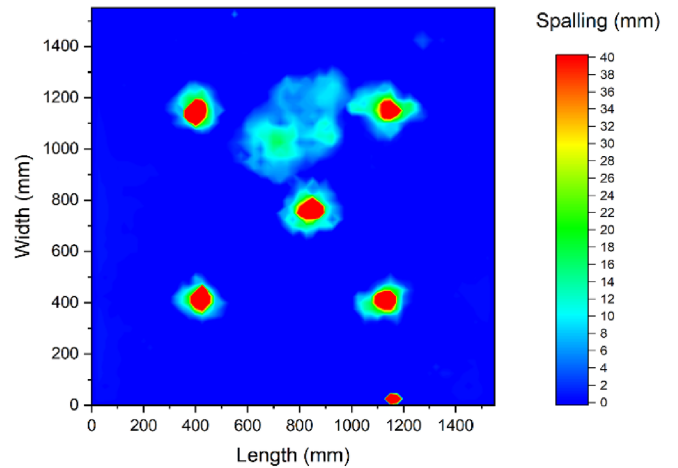
FIGURE 28 Panel 2A spalling contour plot (5.52 mm average spalling within 800 × 800 mm region).

The scanning was performed post-coring, which explains the red circles on the spalling contour plots. The

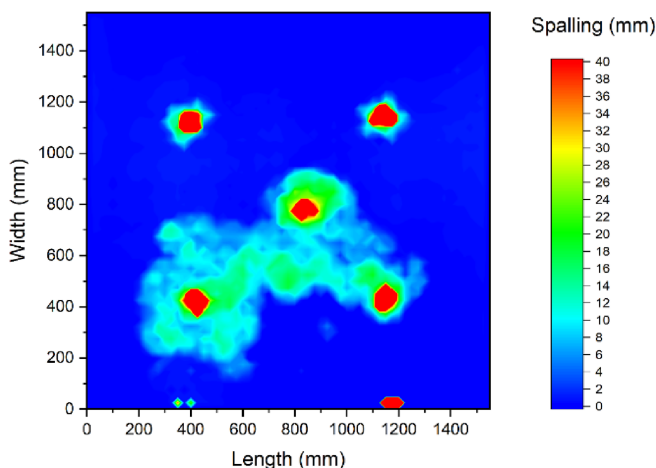
FIGURE 29 Panel 2B spalling contour plot (4.81 mm average spalling within 800 × 800 mm region).
